## **Appendix H: Survey Forms for Removed Properties**

Survey Date:	September 3, 2019
Resource No:	001
Project Location:	Tarrant County
Project Name and CSJ:	Southeast Connector, CSJ 0008-13-125, etc.
Address, Lat/Long:	6501 Brentwood Dr. 32.755926° , -97.218520°
Function/Sub-function:	DOMESTIC/ Single family dwelling
Construction Date:	1958
NRHP Eligibility:	Not eligible
Integrity/Comments:	Ranch style house with wavy brick siding, horizontal vinyl siding under the gables, cross-gabled roof with a shallow pitch and generous eaves, and replacement windows.

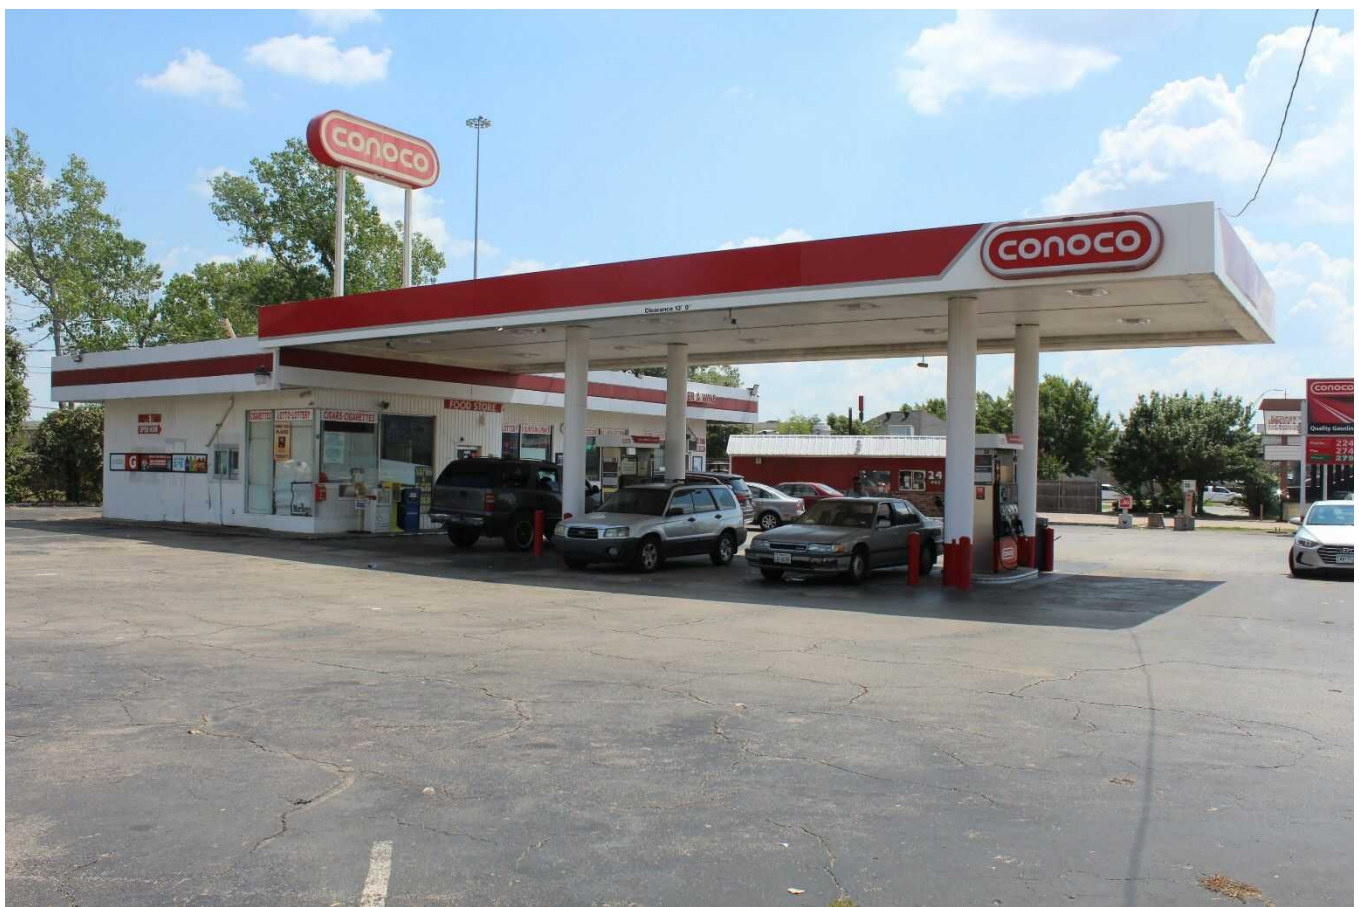
Survey Date:	September 3, 2019
Resource No:	002
Project Location:	Tarrant County
Project Name and CSJ:	Southeast Connector, CSJ 0008-13-125, etc.
Address, Lat/Long:	6509 Brentwood Stair Rd. 32.755775°, -97.217408°
Function/Sub-function:	COMMERCE/ Gas station
Construction Date:	Ca. 1965
NRHP Eligibility:	Not eligible
Integrity/Comments:	Contemporary style gas station with metal siding, flat roof, and modern branded metal canopy. The south end of the building is an addition with some replacement windows; the windows on the north end appear to be original.

Camera facing northeast.

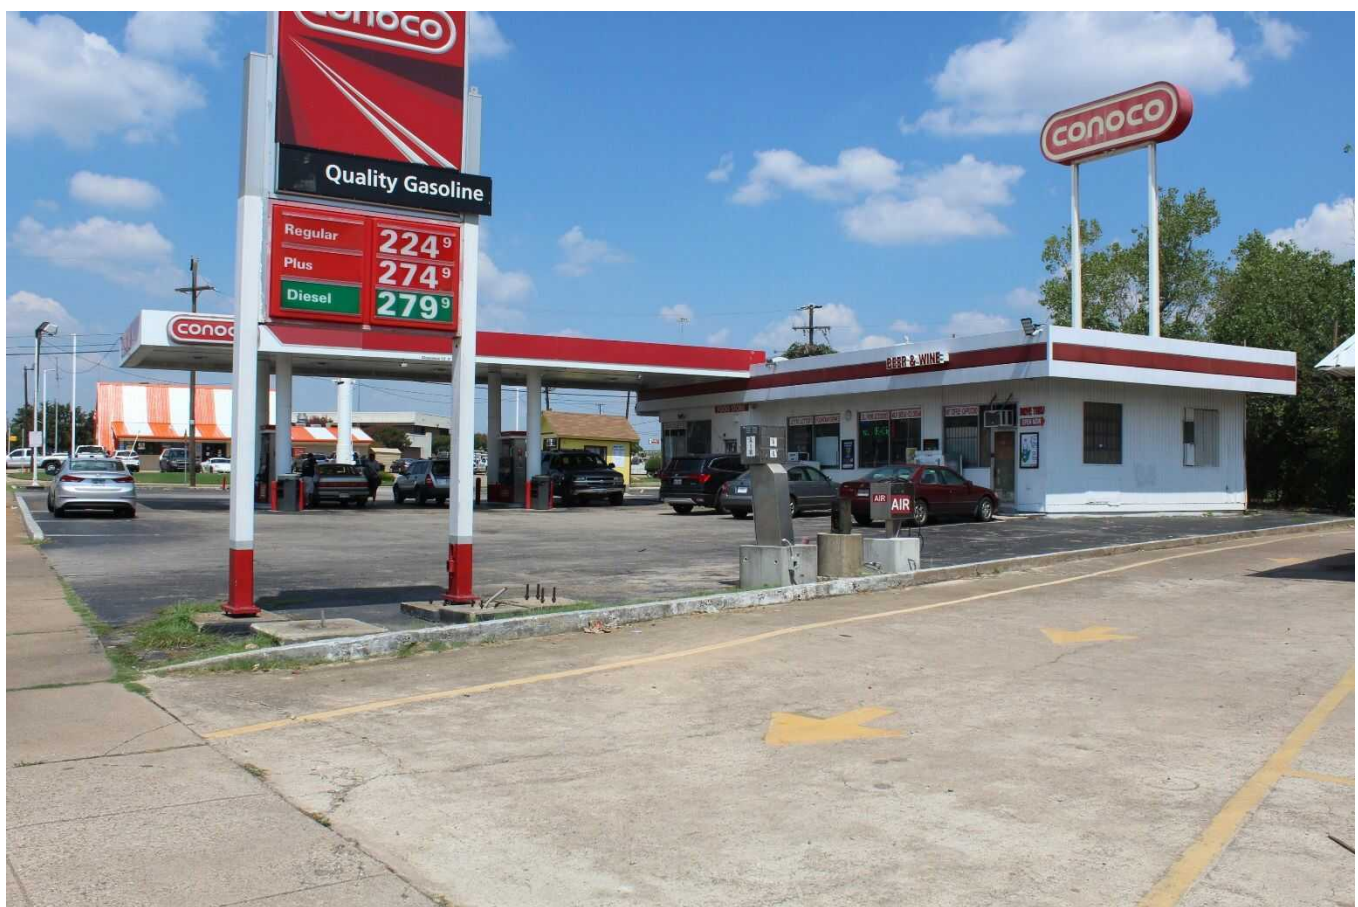
Survey Date:	September 3, 2019
Resource No:	002
Project Location:	Tarrant County
Project Name and CSJ:	Southeast Connector, CSJ 0008-13-125, etc.
Address, Lat/Long:	6509 Brentwood Stair Rd. 32.755775°, -97.217408°
Function/Sub-function:	COMMERCE/ Gas station
Construction Date:	Ca. 1965
NRHP Eligibility:	Not eligible
Integrity/Comments:	Contemporary style gas station with metal siding, flat roof, and modern branded metal canopy. The south end of the building is an addition with some replacement windows; the windows on the north end appear to be original.

Camera facing northwest.

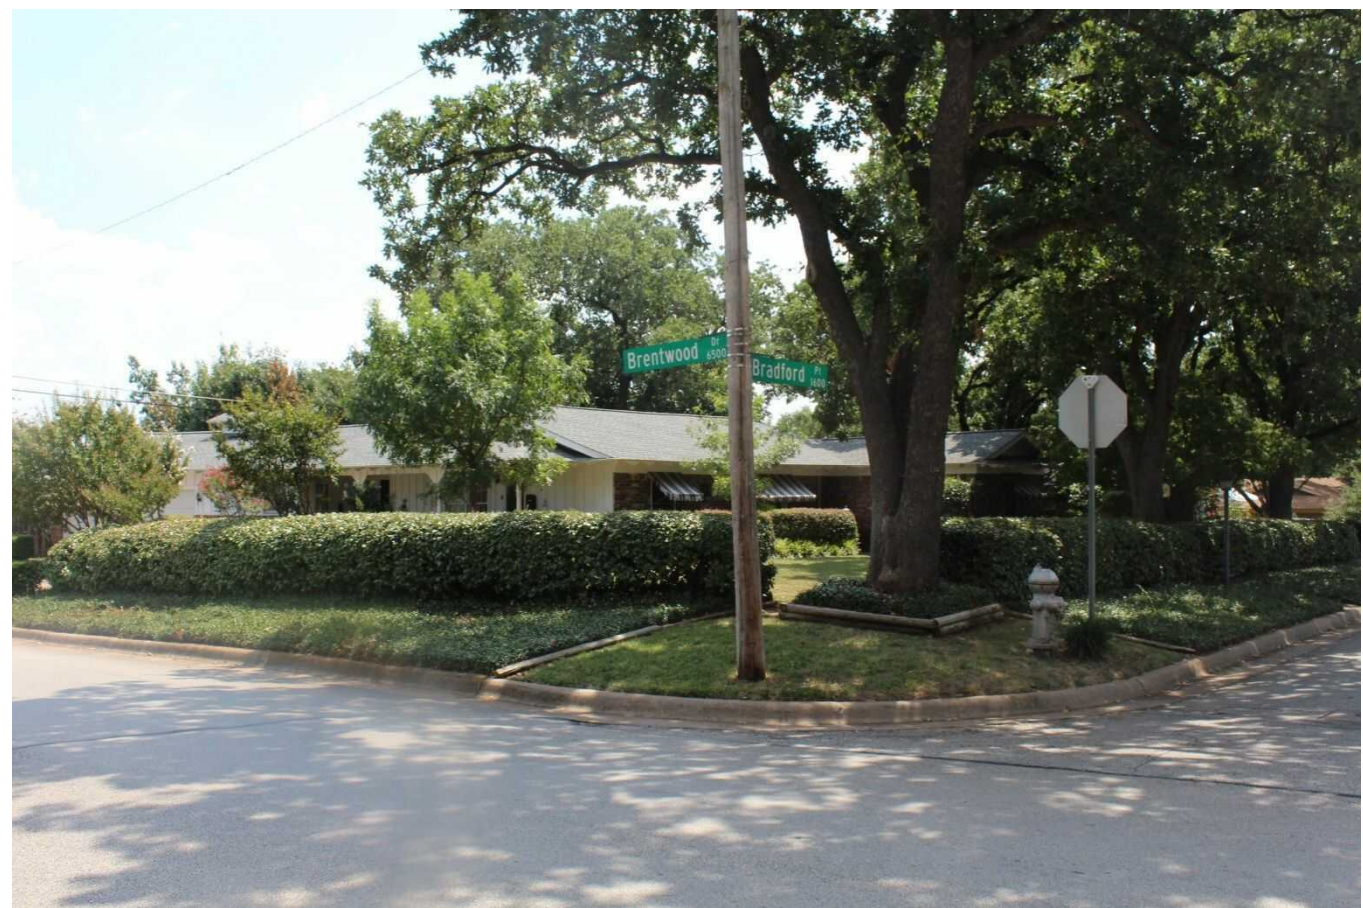
Survey Date:	September 3, 2019
Resource No:	003
Project Location:	Tarrant County
Project Name and CSJ:	Southeast Connector, CSJ 0008-13-125, etc.
Address, Lat/Long:	6500 Brentwood Dr. 32.755520°, -97.218589°
Function/Sub-function:	DOMESTIC/ Single-family dwelling
Construction Date:	1957
NRHP Eligibility:	Not eligible
Integrity/Comments:	Ranch style house with mixed brick and vertical wood siding, a shallow cross-gabled roof with modest eaves and exposed rafter tails, and a small inset porch with turned wood posts. The house has modern replacement windows and added cloth awnings. A modern shed is in the back yard.

Camera facing southeast.

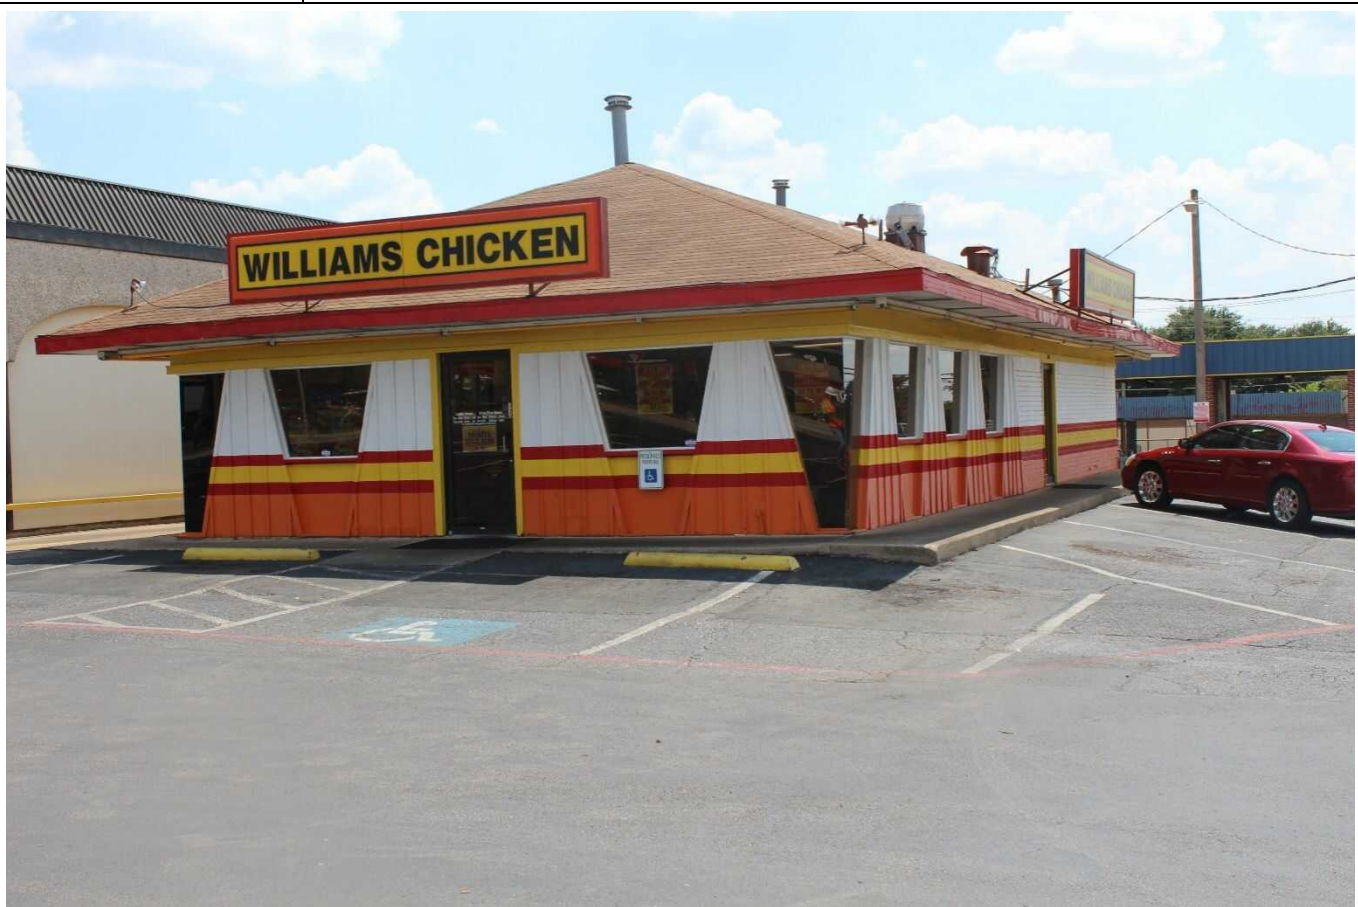
Survey Date:	September 3, 2019
Resource No:	010b
Project Location:	Tarrant County
Project Name and CSJ:	Southeast Connector, CSJ 0008-13-125, etc.
Address, Lat/Long:	1701 McClellen Ct. 32.753729° , -97.215996°
Function/Sub-function:	COMERCE/ Restaurant
Construction Date:	Ca. 1975
NRHP Eligibility:	Not eligible
Integrity/Comments:	Concrete building with added decorative wood siding, metal frame picture windows, and a hipped roof with generous boxed eaves. Currently houses Williams Chicken.

Camera facing southeast.

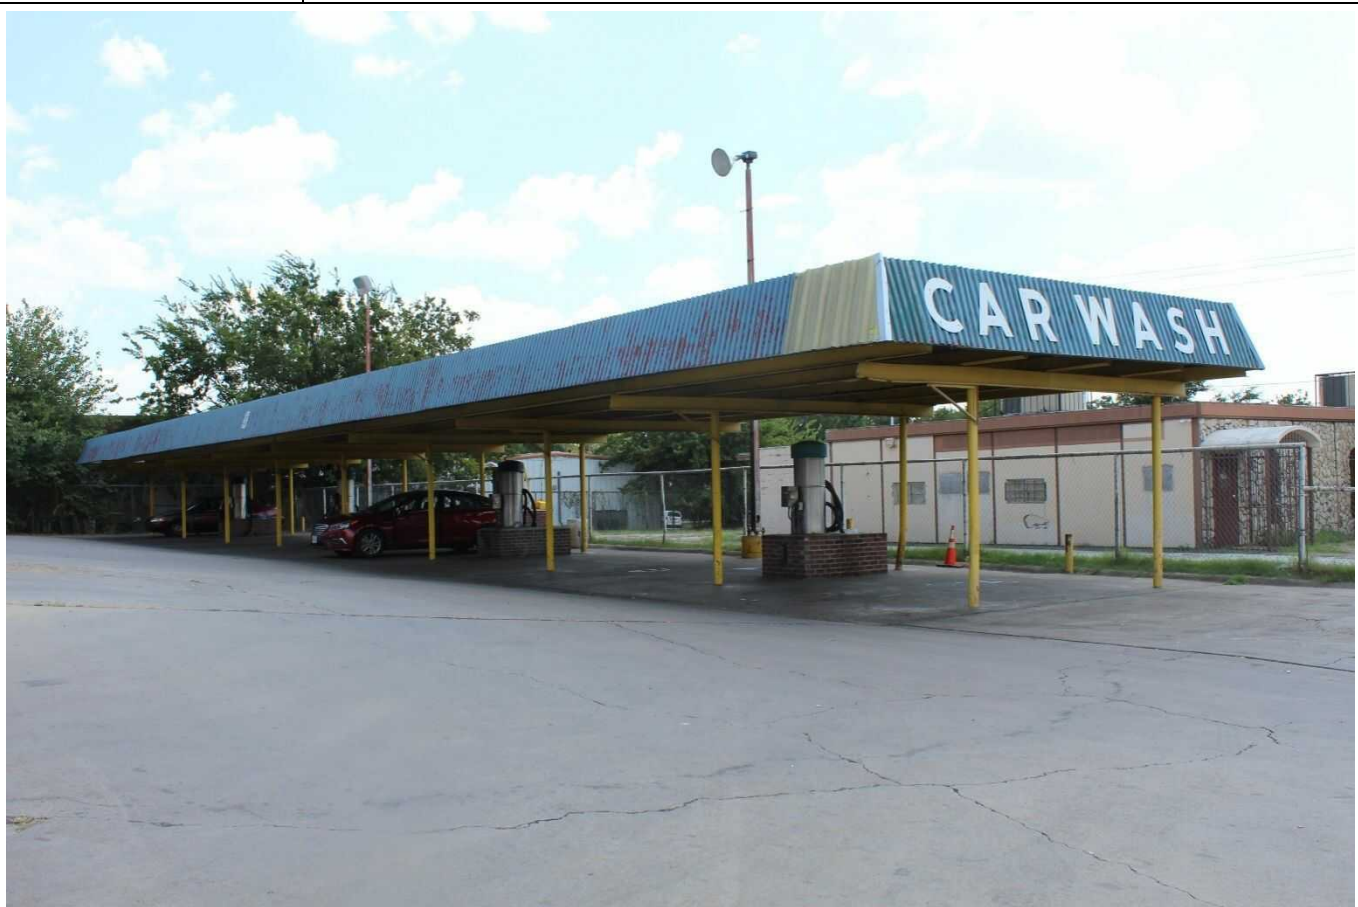
Survey Date:	September 3, 2019
Resource No:	011b
Project Location:	Tarrant County
Project Name and CSJ:	Southeast Connector, CSJ 0008-13-125, etc.
Address, Lat/Long:	1709 McClellan Ct. 32.753293° , -97.215883°
Function/Sub-function:	COMMERCE/ Specialty
Construction Date:	Ca. 1970
NRHP Eligibility:	Not eligible
Integrity/Comments:	Simple open corrugated detailing shed supported by metal poles. Some bays have vacuuming equipment on cast concrete and brick bases.

Camera facing east.

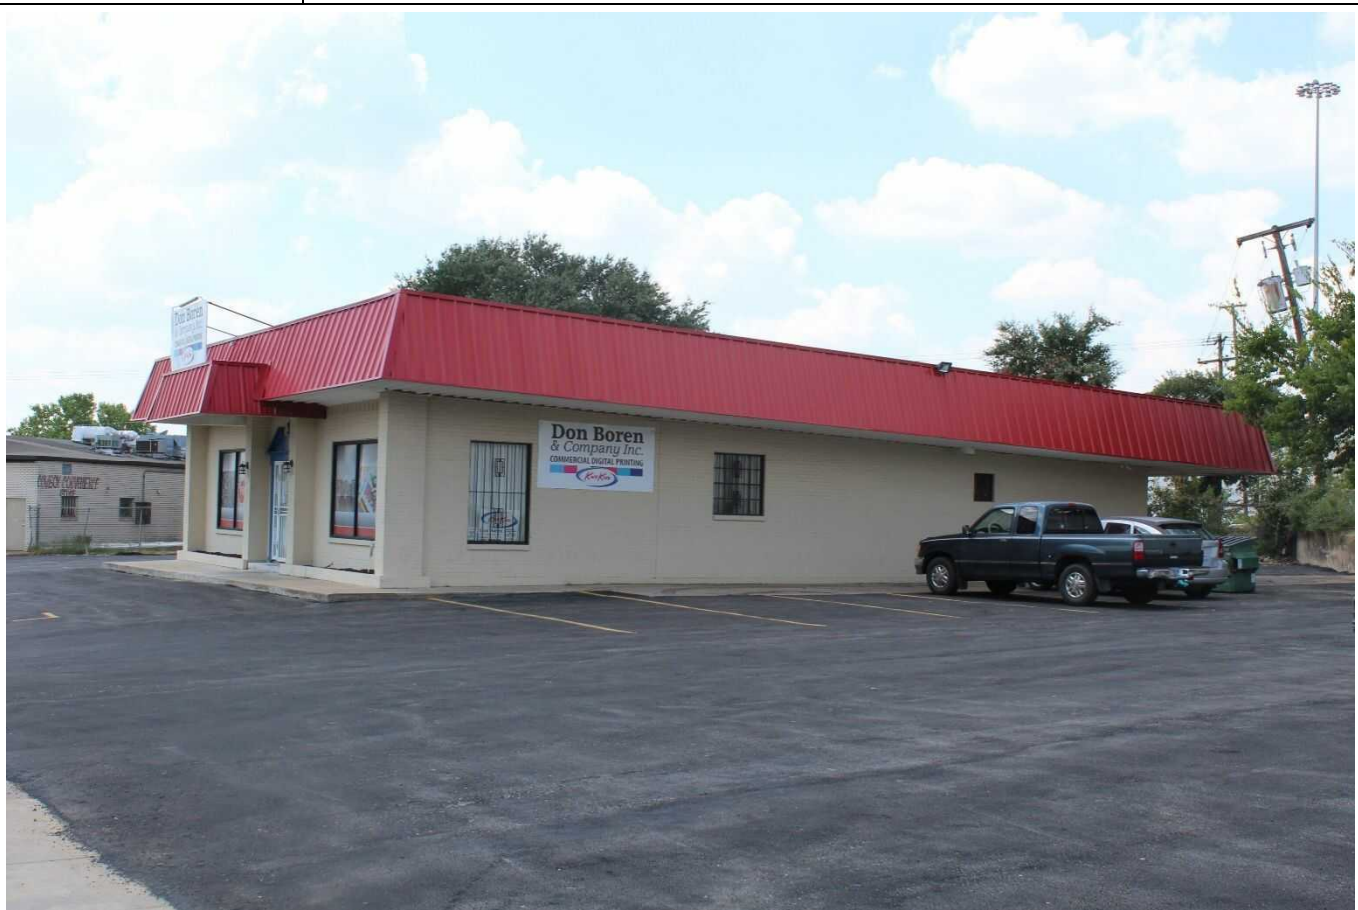
Survey Date:	September 3, 2019
Resource No:	014
Project Location:	Tarrant County
Project Name and CSJ:	Southeast Connector, CSJ 0008-13-125, etc.
Address, Lat/Long:	1850 Handley Dr. 32.752901° , -97.215654°
Function/Sub-function:	COMMERCE/ Specialty
Construction Date:	Ca. 1965
NRHP Eligibility:	Not eligible
Integrity/Comments:	Concrete building with painted brick siding, replacement metal frame picture windows, and an added false mansard metal roof over a flat roof. The small porch stoop has shallow full-height brick wing walls, with similar wing walls on the front corners. Currently houses Don Boren & Company printing services.

Camera facing west.

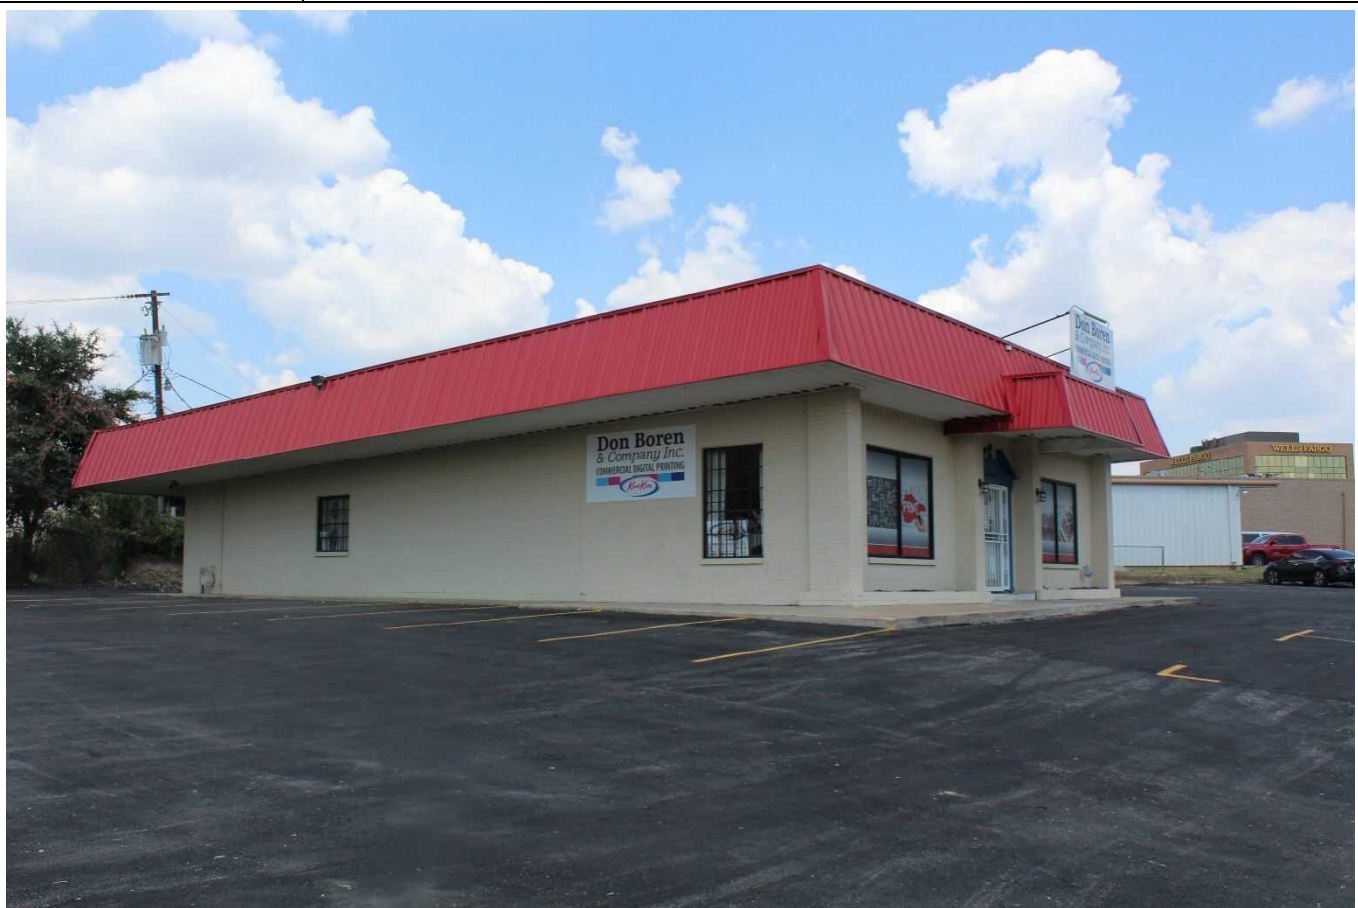
Survey Date:	September 3, 2019
Resource No:	014
Project Location:	Tarrant County
Project Name and CSJ:	Southeast Connector, CSJ 0008-13-125, etc.
Address, Lat/Long:	1850 Handley Dr. 32.752901° , -97.215654°
Function/Sub-function:	COMMERCE/ Specialty
Construction Date:	Ca. 1965
NRHP Eligibility:	Not eligible
Integrity/Comments:	Concrete building with painted brick siding, replacement metal frame picture windows, and an added false mansard metal roof over a flat roof. The small porch stoop has shallow full-height brick wing walls, with similar wing walls on the front corners. Currently houses Don Boren & Company printing services.

Camera facing north.

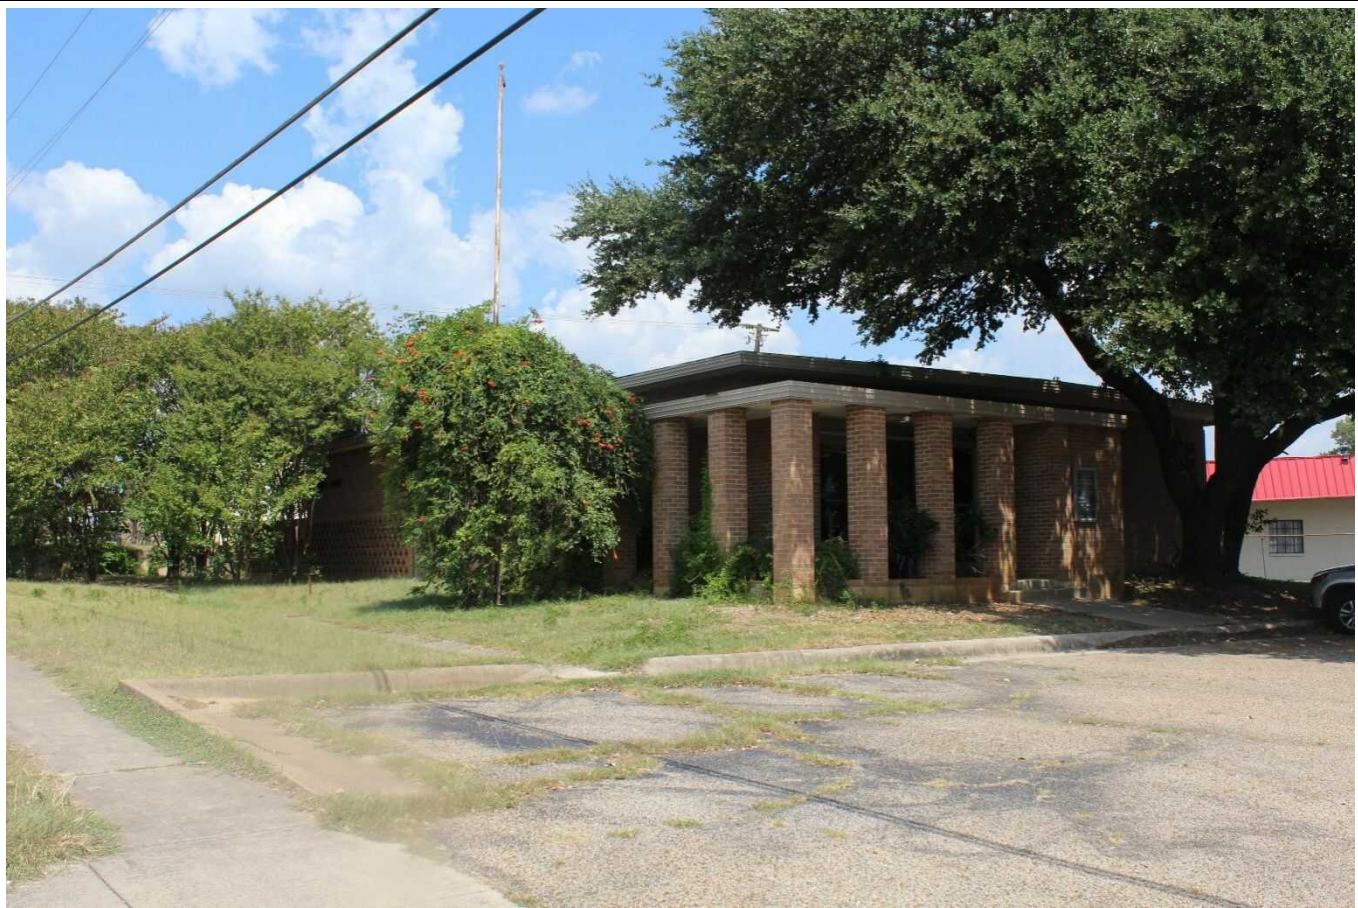
Survey Date:	September 3, 2019
Resource No:	015
Project Location:	Tarrant County
Project Name and CSJ:	Southeast Connector, CSJ 0008-13-125, etc.
Address, Lat/Long:	1851 McClellan Rd. 32.752896°, -97.216004°
Function/Sub-function:	HEALTH CARE/ Veterinary Clinic
Construction Date:	Ca. 1970
NRHP Eligibility:	Not eligible
Integrity/Comments:	Contemporary building with red brick siding, decorative concrete block, recessed windows, and a flat roof with modest overhangs. The projecting porch entry has thick full-height brick columns and a flat roof. A fenced area is behind the building. Currently houses the Village Animal Clinic.

Camera facing northeast.

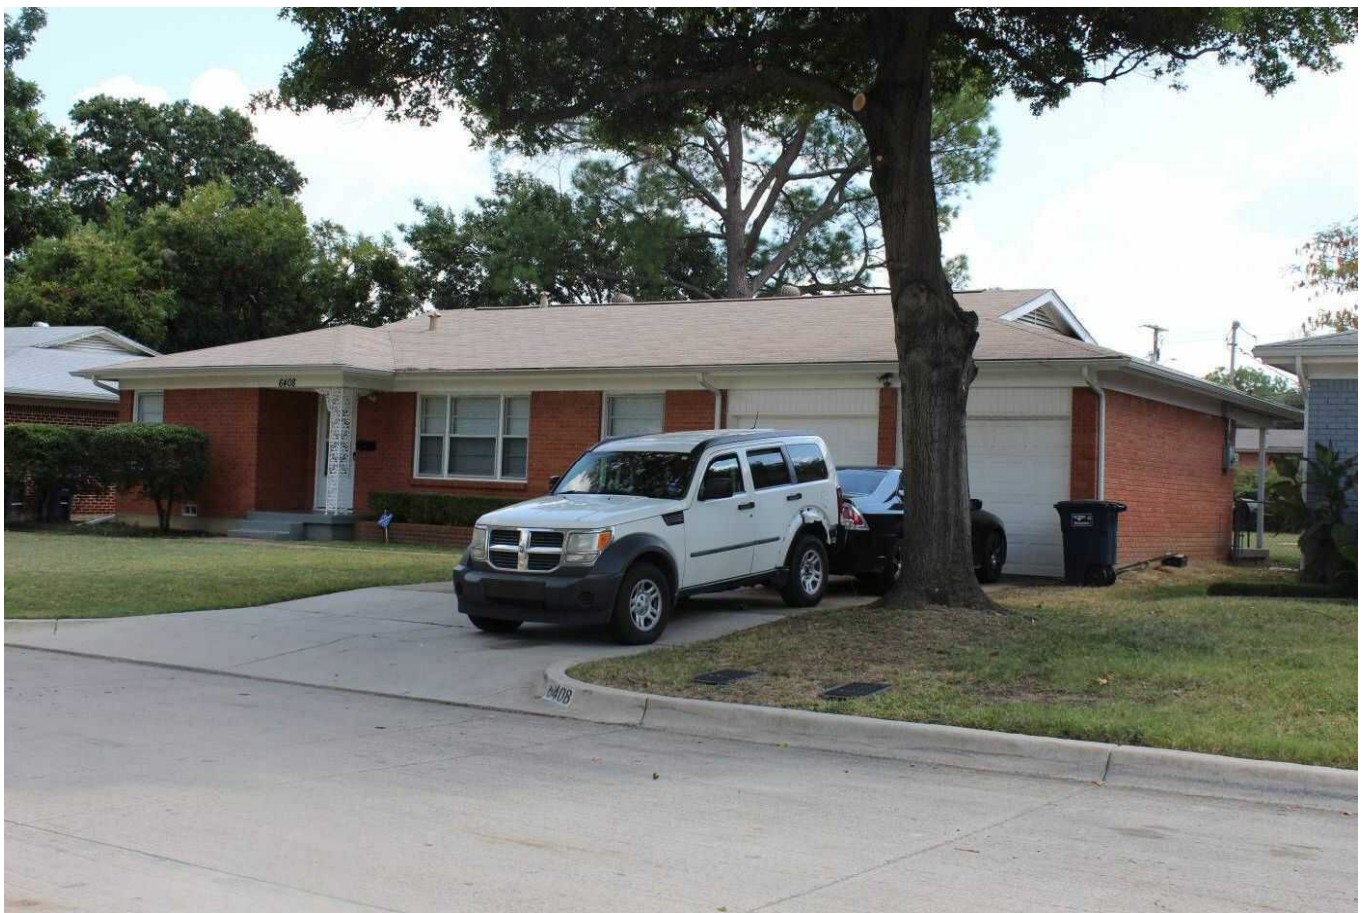
Survey Date:	September 3, 2019
Resource No:	022
Project Location:	Tarrant County
Project Name and CSJ:	Southeast Connector, CSJ 0008-13-125, etc.
Address, Lat/Long:	Meadowbrook Terrace Addition, 6408 Lambeth Ln. 32.746790° , -97.219731°
Function/Sub-function:	DOMESTIC/ Single family dwelling
Construction Date:	Ca. 1955
NRHP Eligibility:	Undetermined
Integrity/Comments:	Ranch style house with brick siding, metal sash windows, and a shallow gable-on-hipped roof with minimal boxed eaves. The small inset porch has a decorative metal post. The two garage doors are modern.

Camera facing southeast.

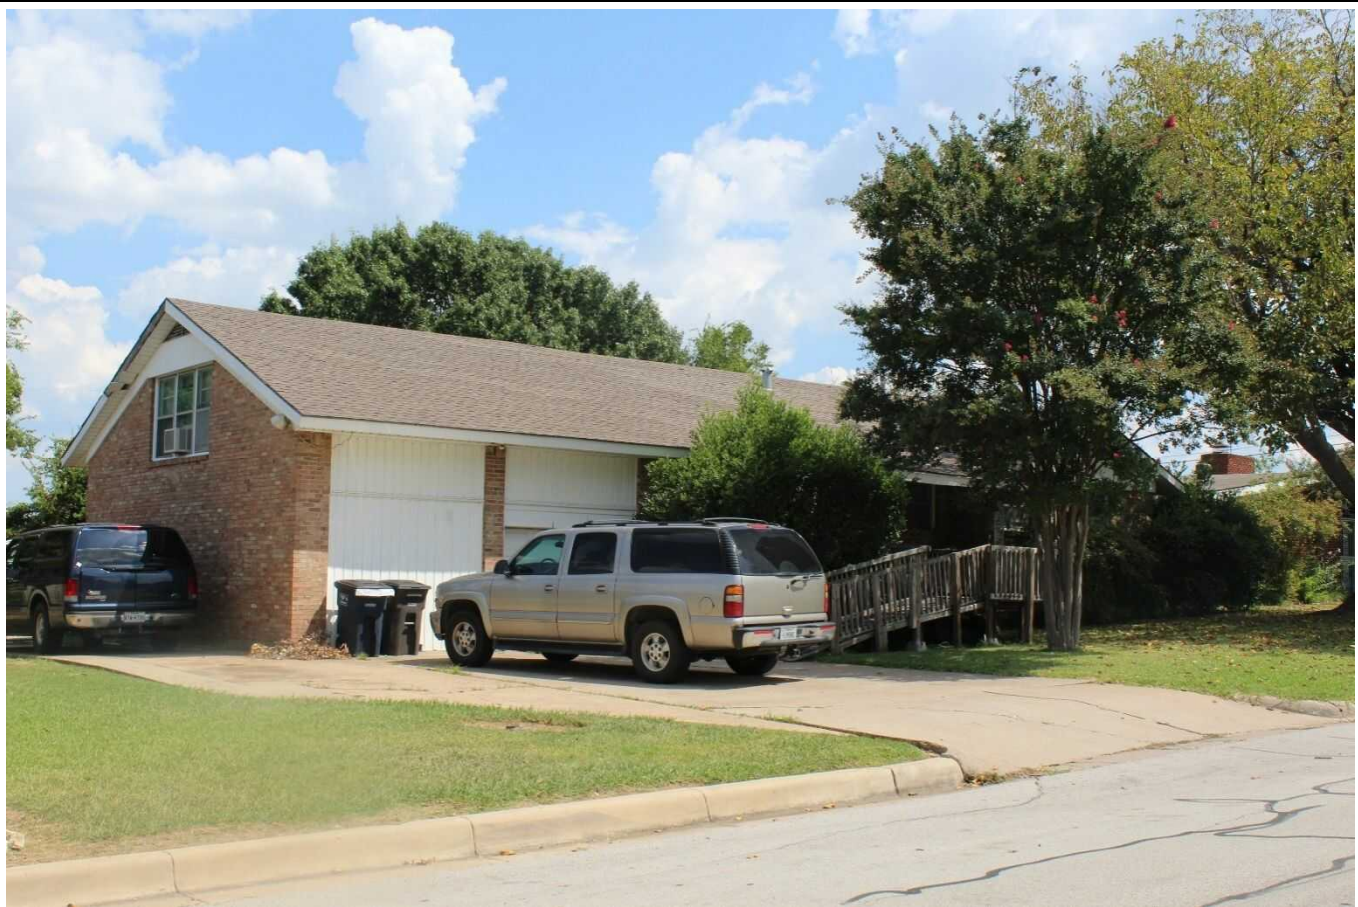
Survey Date:	September 3, 2019
Resource No:	031
Project Location:	Tarrant County
Project Name and CSJ:	Southeast Connector, CSJ 0008-13-125, etc.
Address, Lat/Long:	Meadowbrook Terrace Addition, 2209 Forest Ave. 32.746494° , -97.218806°
Function/Sub-function:	DOMESTIC/ Single family dwelling
Construction Date:	Ca. 1955
NRHP Eligibility:	Undetermined
Integrity/Comments:	Ranch style house with brick siding, replacement metal sash windows, and a shallow side-gabled roof with a single cross gable and modest eaves. The raised inset porch has decorative metal supports. The story-and-a-half garage has been converted to living space.

Camera facing southeast.

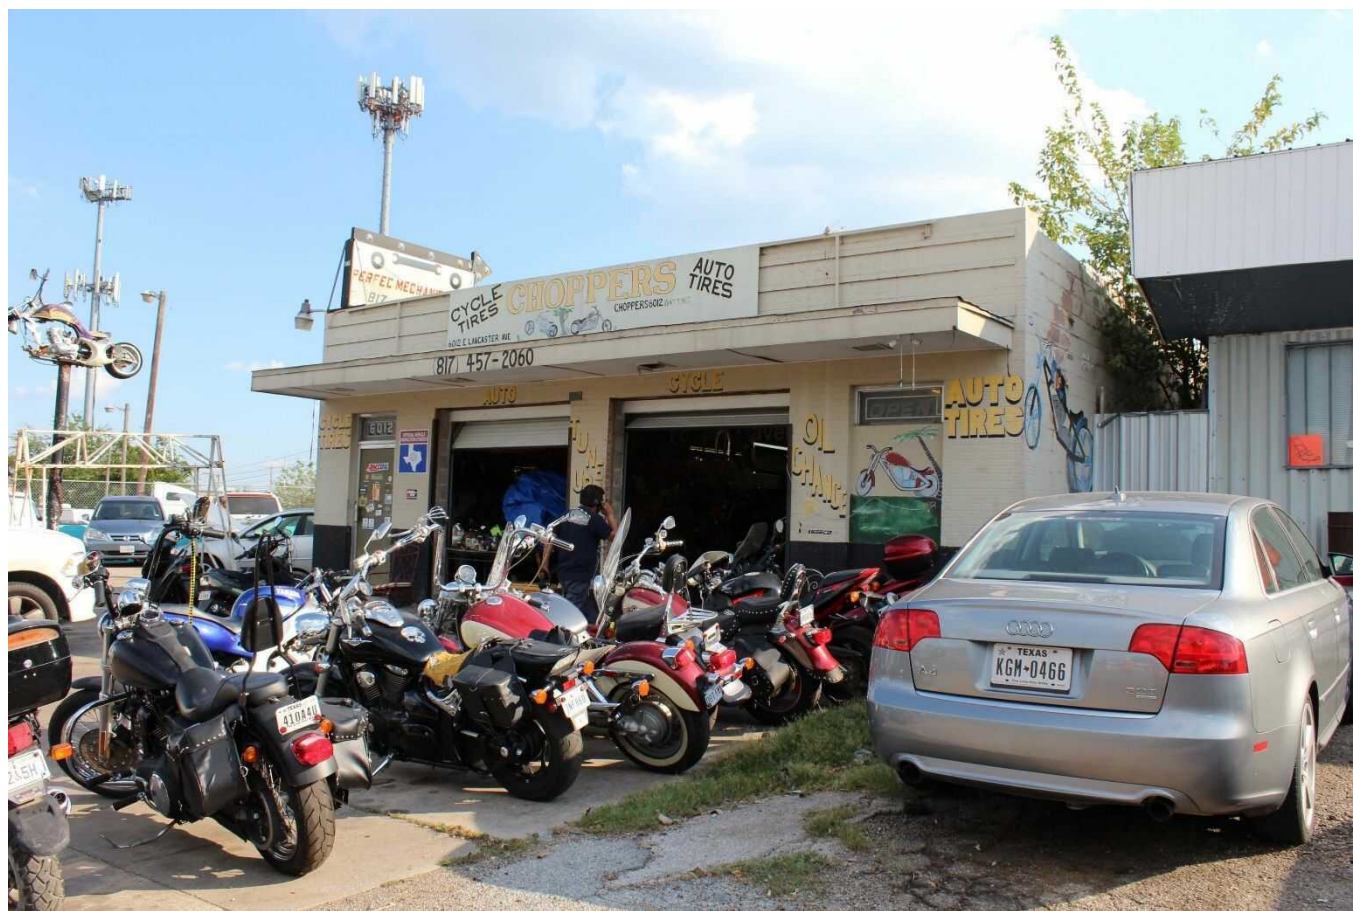
Survey Date:	September 3, 2019
Resource No:	065
Project Location:	Tarrant County
Project Name and CSJ:	Southeast Connector, CSJ 0008-13-125, etc.
Address, Lat/Long:	6012 E. Lancaster Ave 32.735470°, -97.227949°
Function/Sub-function:	COMMERCE/ Specialty
Construction Date:	1956
NRHP Eligibility:	Not eligible
Integrity/Comments:	A motorcycle dealership featuring a parapet roof (according to aerials), a cantilevered shade across the front (north) façade, metal siding, and replacement steel roll bay doors. The attached service garage features a flat roof, metal awning which extends across the front (north) façade, and metal siding. Currently occupied by Choppers.

Camera facing southeast.

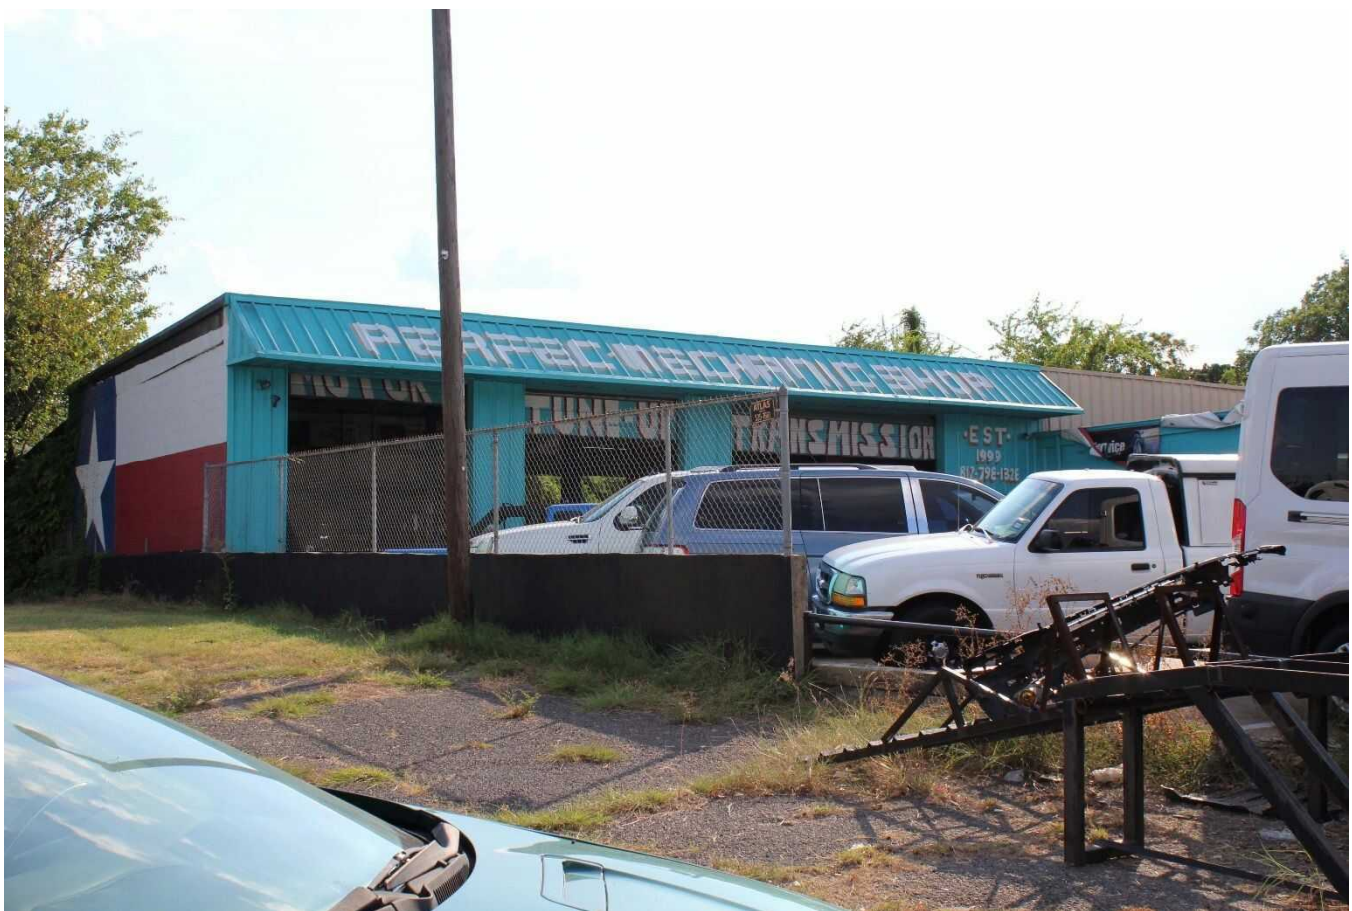
Survey Date:	September 3, 2019
Resource No:	065
Project Location:	Tarrant County
Project Name and CSJ:	Southeast Connector, CSJ 0008-13-125, etc.
Address, Lat/Long:	6012 E. Lancaster Ave 32.735470°, -97.227949°
Function/Sub-function:	COMMERCE/ Service garage
Construction Date:	1956
NRHP Eligibility:	Not eligible
Integrity/Comments:	A motorcycle dealership featuring a parapet roof (according to aerials), a cantilevered shade across the front (north) façade, metal siding, and replacement steel roll bay doors. The attached service garage features a flat roof, metal awning which extends across the front (north) façade, and metal siding. Currently occupied by Choppers.

Camera facing southwest.

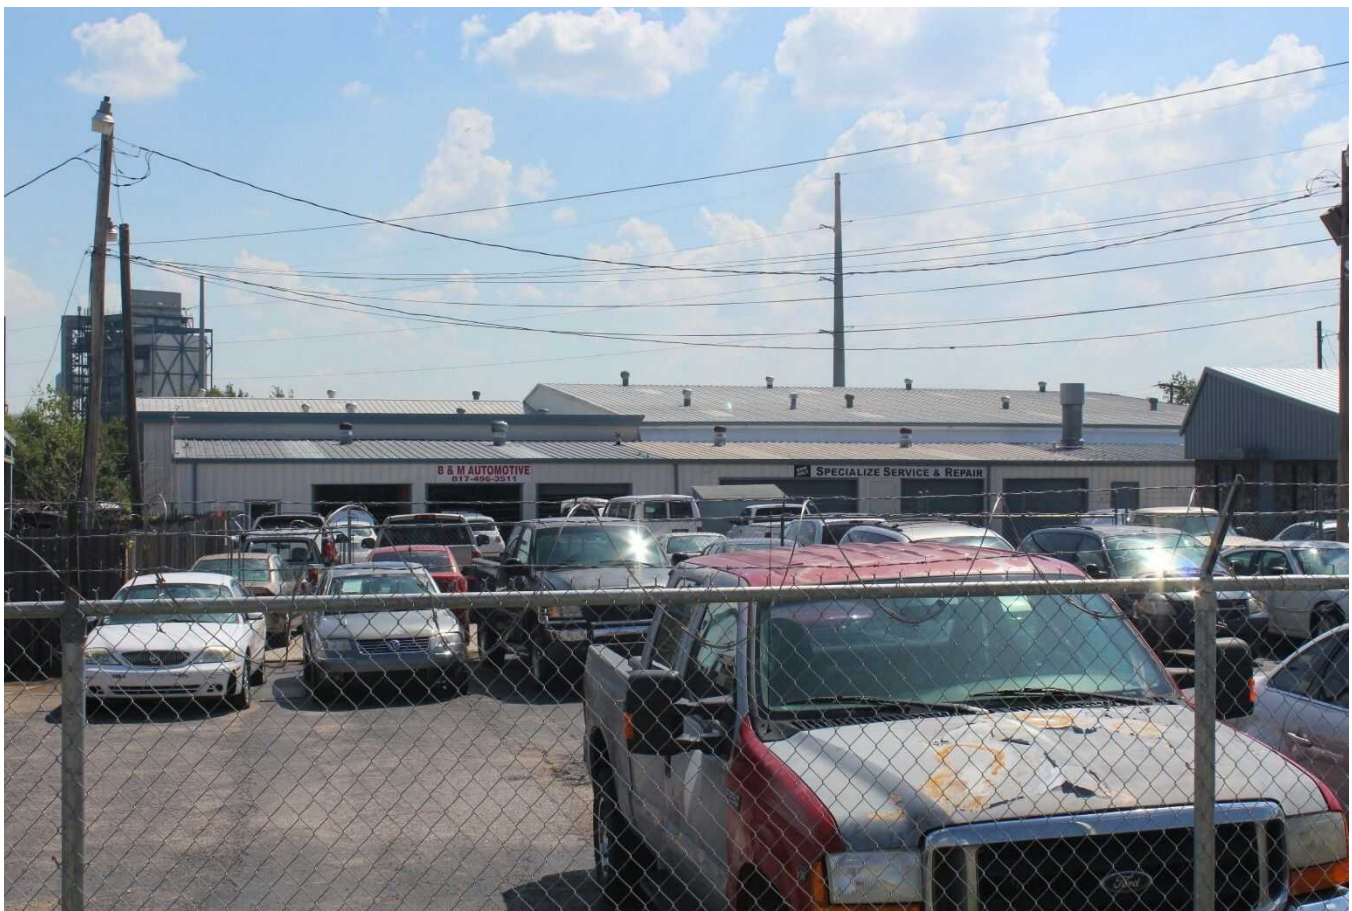
Survey Date:	September 3, 2019
Resource No:	074b
Project Location:	Tarrant County
Project Name and CSJ:	Southeast Connector, CSJ 0008-13-125, etc.
Address, Lat/Long:	2001 E. Loop 820 S. 32.726265°, -97.223616°
Function/Sub-function:	COMMERCE/ Service garage
Construction Date:	1965
NRHP Eligibility:	Not eligible
Integrity/Comments:	Service garage features multiple shallow-pitch roof types, including gable and shed, metal siding, and several replacement steel roll bay doors. Currently occupied by B&M Automotive.

Camera facing east.

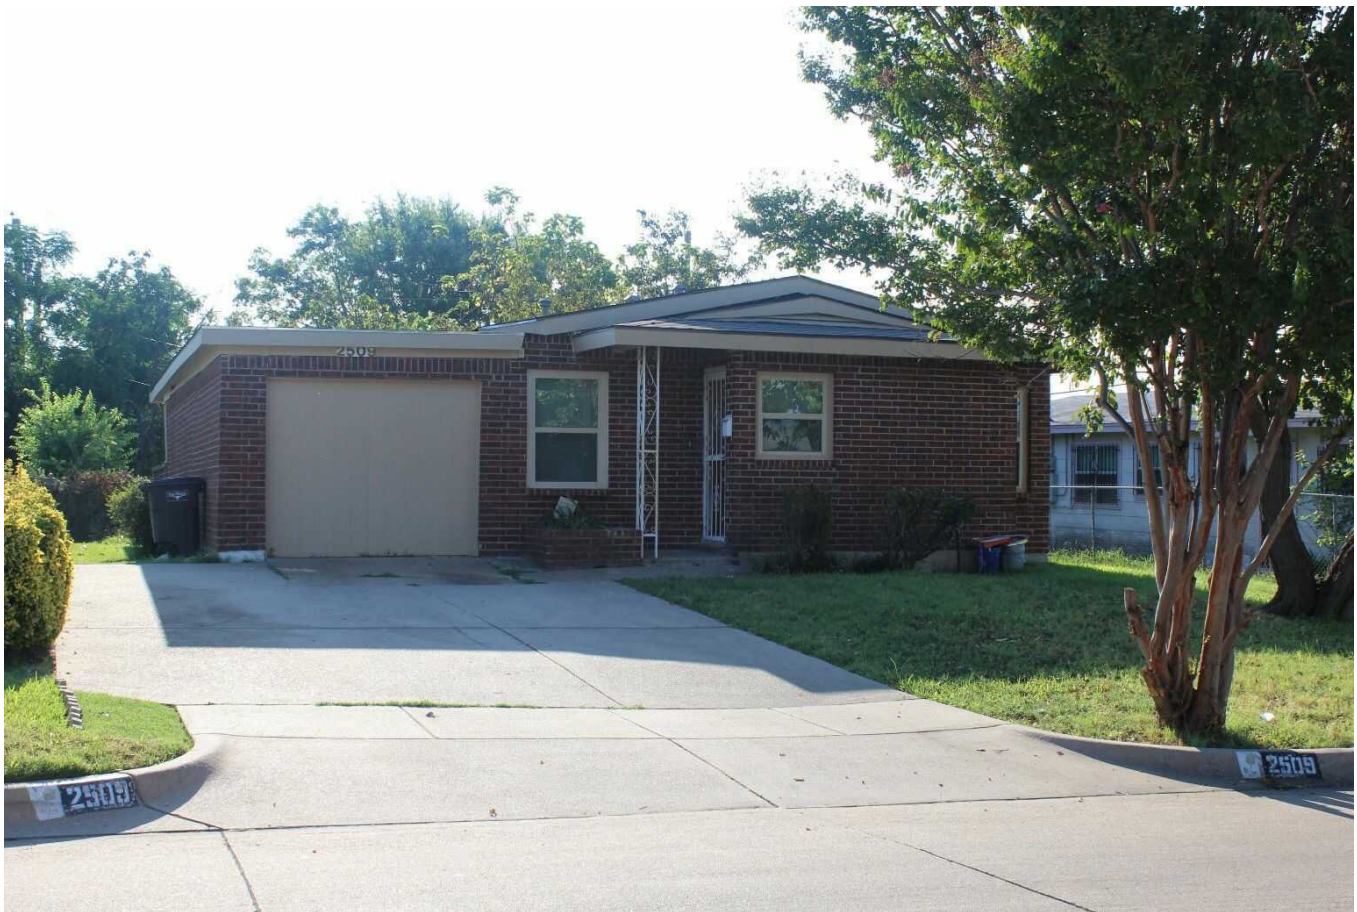
Survey Date:	September 4, 2019
Resource No:	121
Project Location:	Tarrant County
Project Name and CSJ:	Southeast Connector, CSJ 0008-13-125, etc.
Address, Lat/Long:	2509 Lucas Dr. 32.720809°, -97.228080°
Function/Sub-function:	DOMESTIC/ Single family dwelling
Construction Date:	1956
NRHP Eligibility:	Contributing (Criterion A)
Integrity/Comments:	Ranch style house with multiple shallow-pitch, gable- end roofs, in addition to a flat roof over the garage, and a shallow-pitch, hip roof over the enclosed porch. The house also features brick siding, replacement windows, and a replacement garage door.

Camera facing east.

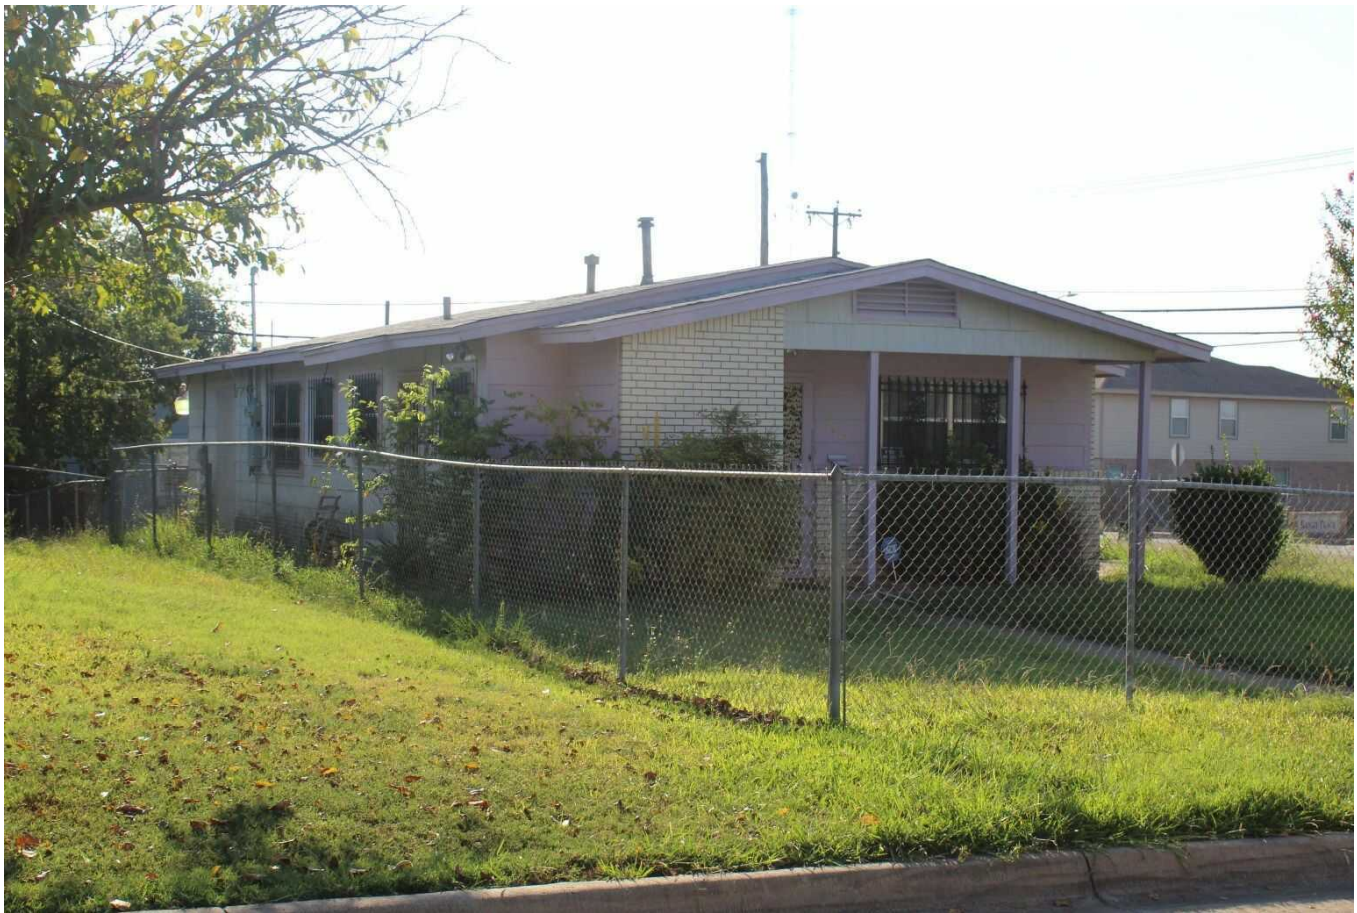
Survey Date:	September 4, 2019
Resource No:	122a
Project Location:	Tarrant County
Project Name and CSJ:	Southeast Connector, CSJ 0008-13-125, etc.
Address, Lat/Long:	2501 Lucas Dr. 32.720679°, -97.228061°
Function/Sub-function:	DOMESTIC/ Single family dwelling
Construction Date:	1959
NRHP Eligibility:	Contributing (Criterion A)
Integrity/Comments:	Ranch style house with a shallow-pitch, side-gable roof, brick and asbestos shingle siding, replacement windows, semi-recessed porch.

Camera facing southeast.

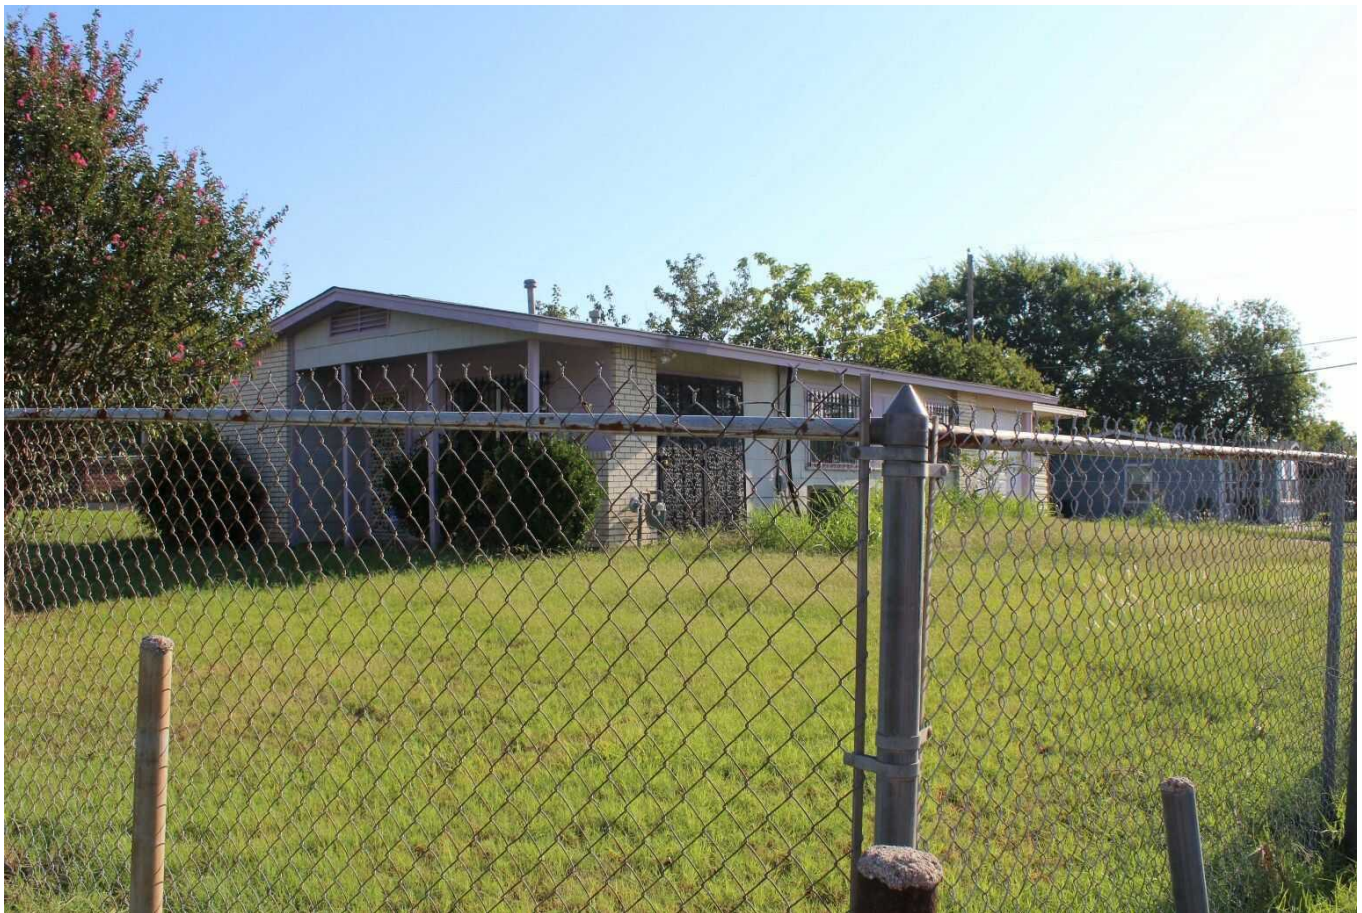
Survey Date:	September 4, 2019
Resource No:	122a
Project Location:	Tarrant County
Project Name and CSJ:	Southeast Connector, CSJ 0008-13-125, etc.
Address, Lat/Long:	2501 Lucas Dr. 32.720679°, -97.228061°
Function/Sub-function:	DOMESTIC/ Single family dwelling
Construction Date:	1959
NRHP Eligibility:	Contributing (Criterion A)
Integrity/Comments:	Ranch style house with a shallow-pitch, side-gable roof, brick and asbestos shingle siding, replacement windows, semi-recessed porch.

Camera facing northeast.
