## **Appendix H: Survey Forms for Removed Properties**

Survey Date:	September 3, 2019
Resource No:	001
Project Location:	Tarrant County
Project Name and CSJ:	Southeast Connector, CSJ 0008-13-125, etc.
Address, Lat/Long:	6501 Brentwood Dr. 32.755926° , -97.218520°
Function/Sub-function:	DOMESTIC/ Single family dwelling
Construction Date:	1958
NRHP Eligibility:	Not eligible
Integrity/Comments:	Ranch style house with wavy brick siding, horizontal vinyl siding under the gables, cross-gabled roof with a shallow pitch and generous eaves, and replacement windows.

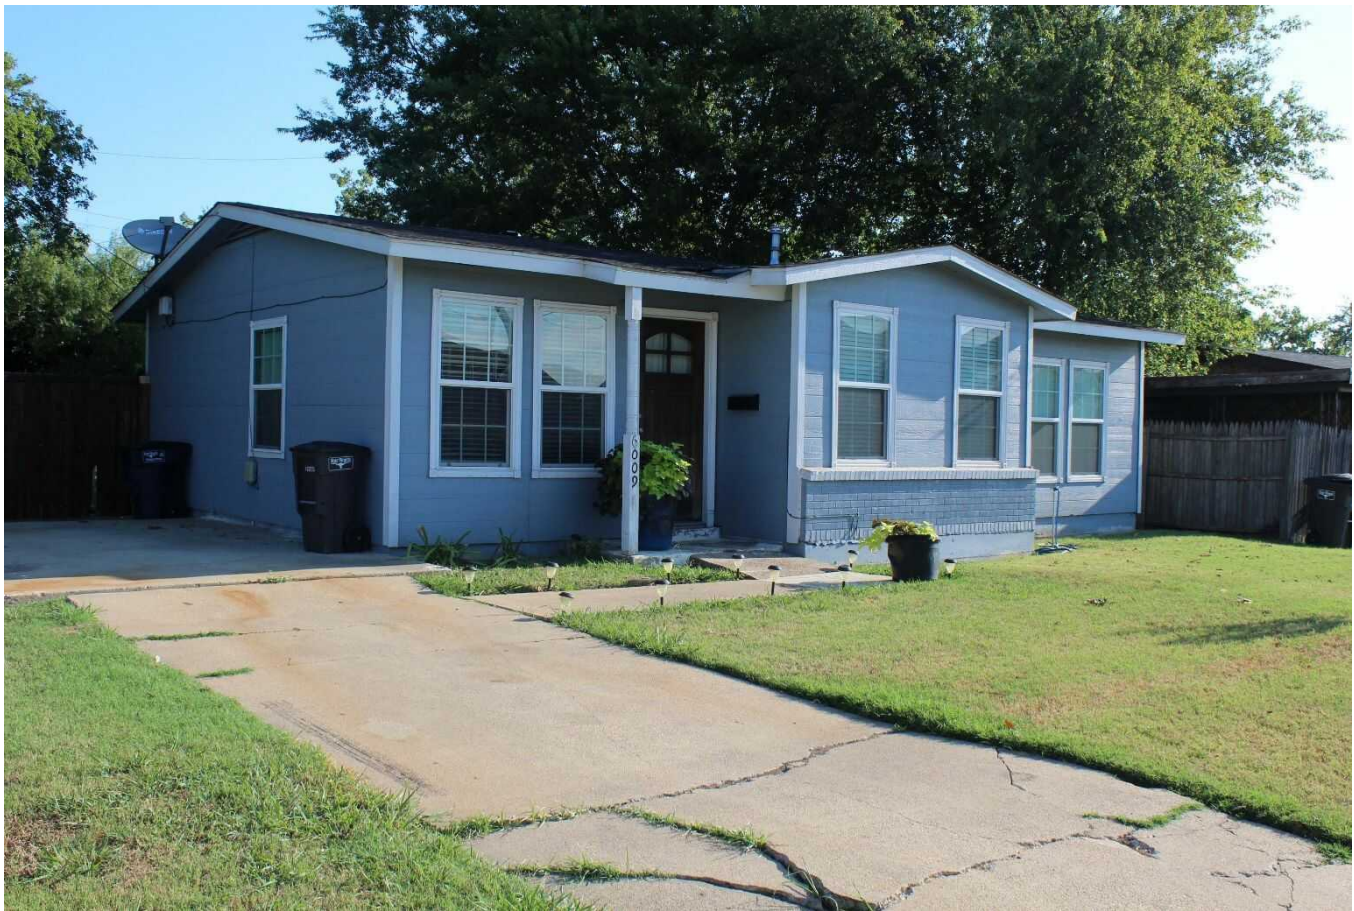
Survey Date:	September 4, 2019
Resource No:	123
Project Location:	Tarrant County
Project Name and CSJ:	Southeast Connector, CSJ 0008-13-125, etc.
Address, Lat/Long:	6009 Ramey Ave. 32.720685°, -97.227740°
Function/Sub-function:	DOMESTIC/ Single family dwelling
Construction Date:	1956
NRHP Eligibility:	Contributing (Criterion A)
Integrity/Comments:	Ranch style house with shallow-pitch, center gable roof, horizontal vinyl and brick siding, and replacement windows.

Camera facing northeast.

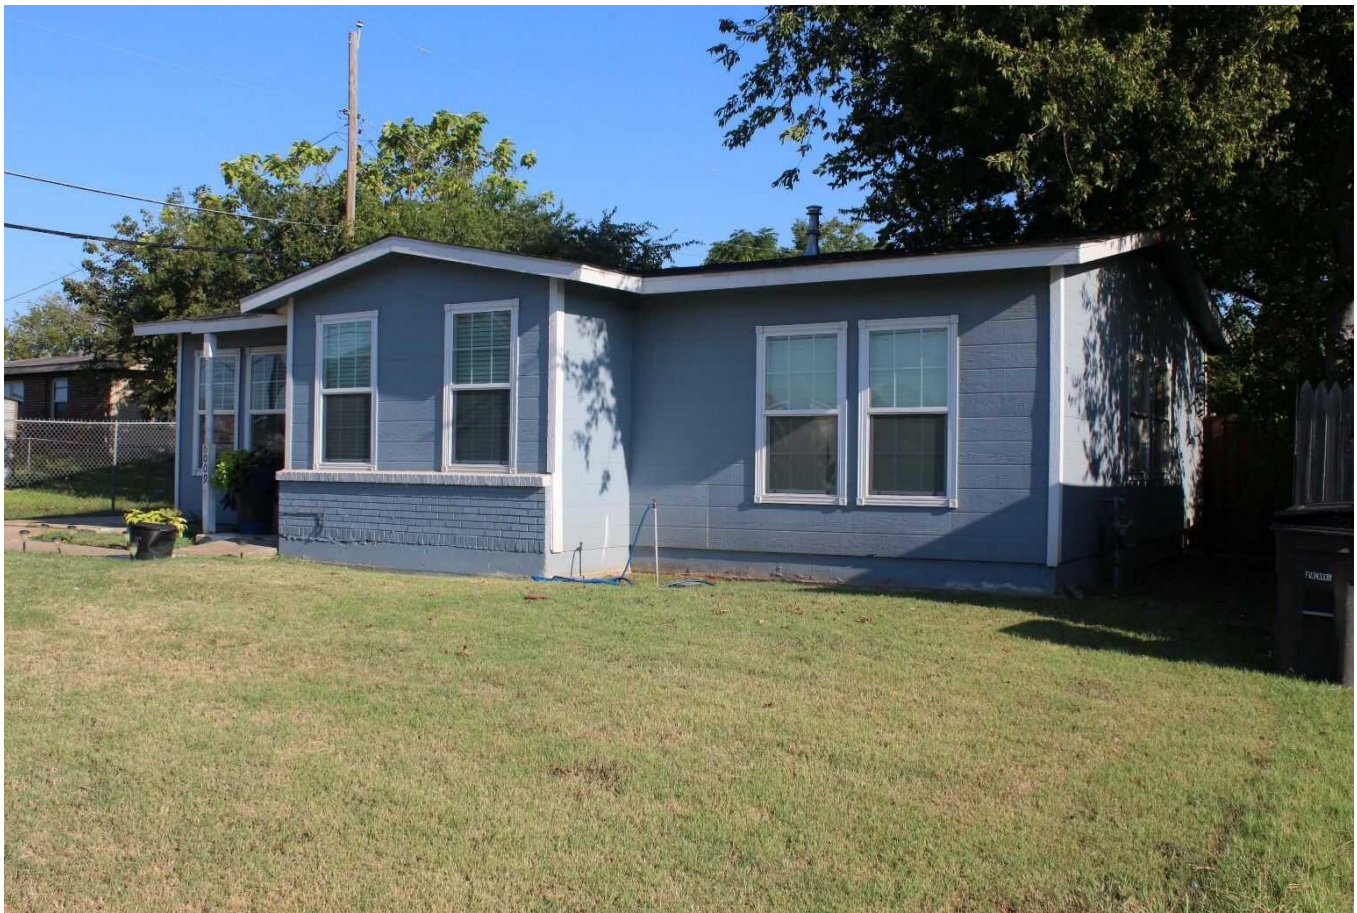
Survey Date:	September 4, 2019
Resource No:	123
Project Location:	Tarrant County
Project Name and CSJ:	Southeast Connector, CSJ 0008-13-125, etc.
Address, Lat/Long:	6009 Ramey Ave. 32.720685°, -97.227740°
Function/Sub-function:	DOMESTIC/ Single family dwelling
Construction Date:	1956
NRHP Eligibility:	Contributing (Criterion A)
Integrity/Comments:	Ranch style house with shallow-pitch, center gable roof, horizontal vinyl and brick siding, and replacement windows.

Camera facing northwest.

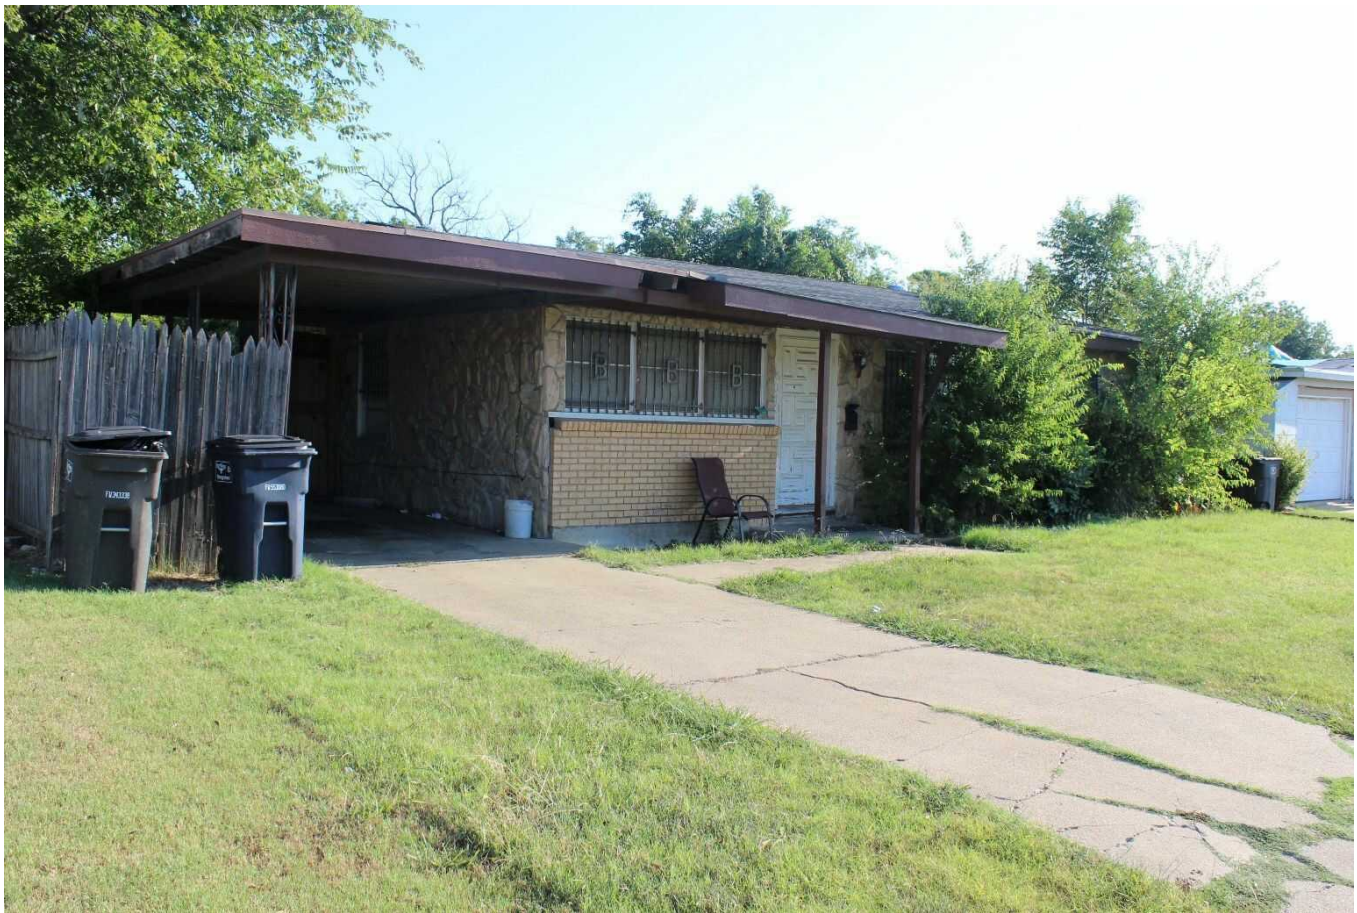
Survey Date:	September 4, 2019
Resource No:	124
Project Location:	Tarrant County
Project Name and CSJ:	Southeast Connector, CSJ 0008-13-125, etc.
Address, Lat/Long:	6013 Ramey Ave. 32.720682°, -97.227531°
Function/Sub-function:	DOMESTIC/ Single family dwelling
Construction Date:	1956
NRHP Eligibility:	Contributing (Criterion A)
Integrity/Comments:	Ranch style house with a shallow-pitch, side-gable roof, rusticated masonry and brick siding, original windows, and a metal carport.

Camera facing northeast.

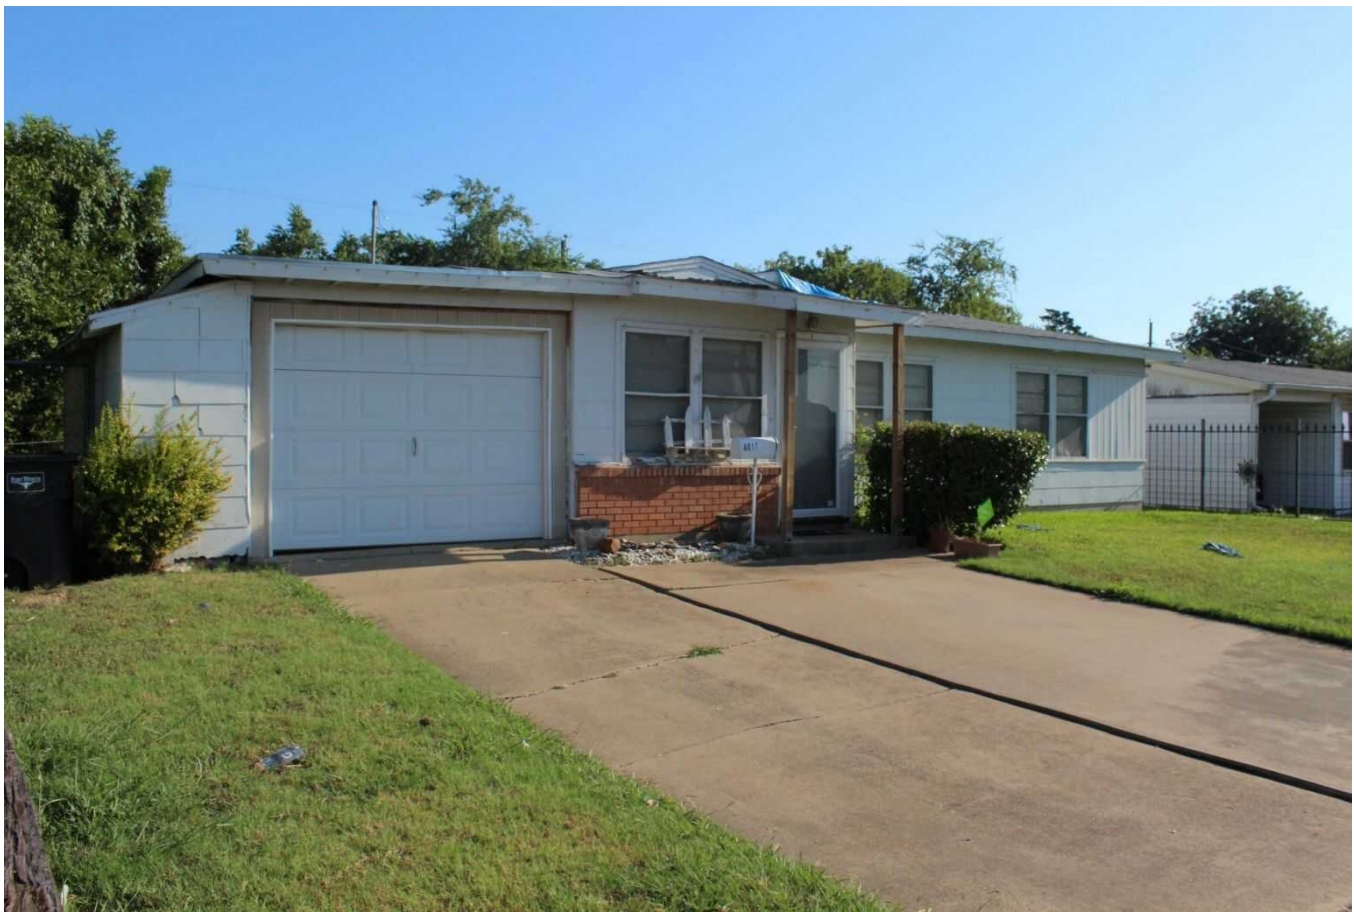
Survey Date:	September 4, 2019
Resource No:	125
Project Location:	Tarrant County
Project Name and CSJ:	Southeast Connector, CSJ 0008-13-125, etc.
Address, Lat/Long:	6017 Ramey Ave. 32.720690°, -97.227338°
Function/Sub-function:	DOMESTIC/ Single family dwelling
Construction Date:	1956
NRHP Eligibility:	Contributing (Criterion A)
Integrity/Comments:	Ranch style house with a shallow-pitch, Dutch gable roof, vinyl shingle, vertical vinyl, and brick siding, replacement windows, an enclosed carport (now a garage), and an addition to the west with a shed roof and vinyl shingle siding.

Camera facing northeast.

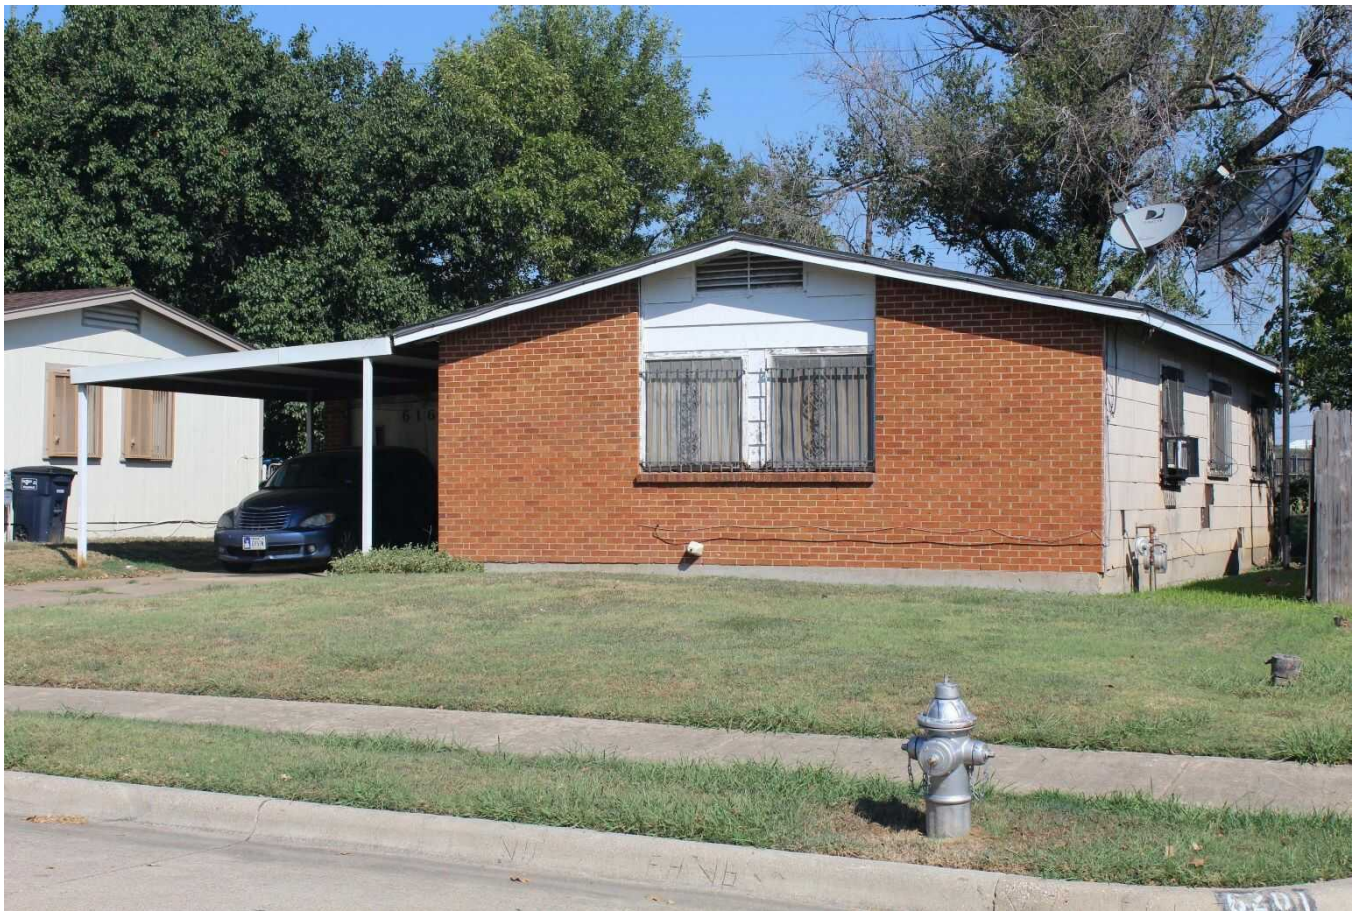
Survey Date:	September 4, 2019
Resource No:	135
Project Location:	Tarrant County
Project Name and CSJ:	Southeast Connector, CSJ 0008-13-125, etc.
Address, Lat/Long:	6163 Truman Dr. 32.725295°, -97.224008°
Function/Sub-function:	DOMESTIC/ Single family dwelling
Construction Date:	1959
NRHP Eligibility:	Not eligible
Integrity/Comments:	Ranch style house with a half-courtyard plan featuring a shallow-pitch, cross-gable roof, brick and horizontal vinyl siding, original windows, and a metal carport.

Camera facing northwest.

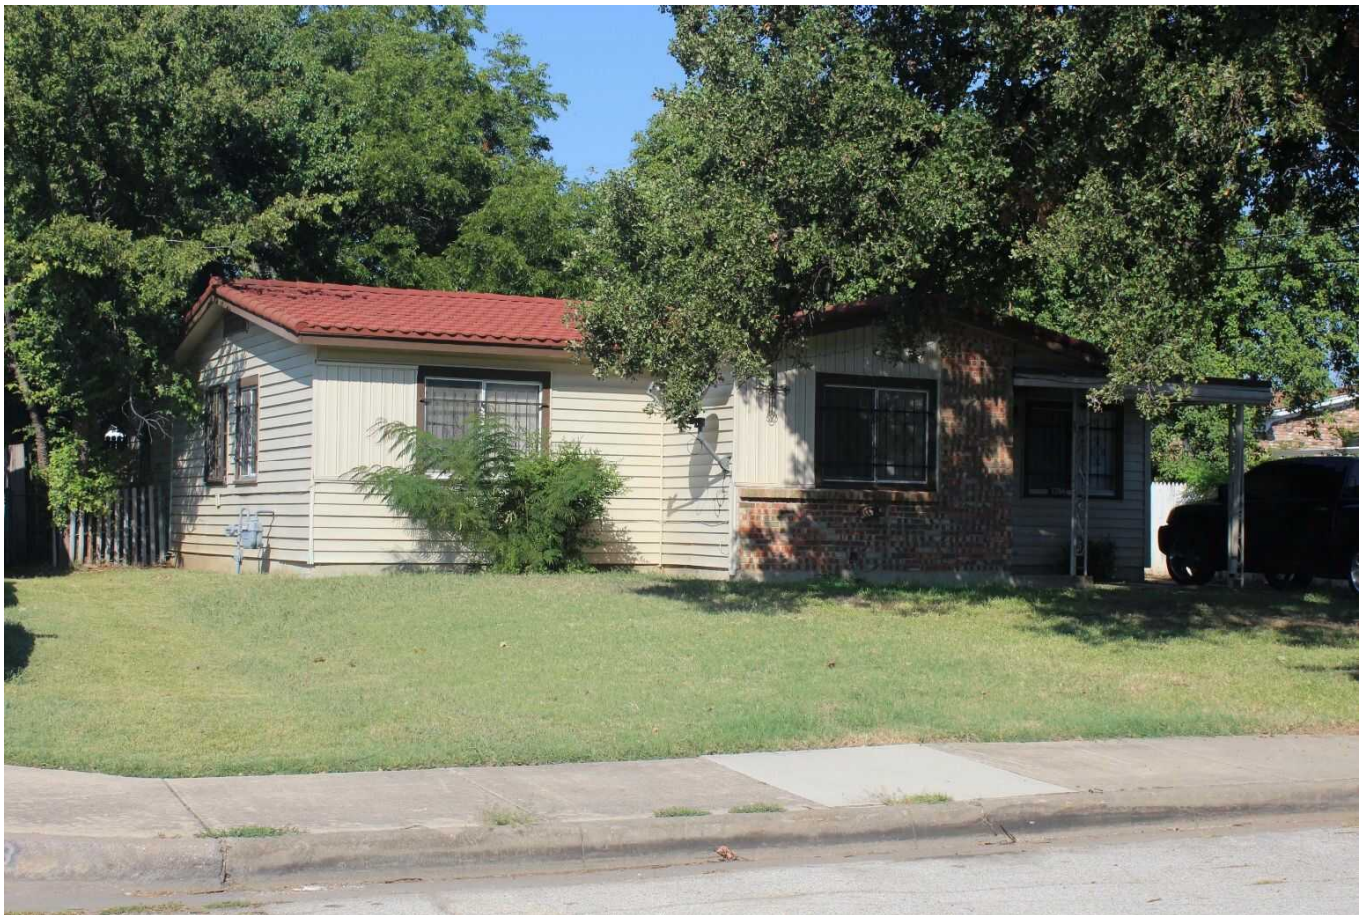
Survey Date:	September 4, 2019
Resource No:	138
Project Location:	Tarrant County
Project Name and CSJ:	Southeast Connector, CSJ 0008-13-125, etc.
Address, Lat/Long:	2204 Carruthers Dr. 32.724667°, -97.224028°
Function/Sub-function:	DOMESTIC/ Single family dwelling
Construction Date:	1957
NRHP Eligibility:	Not eligible
Integrity/Comments:	Ranch style house with shallow-pitch, center gable roof, vinyl and brick siding, original and replacement windows, and a semi-recessed porch.

Camera facing northwest.

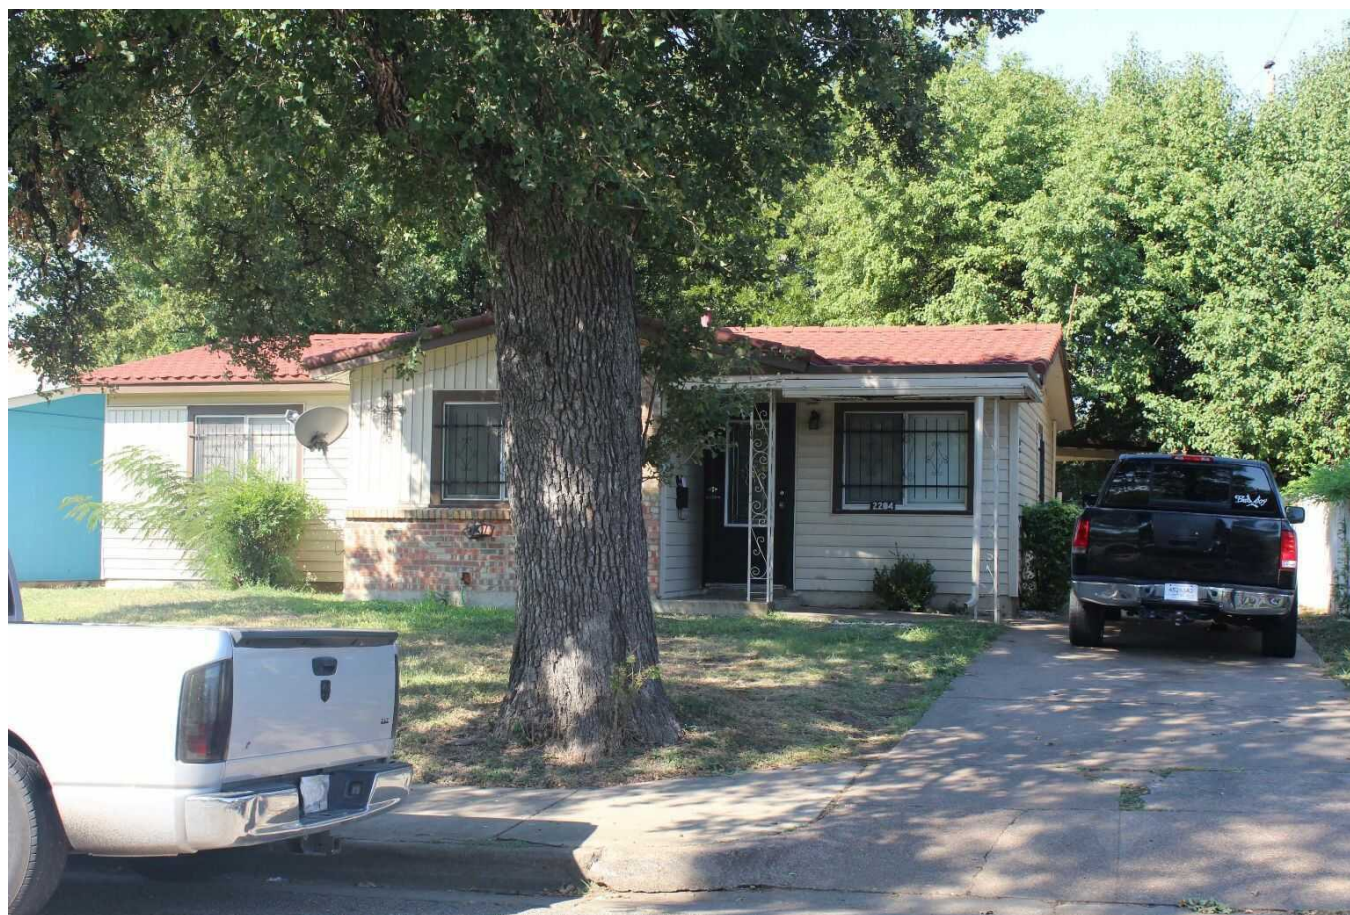
Survey Date:	September 4, 2019
Resource No:	138
Project Location:	Tarrant County
Project Name and CSJ:	Southeast Connector, CSJ 0008-13-125, etc.
Address, Lat/Long:	2204 Carruthers Dr. 32.724667°, -97.224028°
Function/Sub-function:	DOMESTIC/ Single family dwelling
Construction Date:	1957
NRHP Eligibility:	Not eligible
Integrity/Comments:	Ranch style house with shallow-pitch, center gable roof, vinyl and brick siding, original and replacement windows, and a semi-recessed porch.

Camera facing southwest.

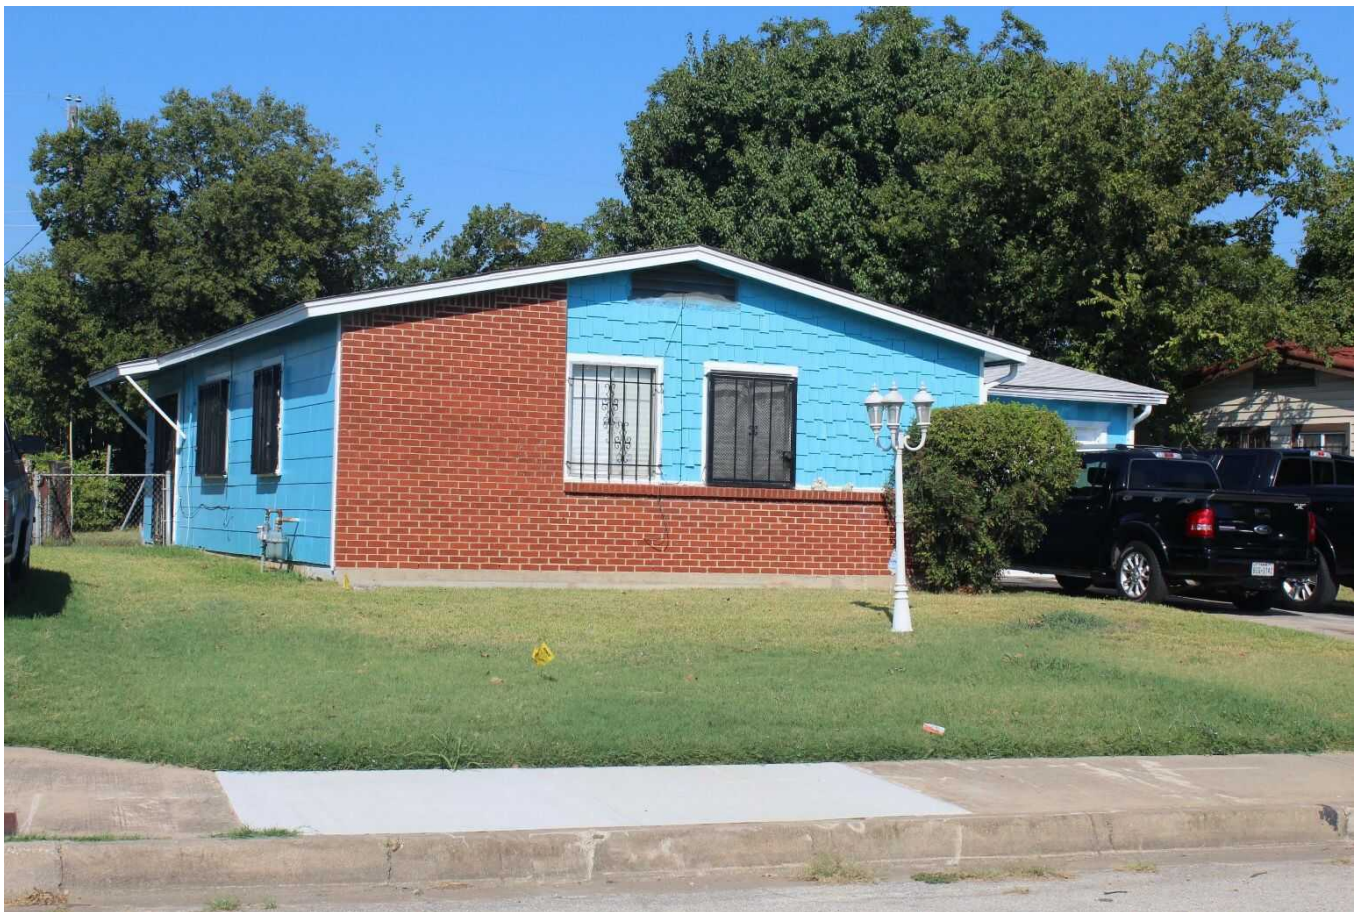
Survey Date:	September 4, 2019
Resource No:	139
Project Location:	Tarrant County
Project Name and CSJ:	Southeast Connector, CSJ 0008-13-125, etc.
Address, Lat/Long:	2208 Carruthers Dr. 32.724509°, -97.224004°
Function/Sub-function:	DOMESTIC/ Single family dwelling
Construction Date:	1957
NRHP Eligibility:	Not eligible
Integrity/Comments:	Ranch style house with a half-courtyard plan featuring a shallow-pitch, cross-gable roof, horizontal vinyl, brick, and cedar shake shingles, replacement windows, and a garage with a replacement garage door.

Camera facing northwest.

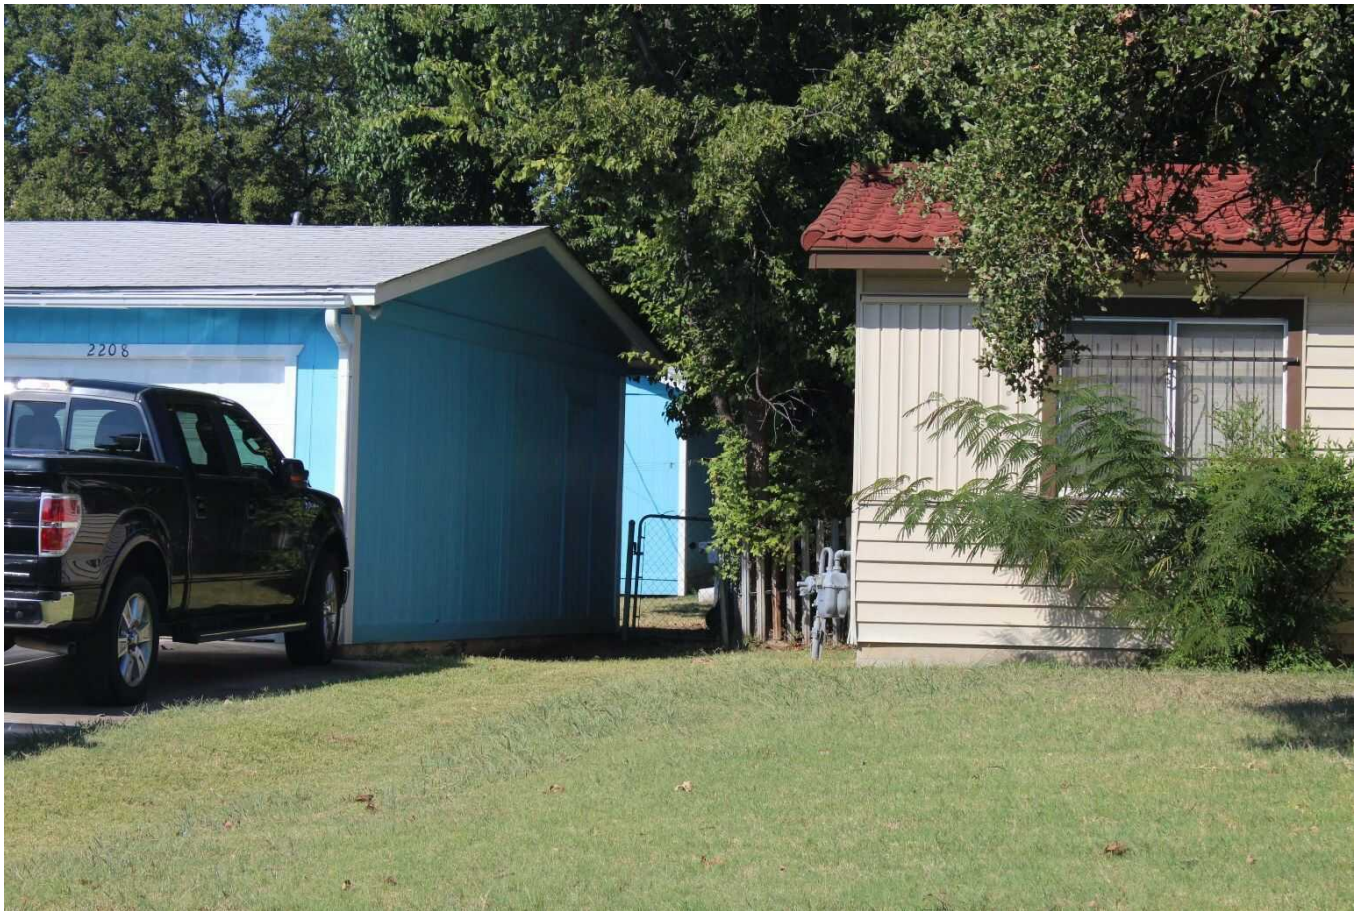
Survey Date:	September 4, 2019
Resource No:	139
Project Location:	Tarrant County
Project Name and CSJ:	Southeast Connector, CSJ 0008-13-125, etc.
Address, Lat/Long:	2208 Carruthers Dr. 32.724509°, -97.224004°
Function/Sub-function:	DOMESTIC/ Shed
Construction Date:	1957
NRHP Eligibility:	Not eligible
Integrity/Comments:	Modern shed.

Camera facing southwest.

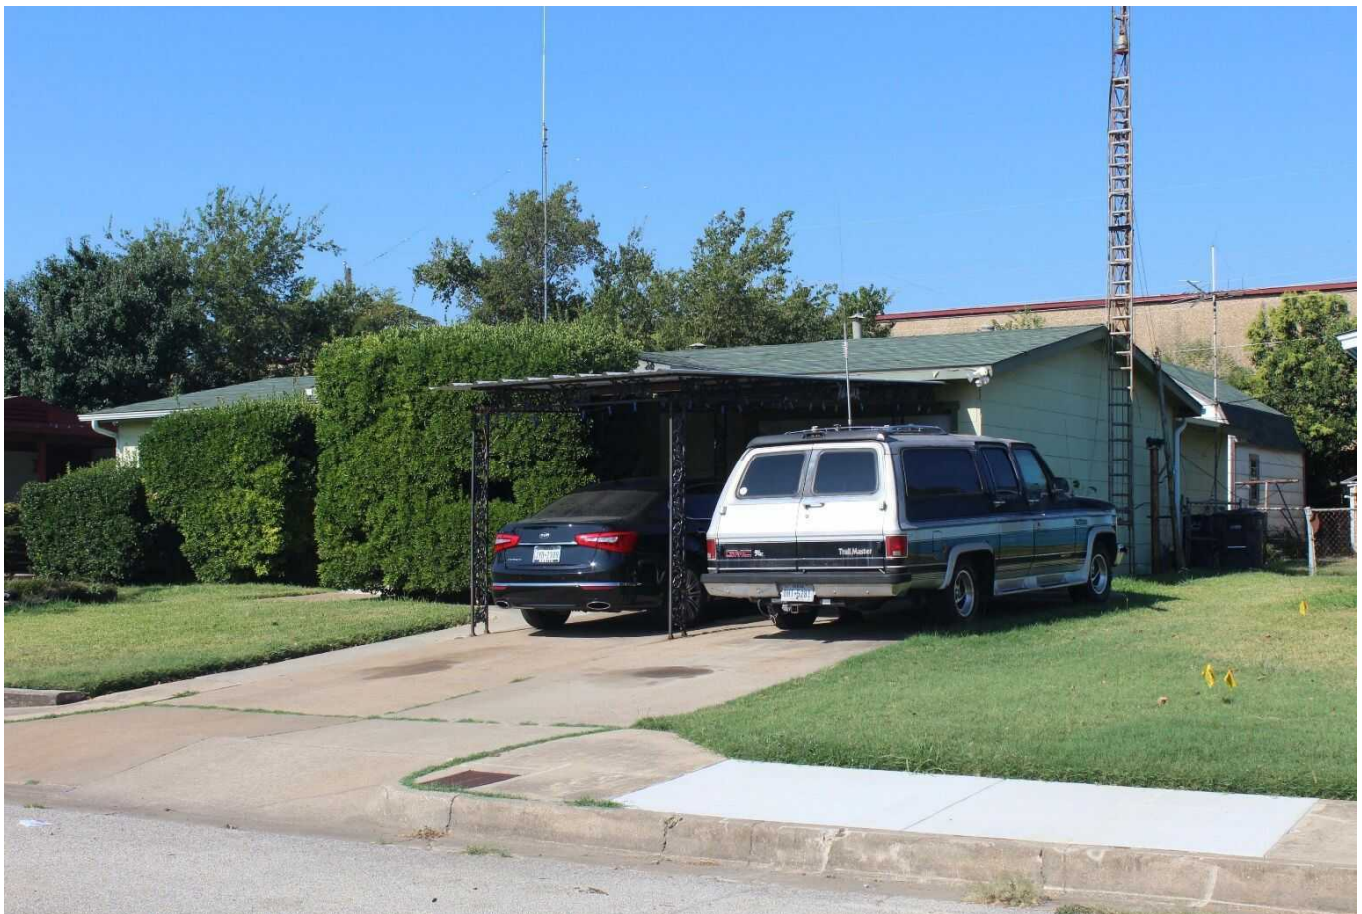
Survey Date:	September 4, 2019
Resource No:	140a
Project Location:	Tarrant County
Project Name and CSJ:	Southeast Connector, CSJ 0008-13-125, etc.
Address, Lat/Long:	2212 Carruthers Dr. 32.724370°, -97.223986°
Function/Sub-function:	DOMESTIC/ Single family dwelling
Construction Date:	1957
NRHP Eligibility:	Not eligible
Integrity/Comments:	Ranch style house with shallow-pitch, cross-gable roof, horizontal vinyl siding, replacement windows, a garage to the north with a replacement garage door, and an extended metal carport. Per aerials, a third shed is present on the property, but is not visible from the ROW.

Camera facing southwest.

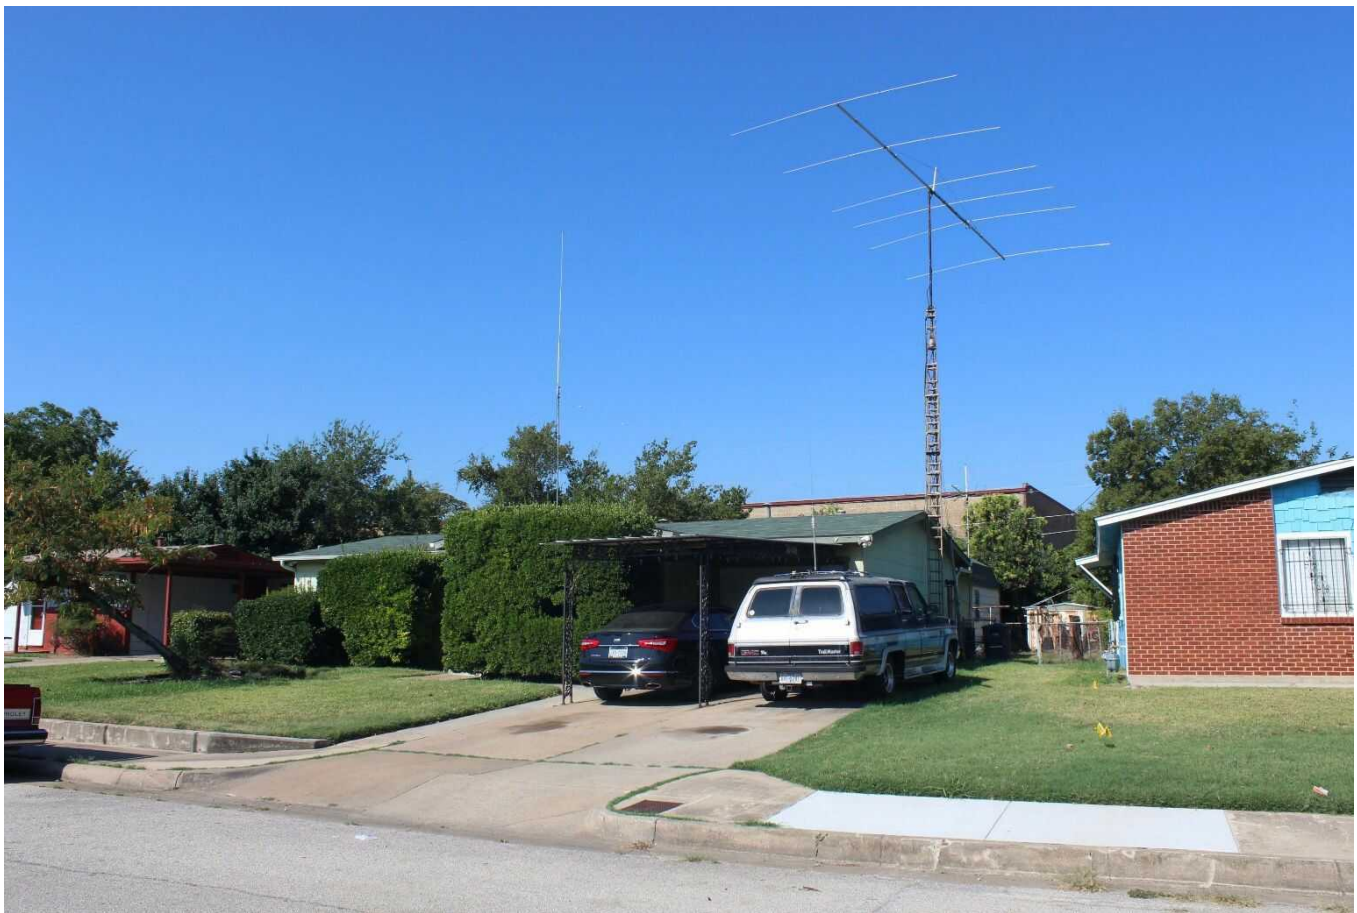
Survey Date:	September 4, 2019
Resource No:	140
Project Location:	Tarrant County
Project Name and CSJ:	Southeast Connector, CSJ 0008-13-125, etc.
Address, Lat/Long:	2212 Carruthers Dr. 32.724378°, -97.224161°
Function/Sub-function:	DOMESTIC/ Antennae
Construction Date:	Ca. 1970
NRHP Eligibility:	Not eligible
Integrity/Comments:	Antennae

Camera facing west.

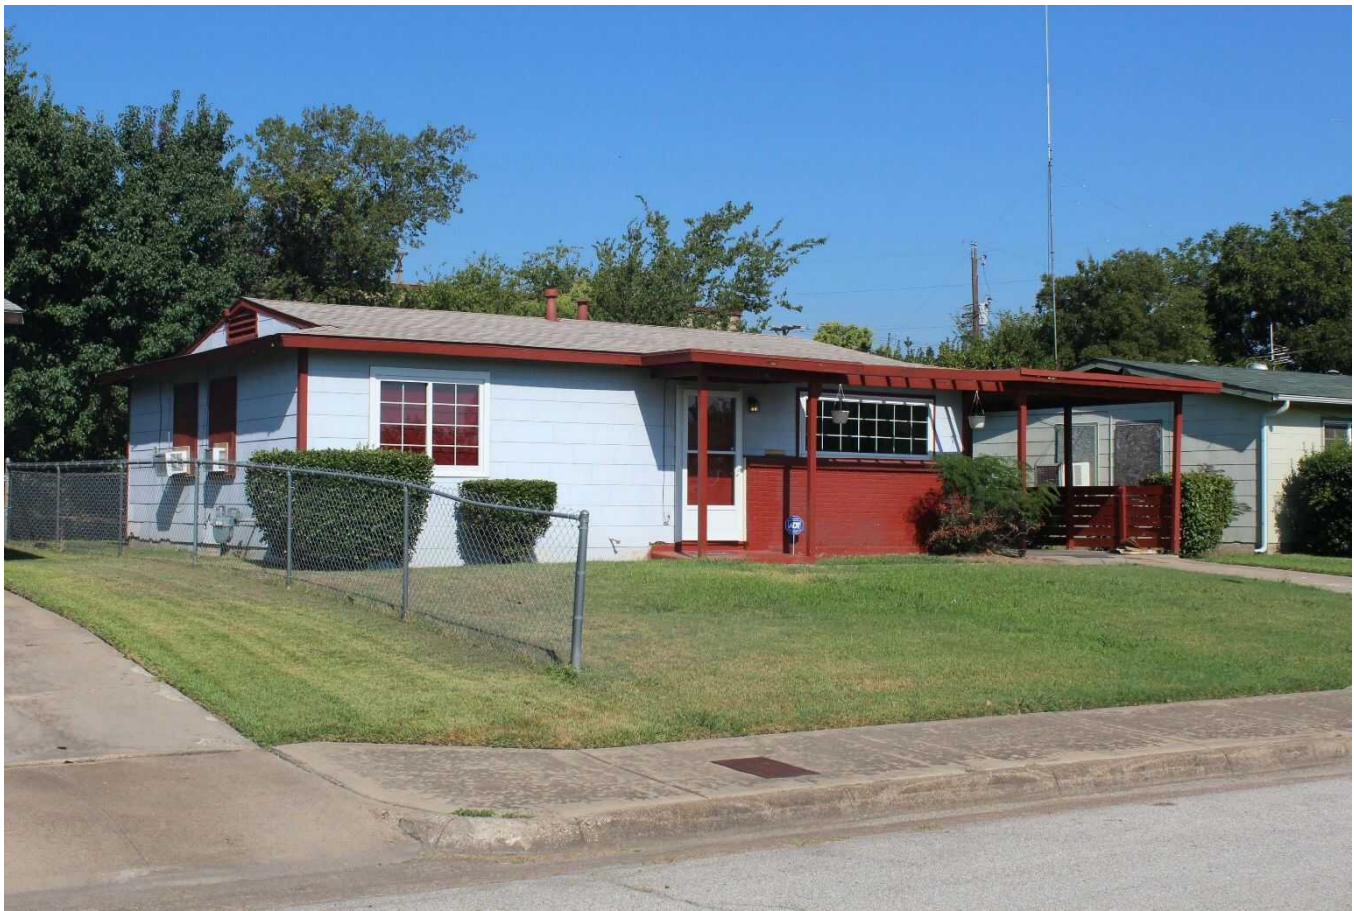
Survey Date:	September 4, 2019
Resource No:	141
Project Location:	Tarrant County
Project Name and CSJ:	Southeast Connector, CSJ 0008-13-125, etc.
Address, Lat/Long:	2216 Carruthers Dr. 32.724201°, -97.223983°
Function/Sub-function:	DOMESTIC/ Single family dwelling
Construction Date:	1957
NRHP Eligibility:	Not eligible
Integrity/Comments:	Ranch style house with shallow-pitch, gable-on-hip roof, horizontal vinyl, brick siding, and asbestos shingle siding, replacement windows, and a carport.

Camera facing northwest.

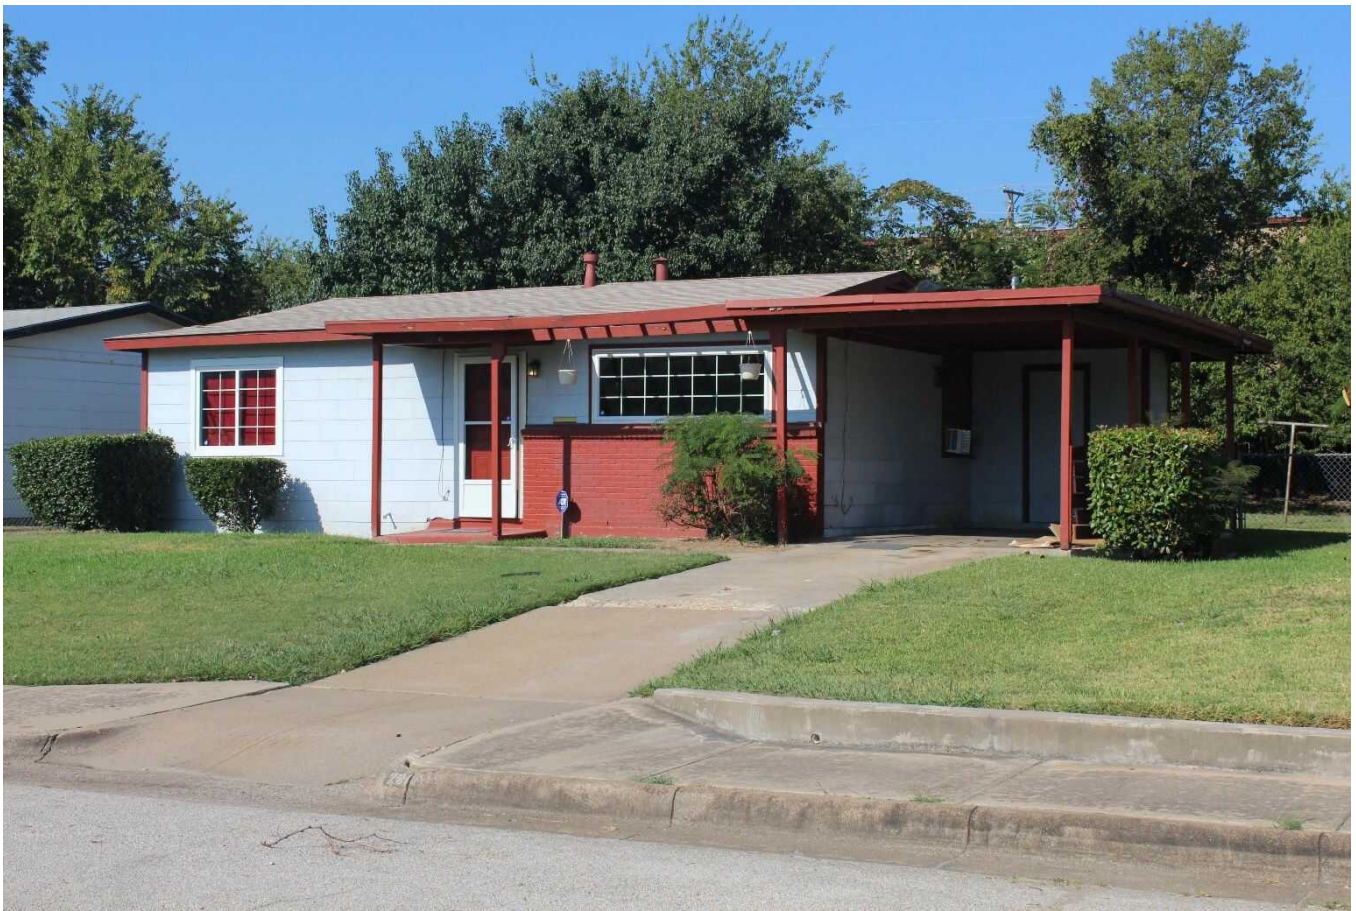
Survey Date:	September 4, 2019
Resource No:	141
Project Location:	Tarrant County
Project Name and CSJ:	Southeast Connector, CSJ 0008-13-125, etc.
Address, Lat/Long:	2216 Carruthers Dr. 32.724201°, -97.223983°
Function/Sub-function:	DOMESTIC/ Single family dwelling
Construction Date:	1957
NRHP Eligibility:	Not eligible
Integrity/Comments:	Ranch style house with shallow-pitch, gable-on-hip roof, horizontal vinyl, brick siding, and asbestos shingle siding, replacement windows, and a carport.

Camera facing southwest.

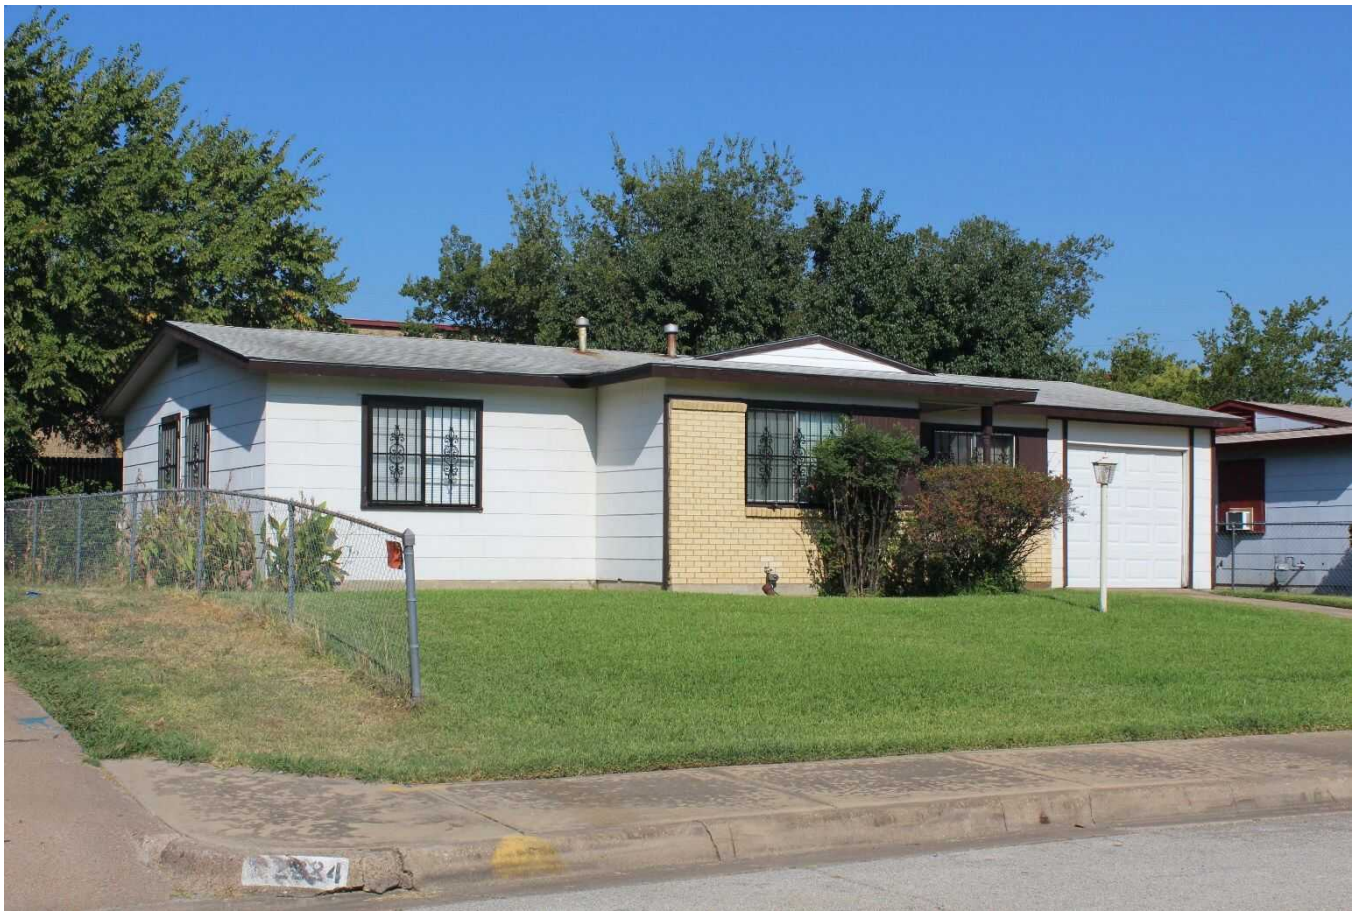
Survey Date:	September 4, 2019
Resource No:	142
Project Location:	Tarrant County
Project Name and CSJ:	Southeast Connector, CSJ 0008-13-125, etc.
Address, Lat/Long:	2220 Carruthers Dr. 32.724031°, -97.223980°
Function/Sub-function:	DOMESTIC/ Single family dwelling
Construction Date:	1957
NRHP Eligibility:	Not eligible
Integrity/Comments:	Ranch style house with shallow-pitch, gable-on-hip roof, horizontal vinyl, brick, and vertical wood siding, original windows, and a garage with a replacement garage door.

Camera facing northwest.

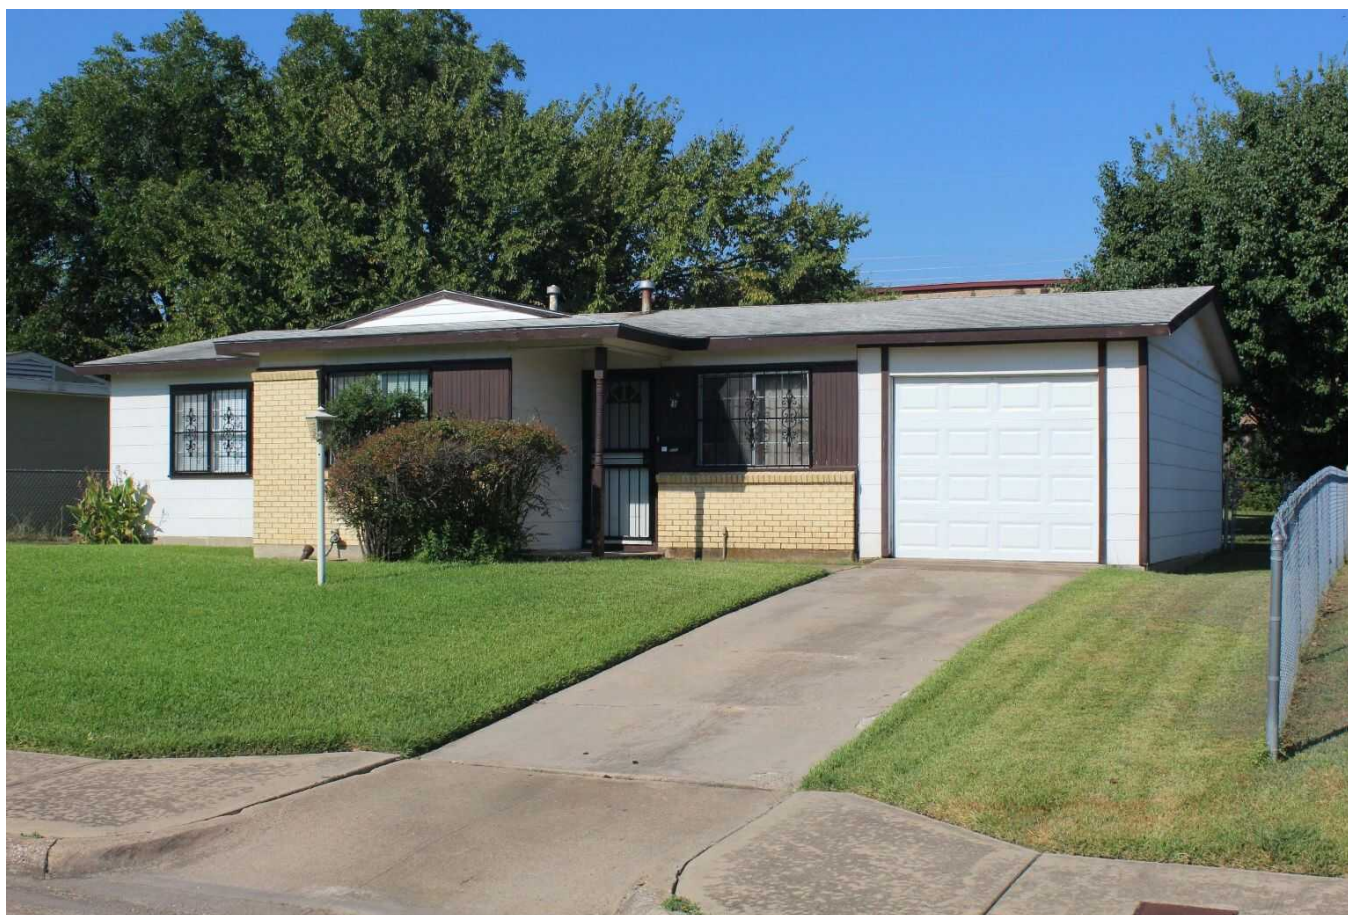
Survey Date:	September 4, 2019
Resource No:	142
Project Location:	Tarrant County
Project Name and CSJ:	Southeast Connector, CSJ 0008-13-125, etc.
Address, Lat/Long:	2220 Carruthers Dr. 32.724031°, -97.223980°
Function/Sub-function:	DOMESTIC/ Single family dwelling
Construction Date:	1957
NRHP Eligibility:	Not eligible
Integrity/Comments:	Ranch style house with shallow-pitch, gable-on-hip roof, horizontal vinyl, brick, and vertical wood siding, original windows, and a garage with a replacement garage door.

Camera facing southwest.

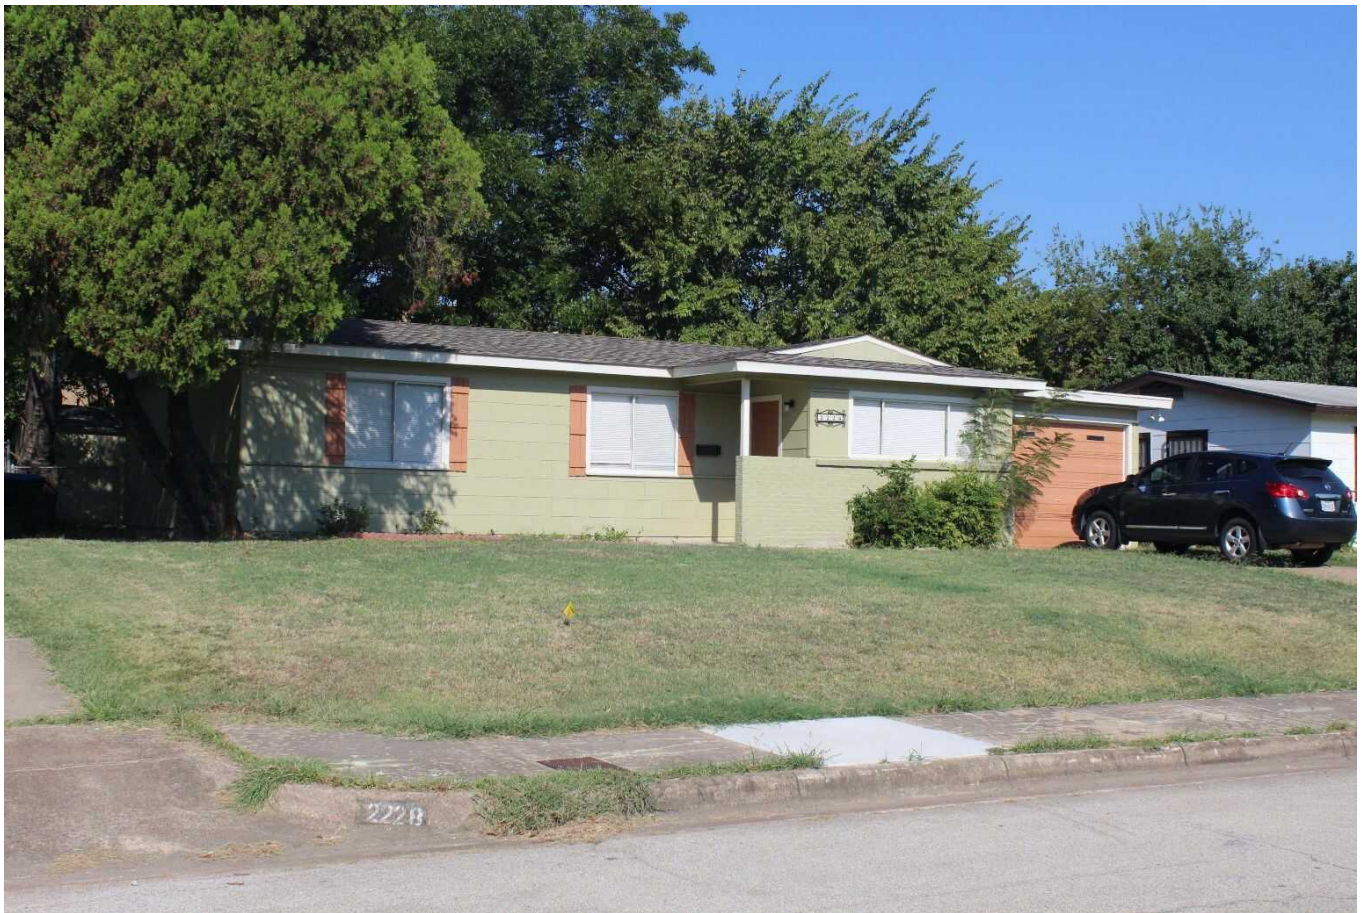
Survey Date:	September 4, 2019
Resource No:	143a
Project Location:	Tarrant County
Project Name and CSJ:	Southeast Connector, CSJ 0008-13-125, etc.
Address, Lat/Long:	2224 Carruthers Dr. 32.723863°, -97.224001°
Function/Sub-function:	DOMESTIC/ Single family dwelling
Construction Date:	1957
NRHP Eligibility:	Not eligible
Integrity/Comments:	Ranch style house with shallow-pitch gable-on-hip roof, horizontal vinyl and brick siding, replacement windows, and a garage addition with a flat roof and horizontal vinyl siding.

Camera facing northwest.
