## **Appendix H: Survey Forms for Removed Properties**

Survey Date:	September 3, 2019
Resource No:	001
Project Location:	Tarrant County
Project Name and CSJ:	Southeast Connector, CSJ 0008-13-125, etc.
Address, Lat/Long:	6501 Brentwood Dr. 32.755926° , -97.218520°
Function/Sub-function:	DOMESTIC/ Single family dwelling
Construction Date:	1958
NRHP Eligibility:	Not eligible
Integrity/Comments:	Ranch style house with wavy brick siding, horizontal vinyl siding under the gables, cross-gabled roof with a shallow pitch and generous eaves, and replacement windows.

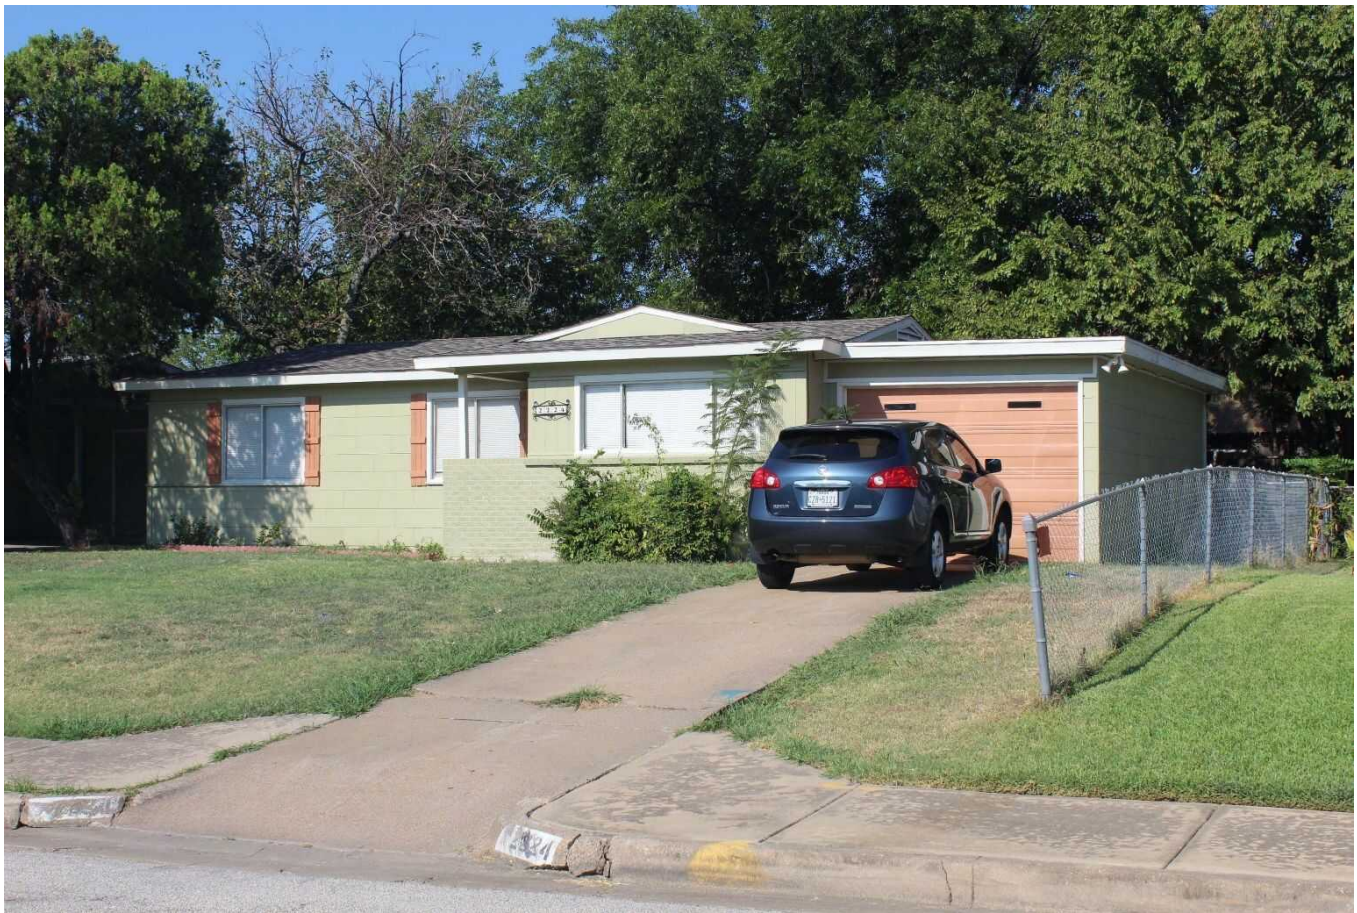
Survey Date:	September 4, 2019
Resource No:	143a
Project Location:	Tarrant County
Project Name and CSJ:	Southeast Connector, CSJ 0008-13-125, etc.
Address, Lat/Long:	2224 Carruthers Dr. 32.723863°, -97.224001°
Function/Sub-function:	DOMESTIC/ Single family dwelling
Construction Date:	1957
NRHP Eligibility:	Not eligible
Integrity/Comments:	Ranch style house with shallow-pitch gable-on-hip roof, horizontal vinyl and brick siding, replacement windows, and a garage addition with a flat roof and horizontal vinyl siding.

Camera facing southwest.

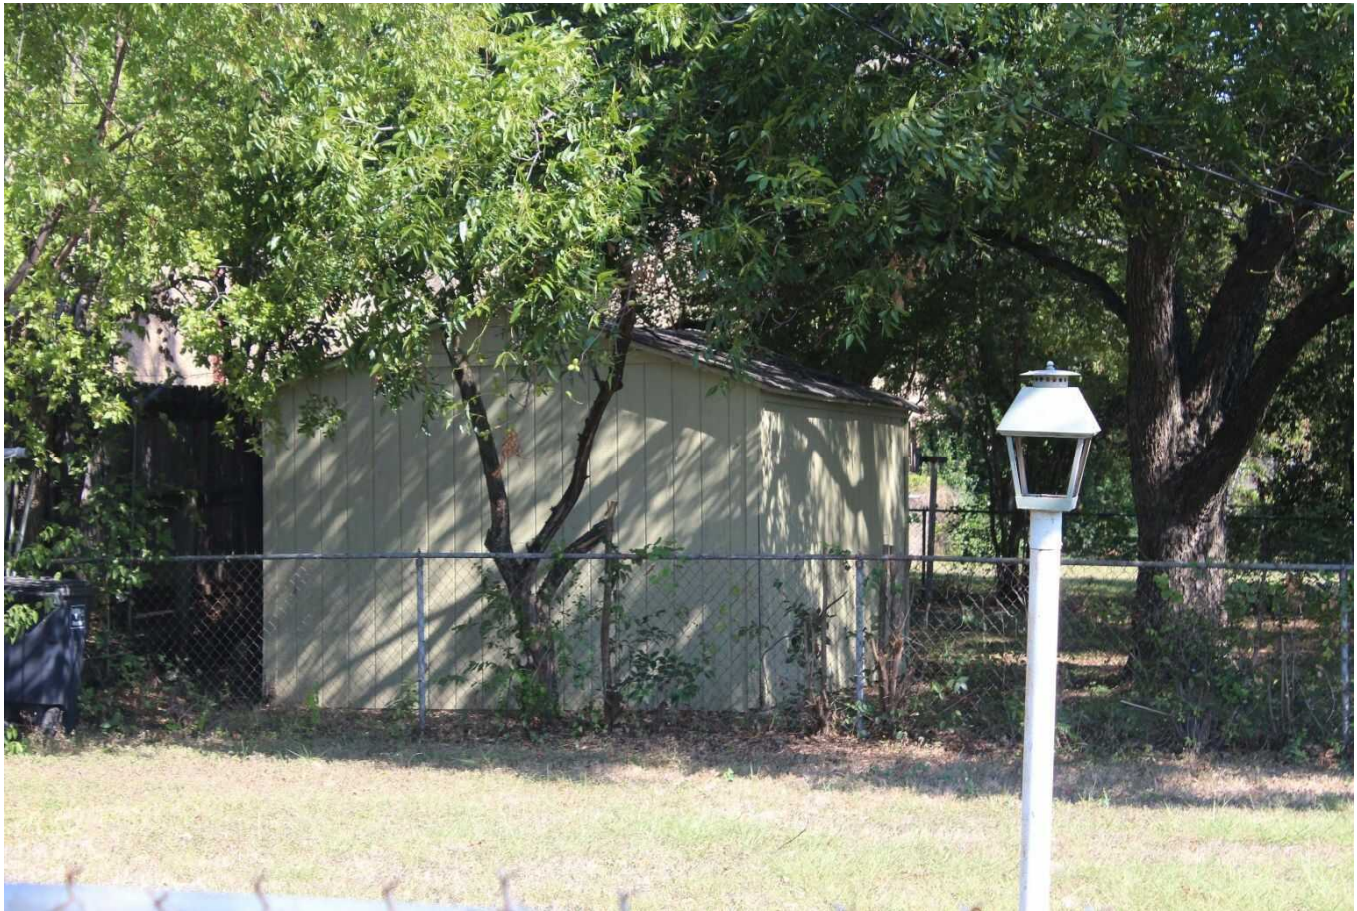
Survey Date:	September 4, 2019
Resource No:	143b
Project Location:	Tarrant County
Project Name and CSJ:	Southeast Connector, CSJ 0008-13-125, etc.
Address, Lat/Long:	2224 Carruthers Dr. 32.723822°, -97.224196°
Function/Sub-function:	DOMESTIC/ Shed
Construction Date:	Ca. 1970
NRHP Eligibility:	Not eligible
Integrity/Comments:	Shed with front-gable roof, vertical wood siding, and horizontal wood siding on the gable ends.

Camera facing north.

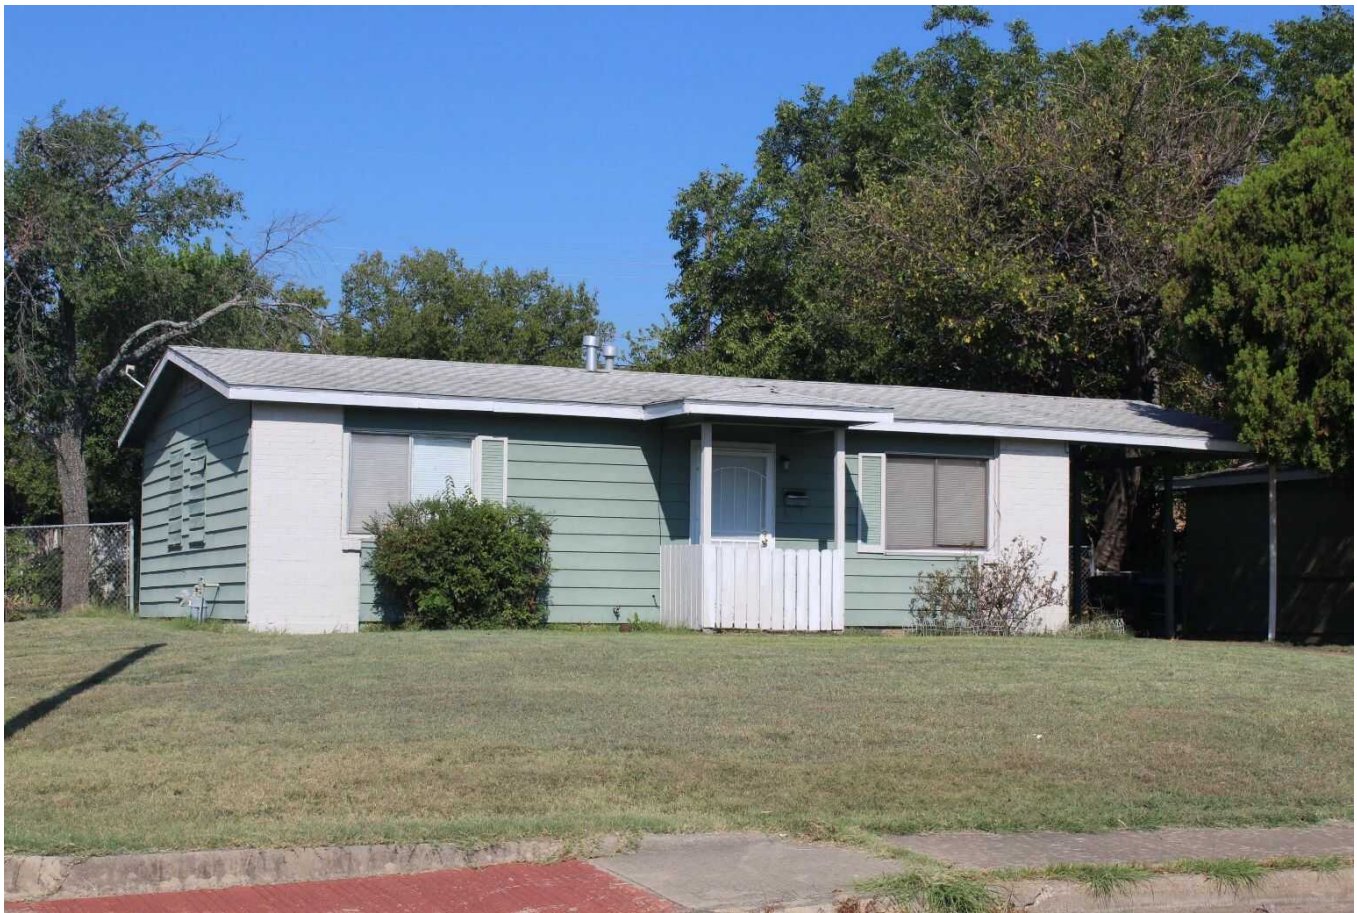
Survey Date:	September 4, 2019
Resource No:	144
Project Location:	Tarrant County
Project Name and CSJ:	Southeast Connector, CSJ 0008-13-125, etc.
Address, Lat/Long:	2228 Carruthers Dr. 32.723714°, -97.224004°
Function/Sub-function:	DOMESTIC/ Single family dwelling
Construction Date:	1957
NRHP Eligibility:	Not eligible
Integrity/Comments:	Ranch style house with shallow-pitch, side-gable roof, horizontal vinyl and brick siding, replacement windows, and a carport.

Camera facing northwest.

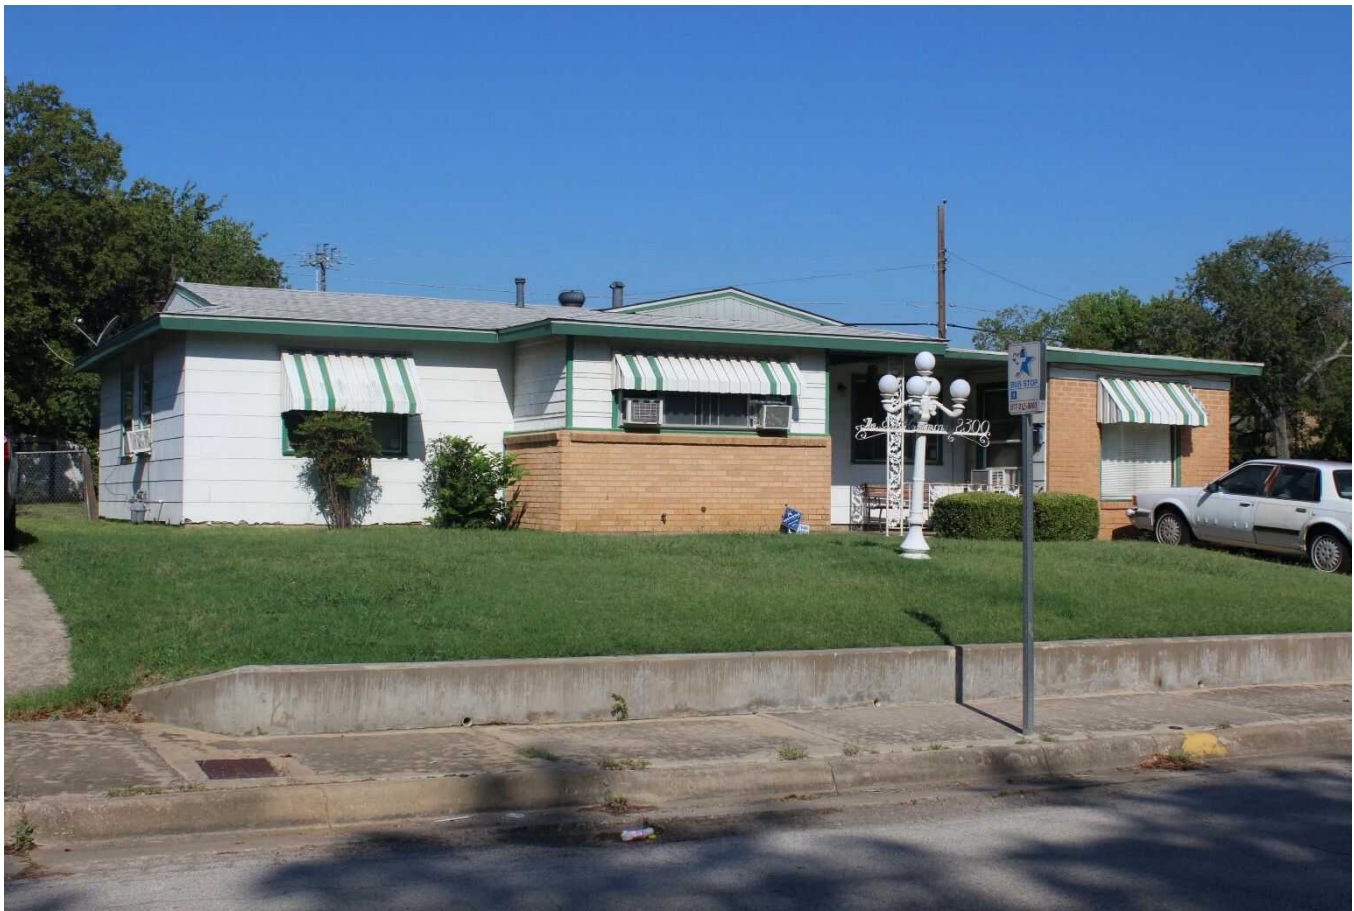
Survey Date:	September 4, 2019
Resource No:	146
Project Location:	Tarrant County
Project Name and CSJ:	Southeast Connector, CSJ 0008-13-125, etc.
Address, Lat/Long:	2300 Carruthers Dr. 32.723405°, -97.223990°
Function/Sub-function:	DOMESTIC/ Single family dwelling
Construction Date:	1956
NRHP Eligibility:	Not eligible
Integrity/Comments:	Ranch style house with gable-on-hip roof, horizontal and vertical vinyl and brick siding, original and replacement windows, and a recessed porch.

Camera facing northwest.

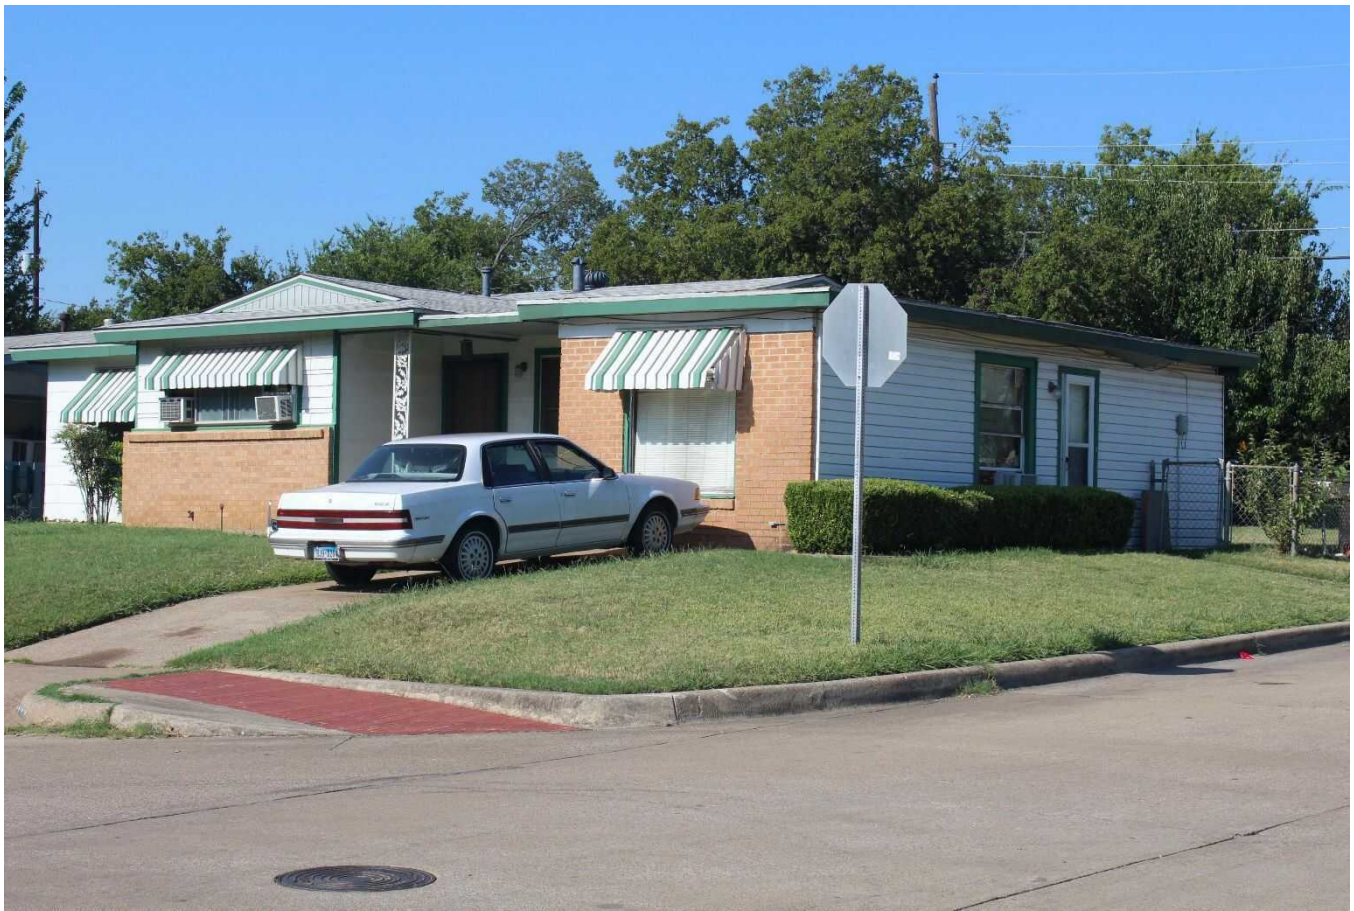
Survey Date:	September 4, 2019
Resource No:	146
Project Location:	Tarrant County
Project Name and CSJ:	Southeast Connector, CSJ 0008-13-125, etc.
Address, Lat/Long:	2300 Carruthers Dr. 32.723405°, -97.223990°
Function/Sub-function:	DOMESTIC/ Single family dwelling
Construction Date:	1956
NRHP Eligibility:	Not eligible
Integrity/Comments:	Ranch style house with gable-on-hip roof, horizontal and vertical vinyl and brick siding, original and replacement windows, and a recessed porch.

Camera facing southwest.

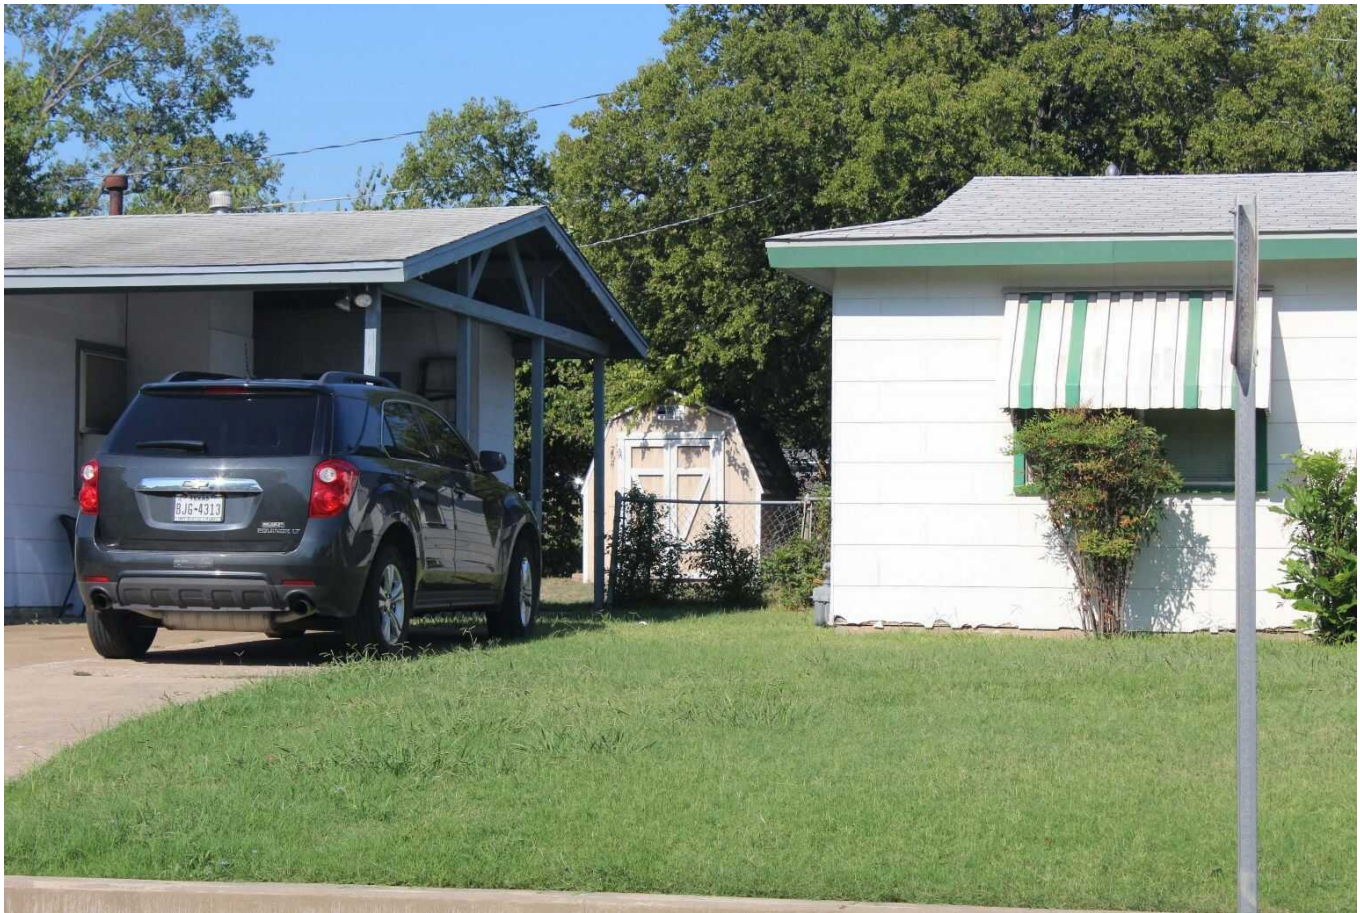
Survey Date:	September 4, 2019
Resource No:	147
Project Location:	Tarrant County
Project Name and CSJ:	Southeast Connector, CSJ 0008-13-125, etc.
Address, Lat/Long:	2304 Carruthers Dr. 32.723241°, -97.224011°
Function/Sub-function:	DOMESTIC/ Shed
Construction Date:	Ca. 2000
NRHP Eligibility:	Not eligible
Integrity/Comments:	Modern shed.

Camera facing southwest.

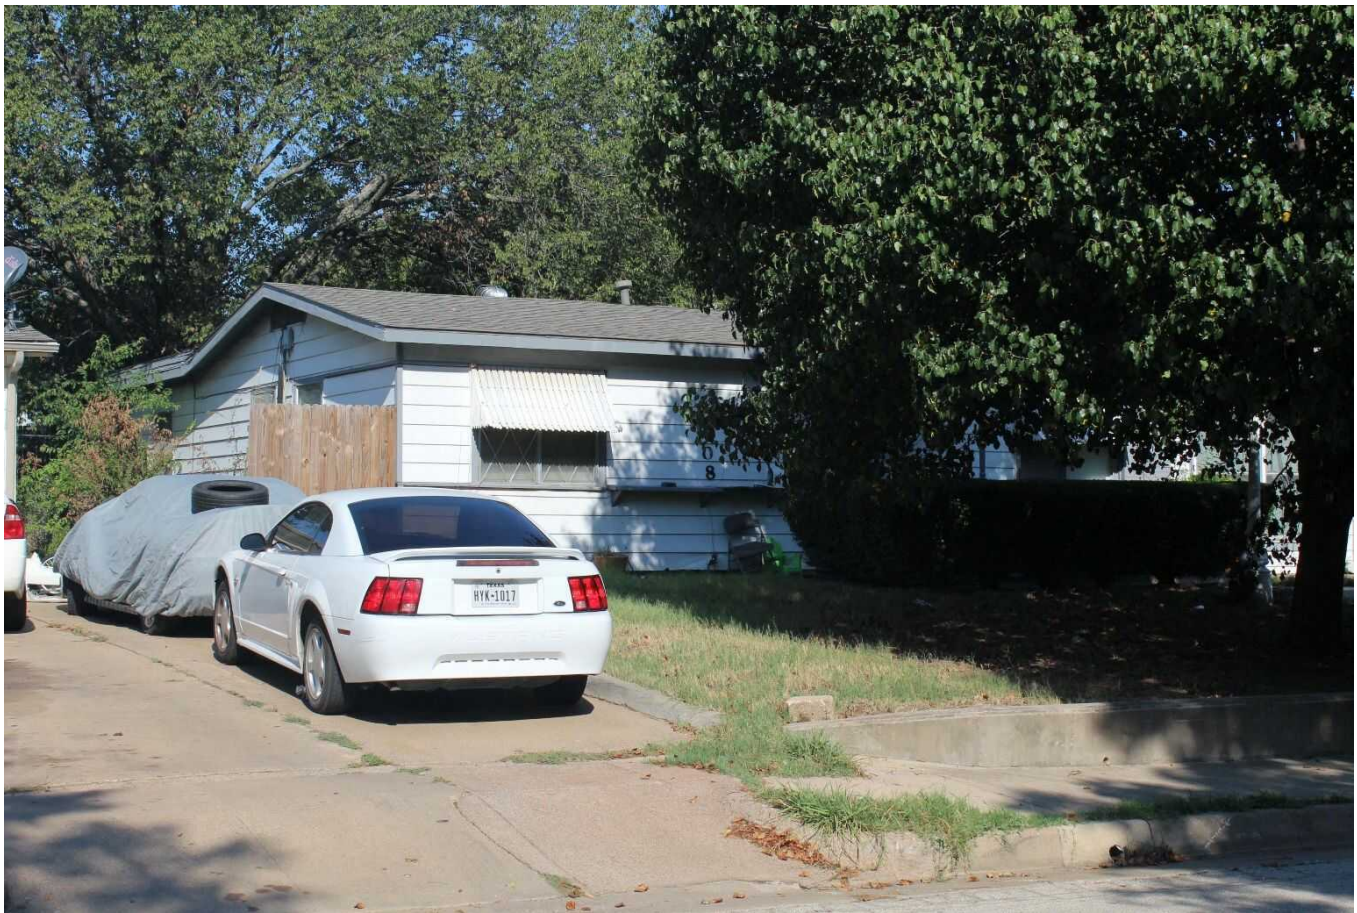
Survey Date:	September 4, 2019
Resource No:	148
Project Location:	Tarrant County
Project Name and CSJ:	Southeast Connector, CSJ 0008-13-125, etc.
Address, Lat/Long:	2308 Carruthers Dr. 32.723080°, -97.224003°
Function/Sub-function:	DOMESTIC/ Single family dwelling
Construction Date:	1956
NRHP Eligibility:	Not eligible
Integrity/Comments:	Ranch style house with shallow-pitch, side-gable roof, horizontal vinyl and brick siding, both original and replacement windows.

Camera facing northwest.

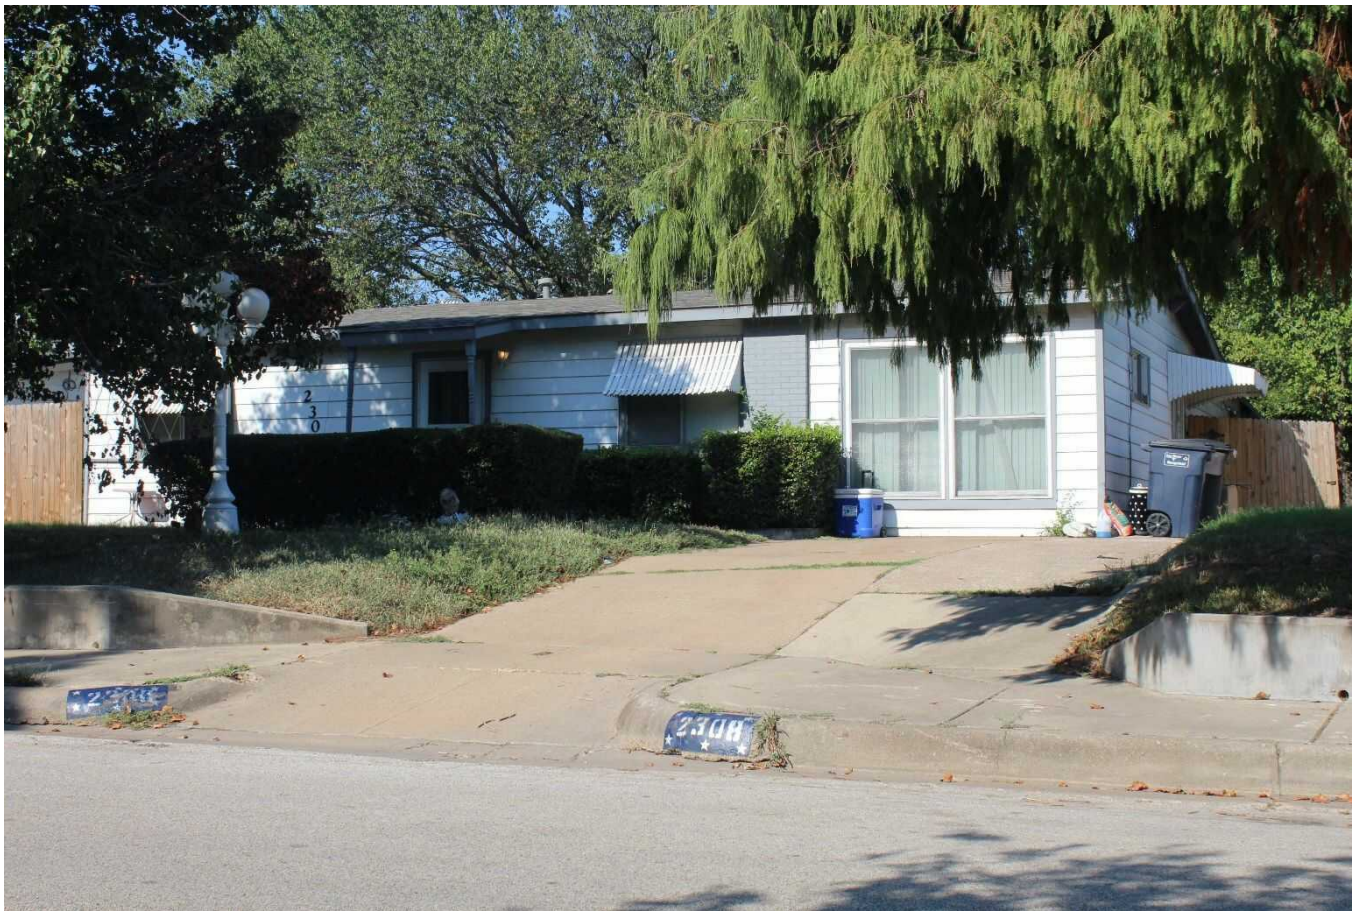
Survey Date:	September 4, 2019
Resource No:	148
Project Location:	Tarrant County
Project Name and CSJ:	Sout8heast Connector, CSJ 0008-13-125, etc.
Address, Lat/Long:	2308 Carruthers Dr. 32.723080°, -97.224003°
Function/Sub-function:	DOMESTIC/ Single family dwelling
Construction Date:	1956
NRHP Eligibility:	Not eligible
Integrity/Comments:	Ranch style house with shallow-pitch, side-gable roof, horizontal vinyl and brick siding, both original and replacement windows.

Camera facing southwest.

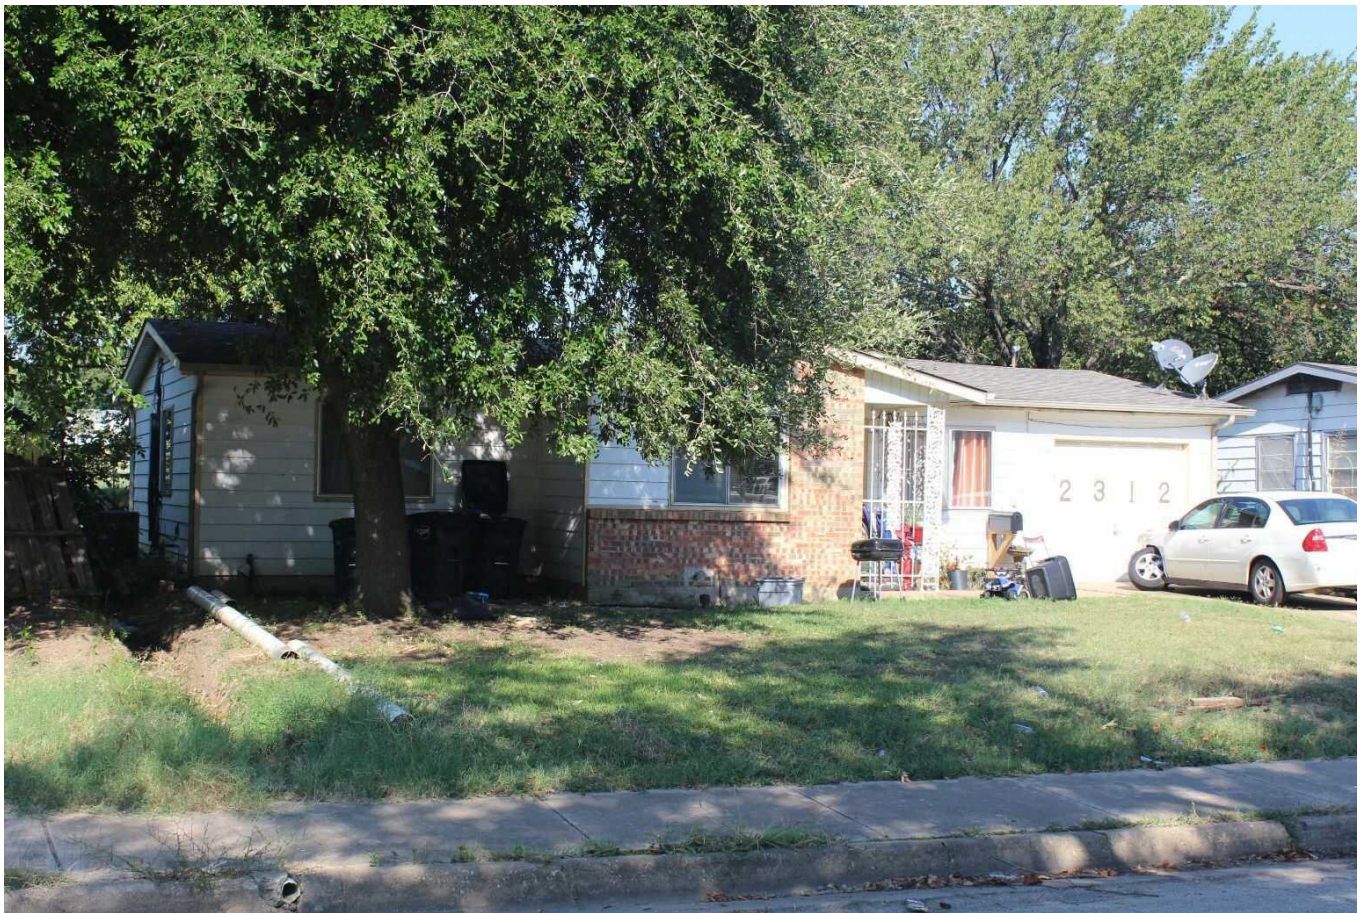
Survey Date:	September 4, 2019
Resource No:	149
Project Location:	Tarrant County
Project Name and CSJ:	Sout8heast Connector, CSJ 0008-13-125, etc.
Address, Lat/Long:	2312 Carruthers Dr. 32.722951°, -97.224014°
Function/Sub-function:	DOMESTIC/ Single family dwelling
Construction Date:	1956
NRHP Eligibility:	Not eligible
Integrity/Comments:	Ranch style house with shallow-pitch, center gable roof, horizontal and brick siding, both original and replacement windows, and a garage with a replacement garage door.

Camera facing northwest.

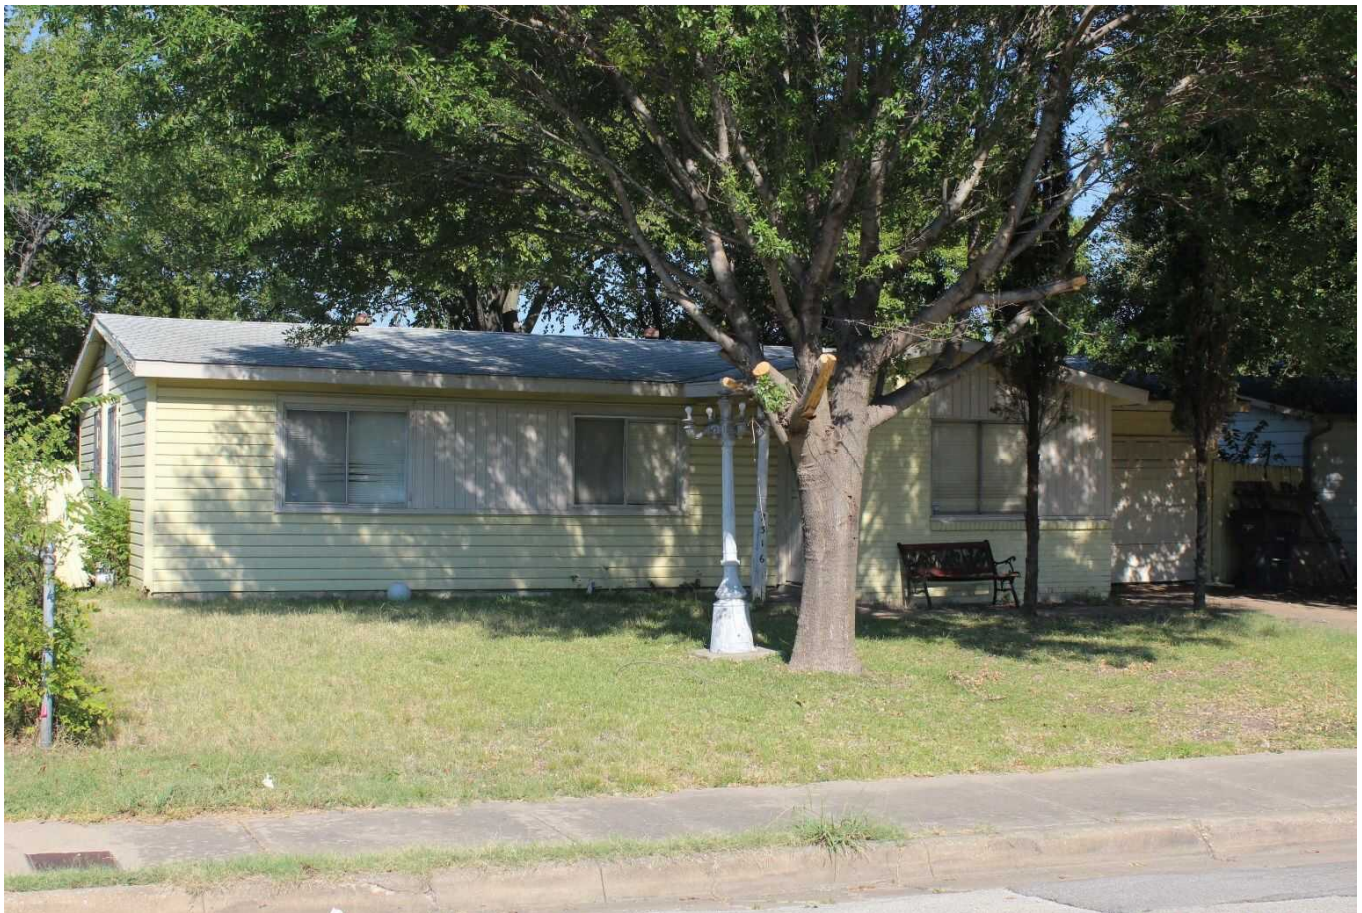
Survey Date:	September 4, 2019
Resource No:	150
Project Location:	Tarrant County
Project Name and CSJ:	Sout8heast Connector, CSJ 0008-13-125, etc.
Address, Lat/Long:	2316 Carruthers Dr. 32.722747°, -97.223995°
Function/Sub-function:	DOMESTIC/ Single family dwelling
Construction Date:	1956
NRHP Eligibility:	Not eligible
Integrity/Comments:	Ranch style house with shallow-pitch, cross-gable roof, horizontal and vertical siding, brick siding, replacement windows, a garage with a replacement garage door. Per aerial imagery, the house has a large addition on the rear (west) façade. The addition features a front-gable roof and a breezeway.

Camera facing northwest.
