## **Appendix H: Survey Forms for Removed Properties**

Survey Date:	September 3, 2019
Resource No:	001
Project Location:	Tarrant County
Project Name and CSJ:	Southeast Connector, CSJ 0008-13-125, etc.
Address, Lat/Long:	6501 Brentwood Dr. 32.755926° , -97.218520°
Function/Sub-function:	DOMESTIC/ Single family dwelling
Construction Date:	1958
NRHP Eligibility:	Not eligible
Integrity/Comments:	Ranch style house with wavy brick siding, horizontal vinyl siding under the gables, cross-gabled roof with a shallow pitch and generous eaves, and replacement windows.

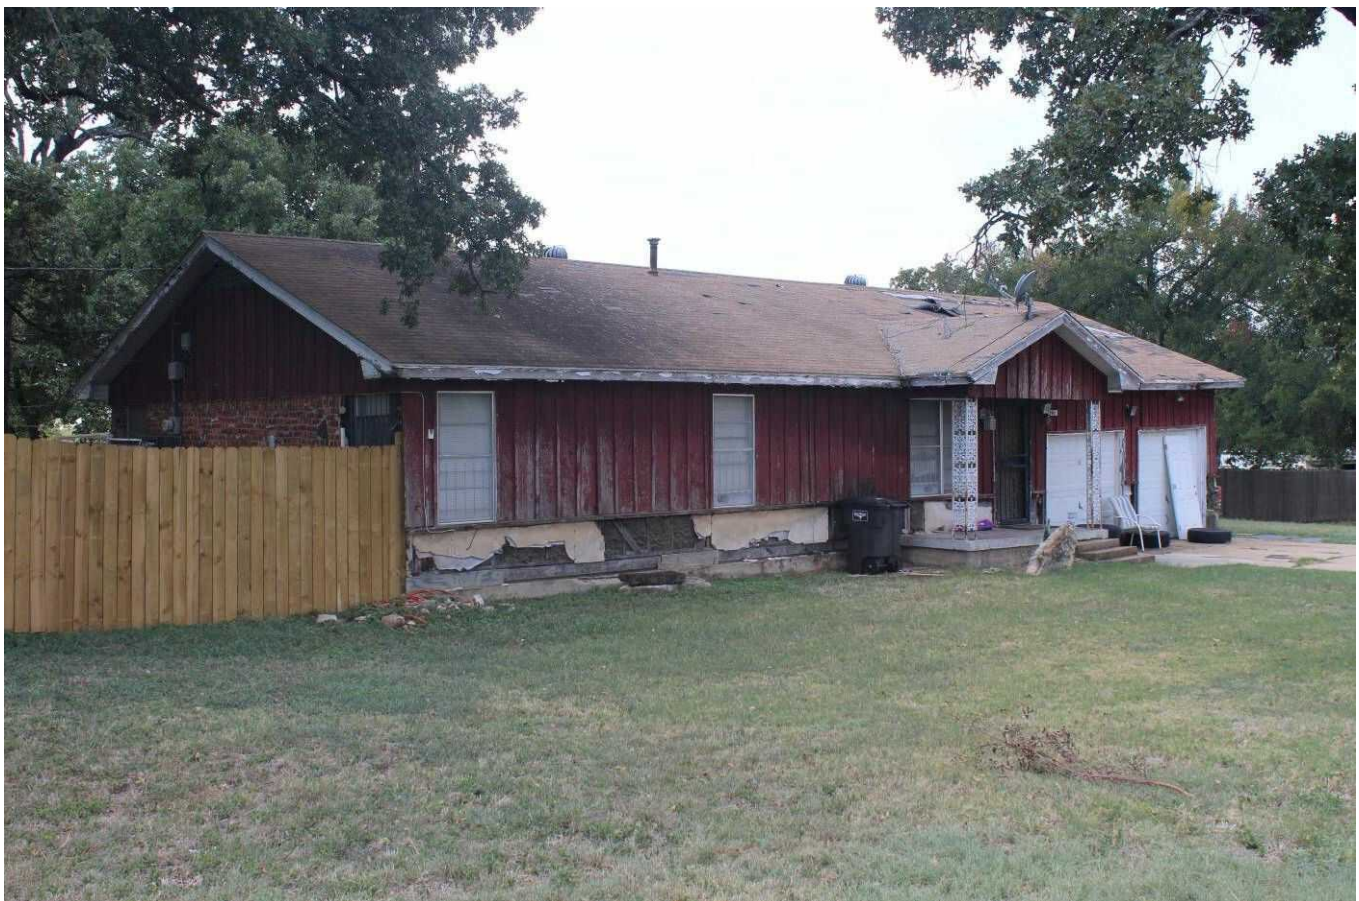
Camera facing southwest.

Survey Date:	September 5, 2019
Resource No:	337a
Project Location:	Tarrant County
Project Name and CSJ:	Southeast Connector, CSJ 0008-13-125, etc.
Address, Lat/Long:	4238 Chickasaw Ave 32.696489° , -97.259646°
Function/Sub-function:	DOMESTIC/ Single family dwelling
Construction Date:	1963
NRHP Eligibility:	Not eligible
Integrity/Comments:	Ranch style house with center-box gable roof with generous eaves, vertical wood, stucco, and wavy brick siding with projecting stones, a portico with decorative iron posts, replacement windows, and a garage with replaced garage doors.

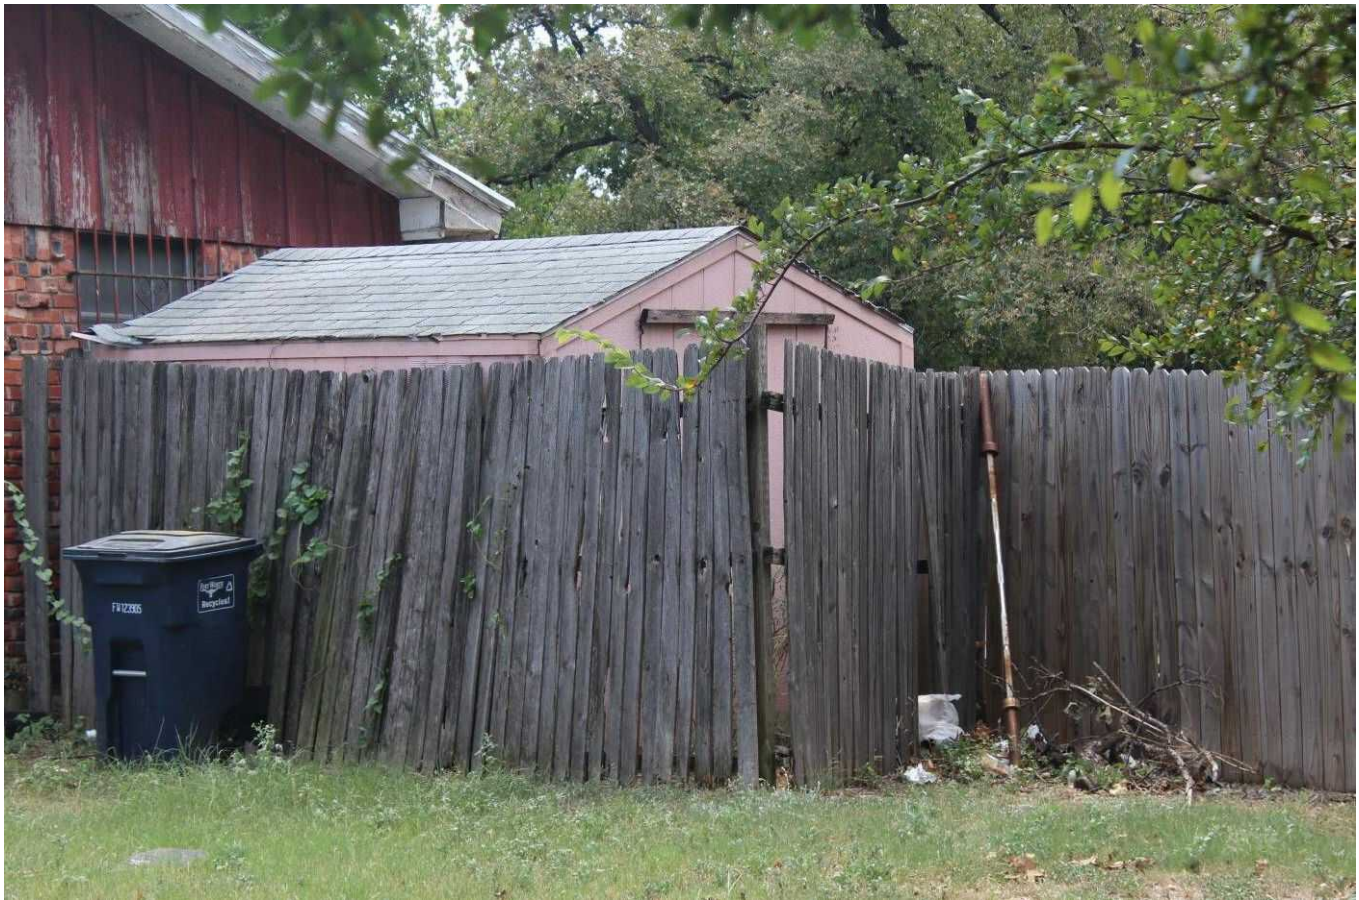
Camera facing southeast.

Survey Date:	September 5, 2019
Resource No:	337b
Project Location:	Tarrant County
Project Name and CSJ:	Southeast Connector, CSJ 0008-13-125, etc.
Address, Lat/Long:	4238 Chickasaw Ave 32.696537° , -97.259777°
Function/Sub-function:	DOMESTIC/ Shed
Construction Date:	Ca. 1970
NRHP Eligibility:	Not eligible
Integrity/Comments:	Shed with shallow-pitch, front-gable roof and vertical wood siding.

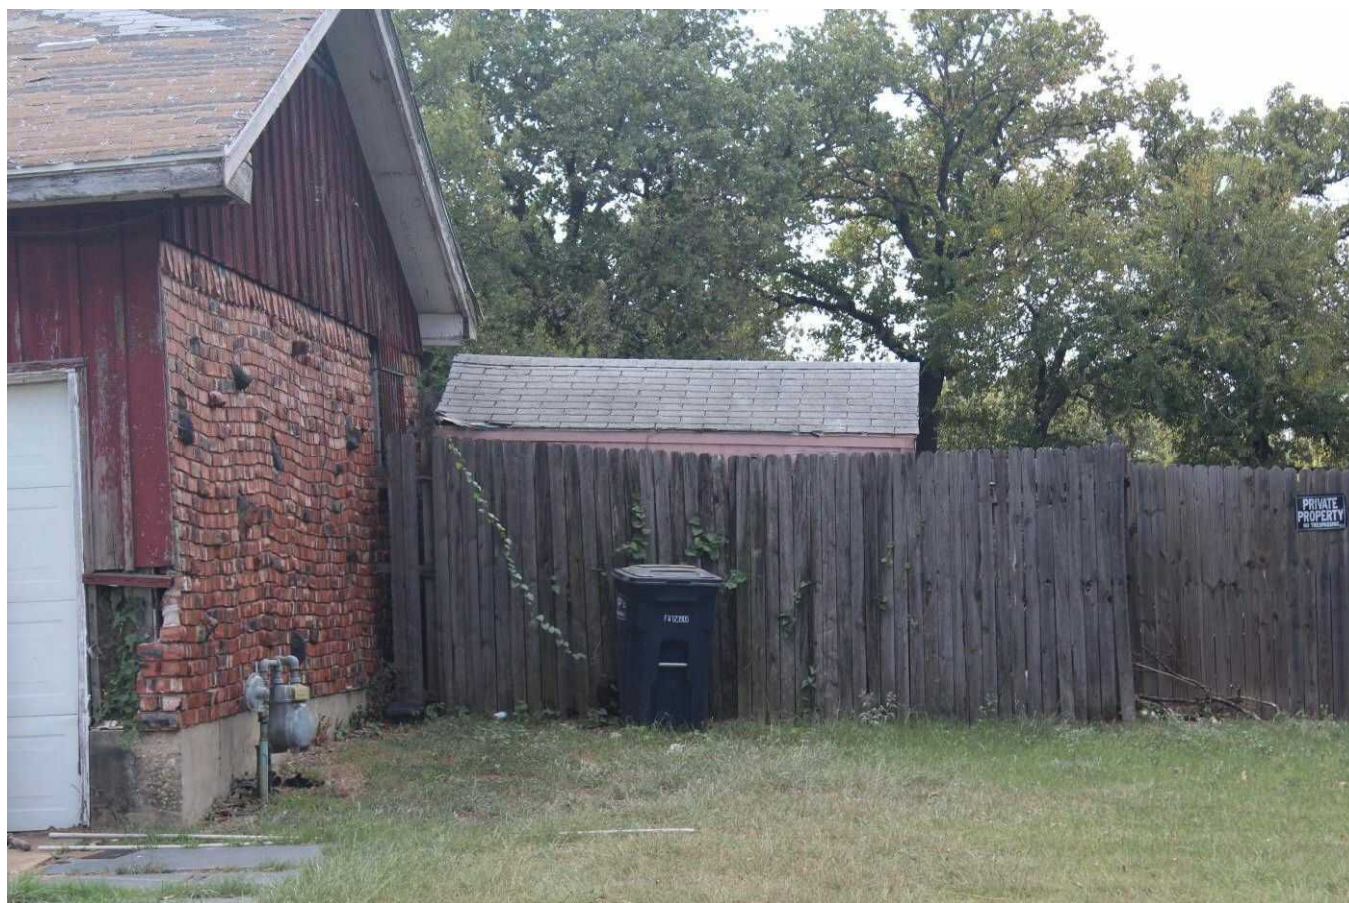
Camera facing south.

Survey Date:	September 5, 2019
Resource No:	337b
Project Location:	Tarrant County
Project Name and CSJ:	Southeast Connector, CSJ 0008-13-125, etc.
Address, Lat/Long:	4238 Chickasaw Ave 32.696537°, -97.259777°
Function/Sub-function:	DOMESTIC/ Shed
Construction Date:	Ca. 1970
NRHP Eligibility:	Not eligible
Integrity/Comments:	Shed with shallow-pitch, front-gable roof and vertical wood siding.

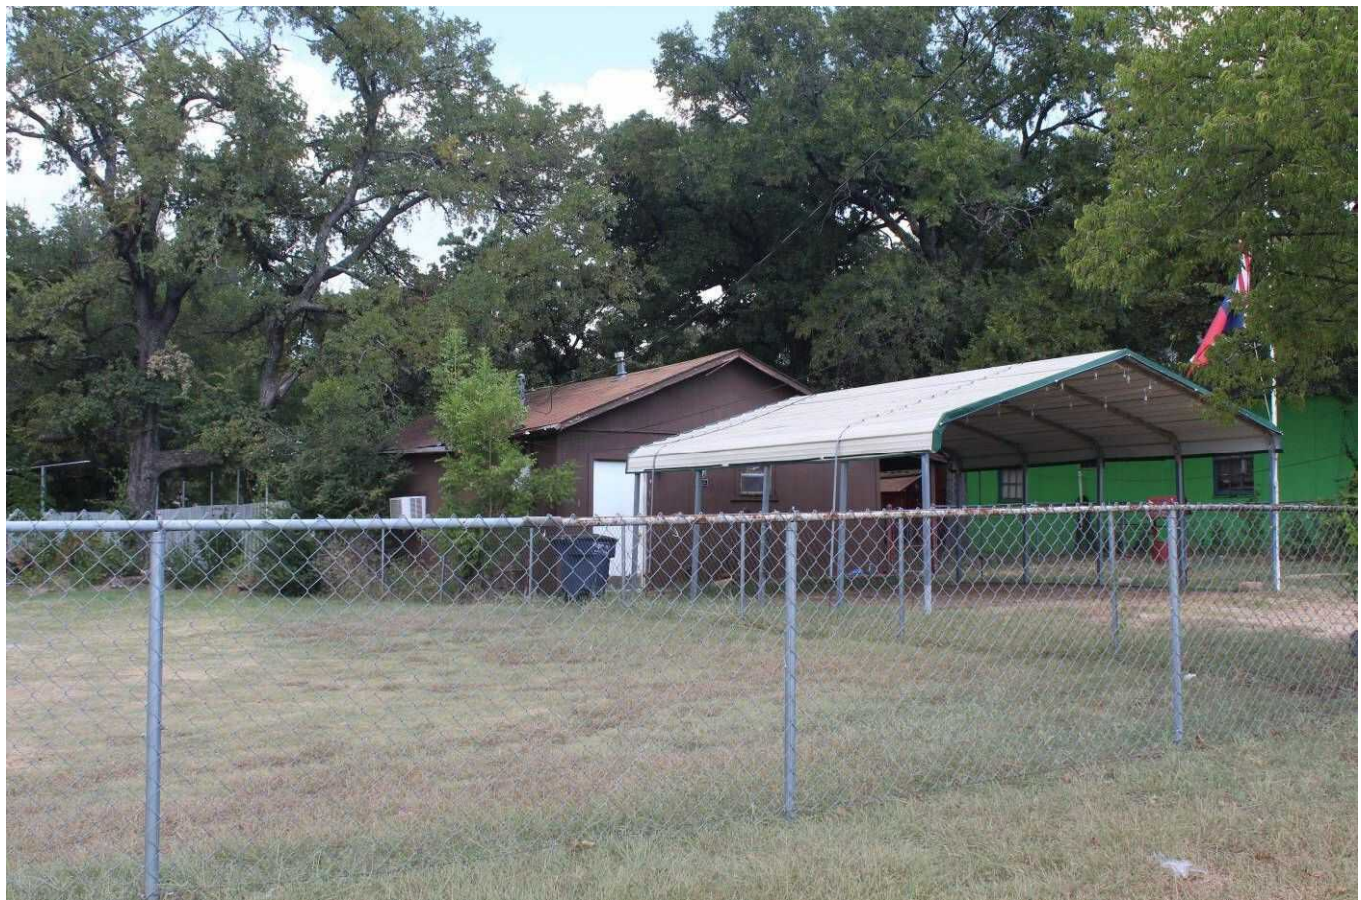
Camera facing northeast.

Survey Date:	September 5, 2019
Resource No:	338
Project Location:	Tarrant County
Project Name and CSJ:	Southeast Connector, CSJ 0008-13-125, etc.
Address, Lat/Long:	4321 Pierce St. 32.695682° , -97.259841°
Function/Sub-function:	DOMESTIC/ Single family dwelling
Construction Date:	1948
NRHP Eligibility:	Not eligible
Integrity/Comments:	House with no discernible style, featuring side-gable roof, vertical wood siding, a full-width porch, and replacement windows. A modern metal carport is positioned south of the house.

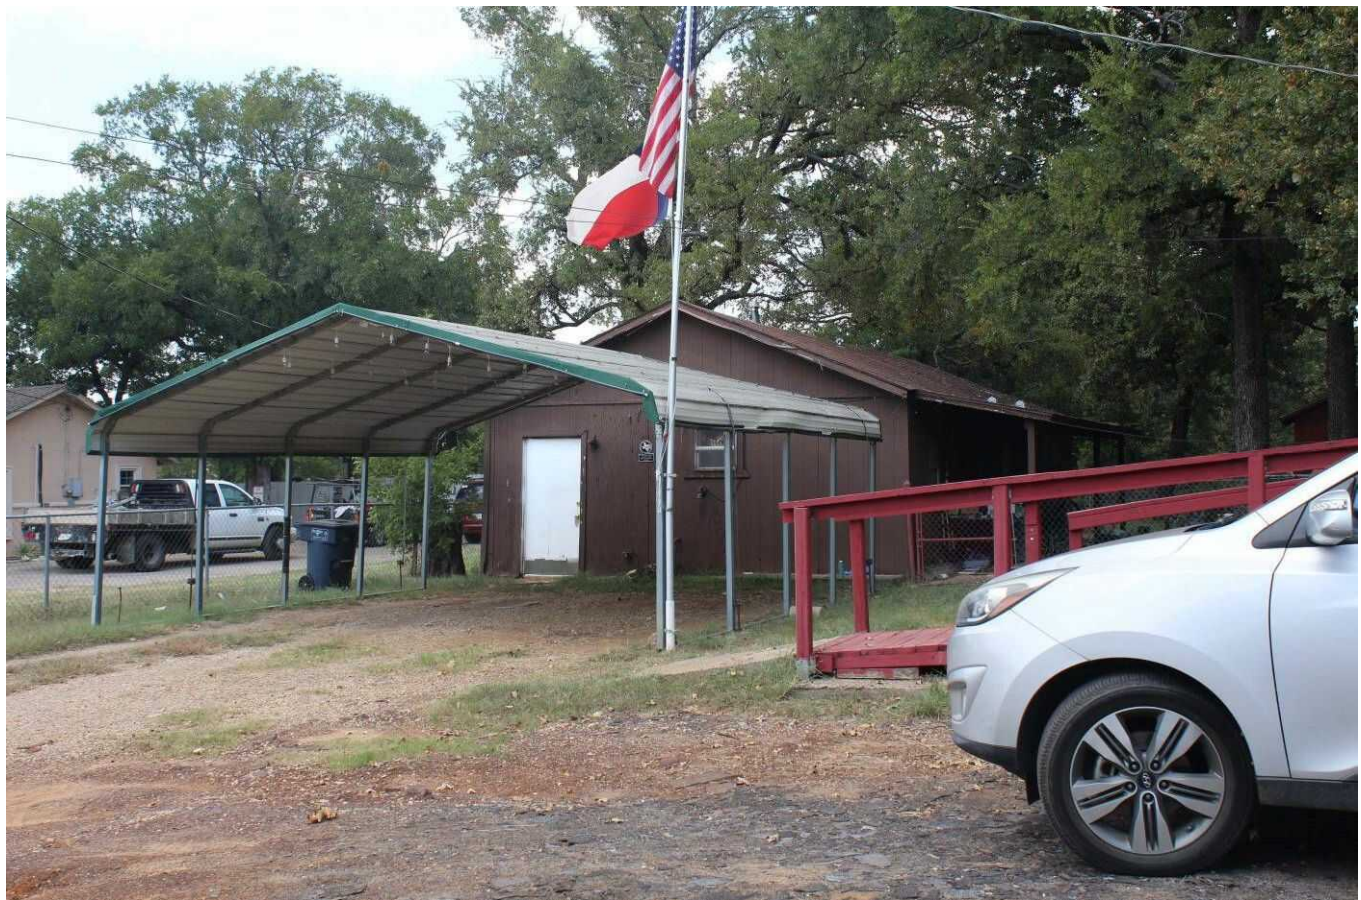
Camera facing northwest.

Survey Date:	September 5, 2019
Resource No:	338
Project Location:	Tarrant County
Project Name and CSJ:	Southeast Connector, CSJ 0008-13-125, etc.
Address, Lat/Long:	4321 Pierce St. 32.695682° , -97.259841°
Function/Sub-function:	DOMESTIC/ Single family dwelling
Construction Date:	1948
NRHP Eligibility:	Not eligible
Integrity/Comments:	House with no discernible style, featuring side-gable roof, vertical wood siding, a full-width porch, and replacement windows. A modern metal carport is positioned south of the house.

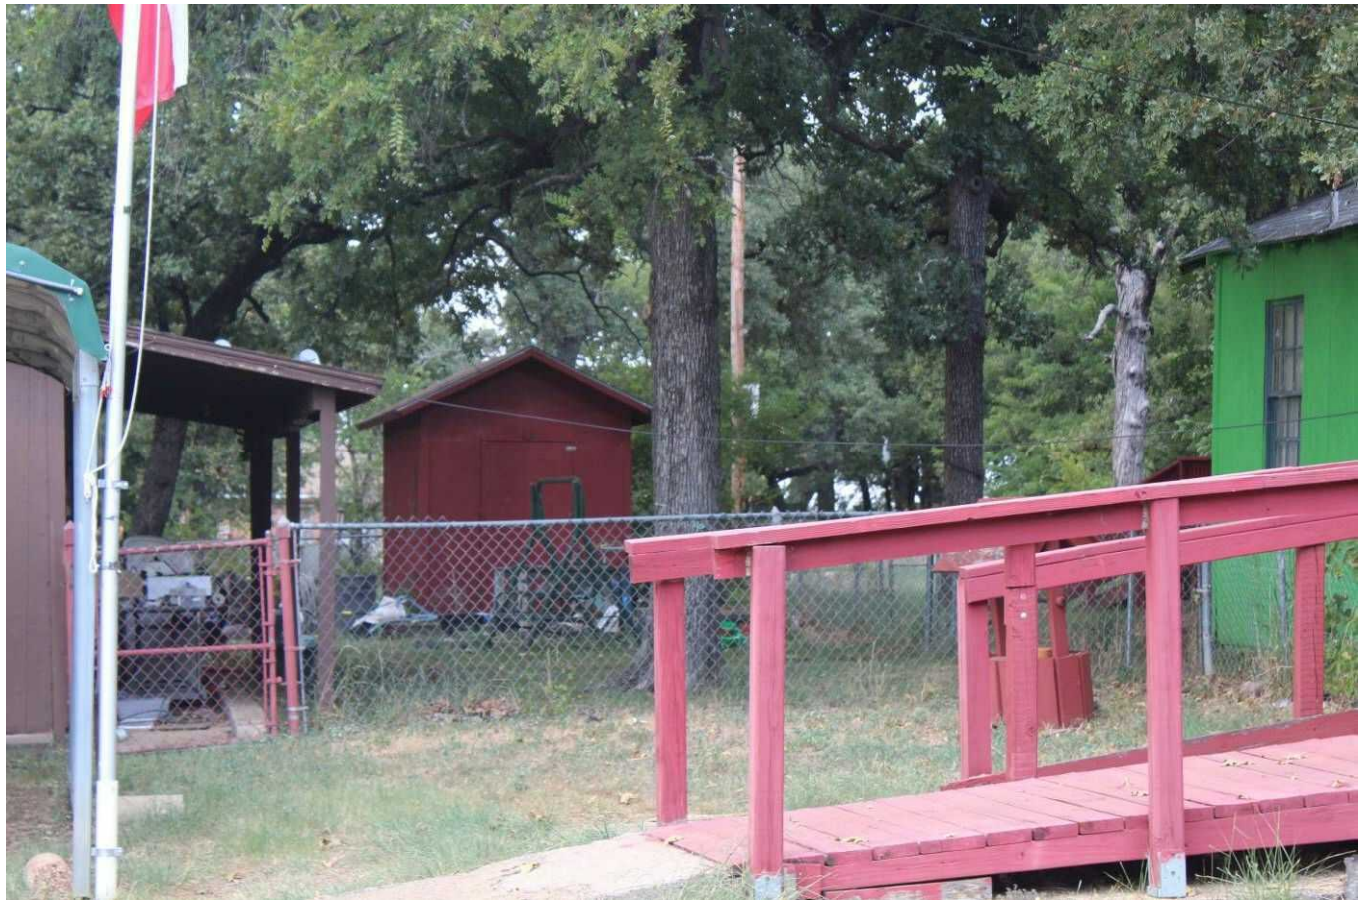
Camera facing north.

Survey Date:	September 5, 2019
Resource No:	338
Project Location:	Tarrant County
Project Name and CSJ:	Southeast Connector, CSJ 0008-13-125, etc.
Address, Lat/Long:	4321 Pierce St. 32.695682° , -97.259841°
Function/Sub-function:	DOMESTIC/ Shed
Construction Date:	Ca. 1980
NRHP Eligibility:	Not eligible
Integrity/Comments:	Modern shed.

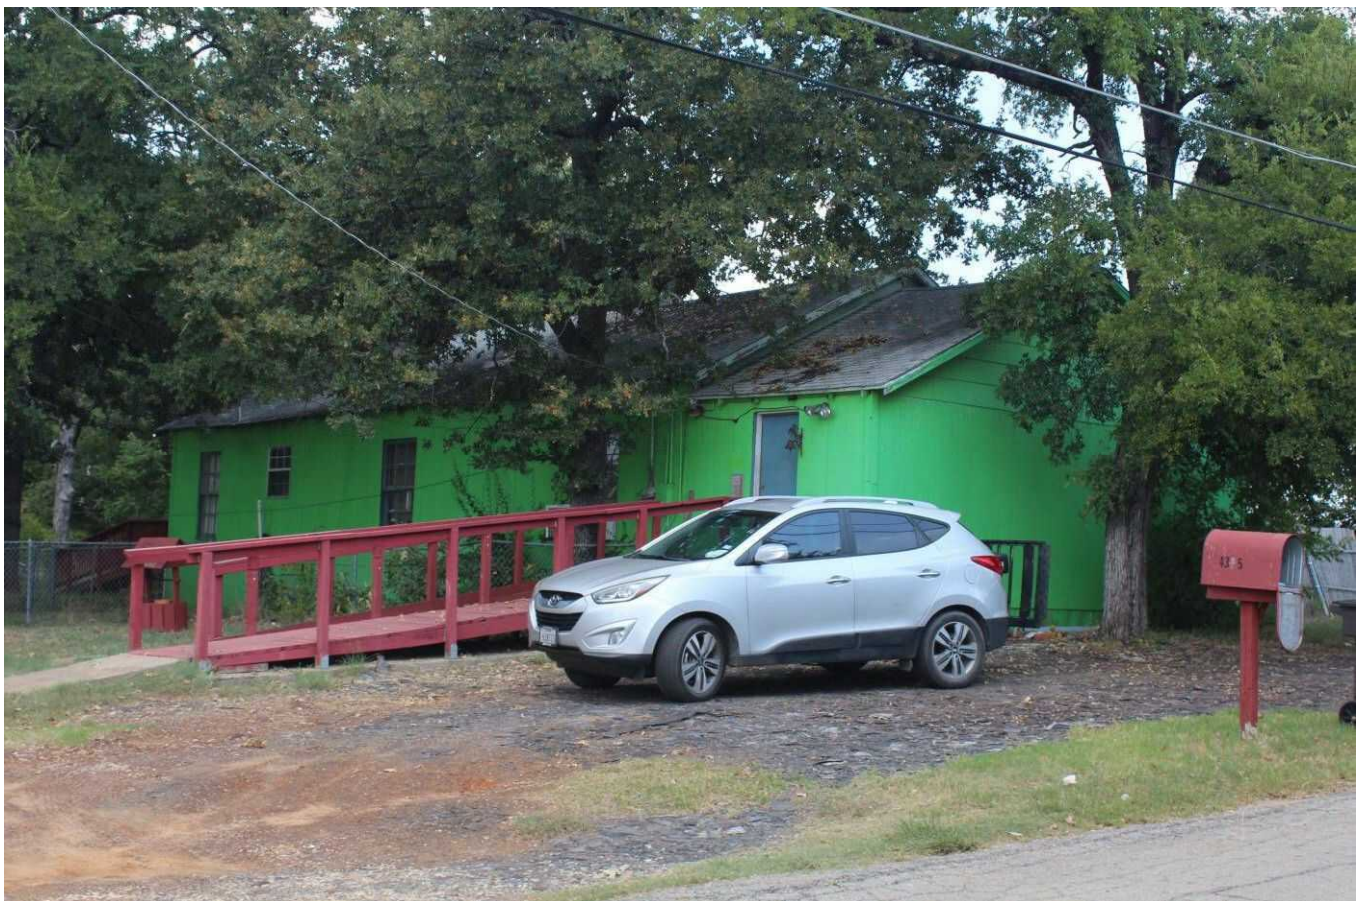
Camera facing northeast.

Survey Date:	September 5, 2019
Resource No:	339a
Project Location:	Tarrant County
Project Name and CSJ:	Southeast Connector, CSJ 0008-13-125, etc.
Address, Lat/Long:	4325 Pierce St. 32.695653° , -97.259663°
Function/Sub-function:	DOMESTIC/ Single family dwelling
Construction Date:	1948
NRHP Eligibility:	Not eligible
Integrity/Comments:	Minimal traditional style house with gable roof with exposed rafter tails, plywood siding and horizontal vinyl siding on the gable fronts, replacement windows, and an addition on the south façade of the house.

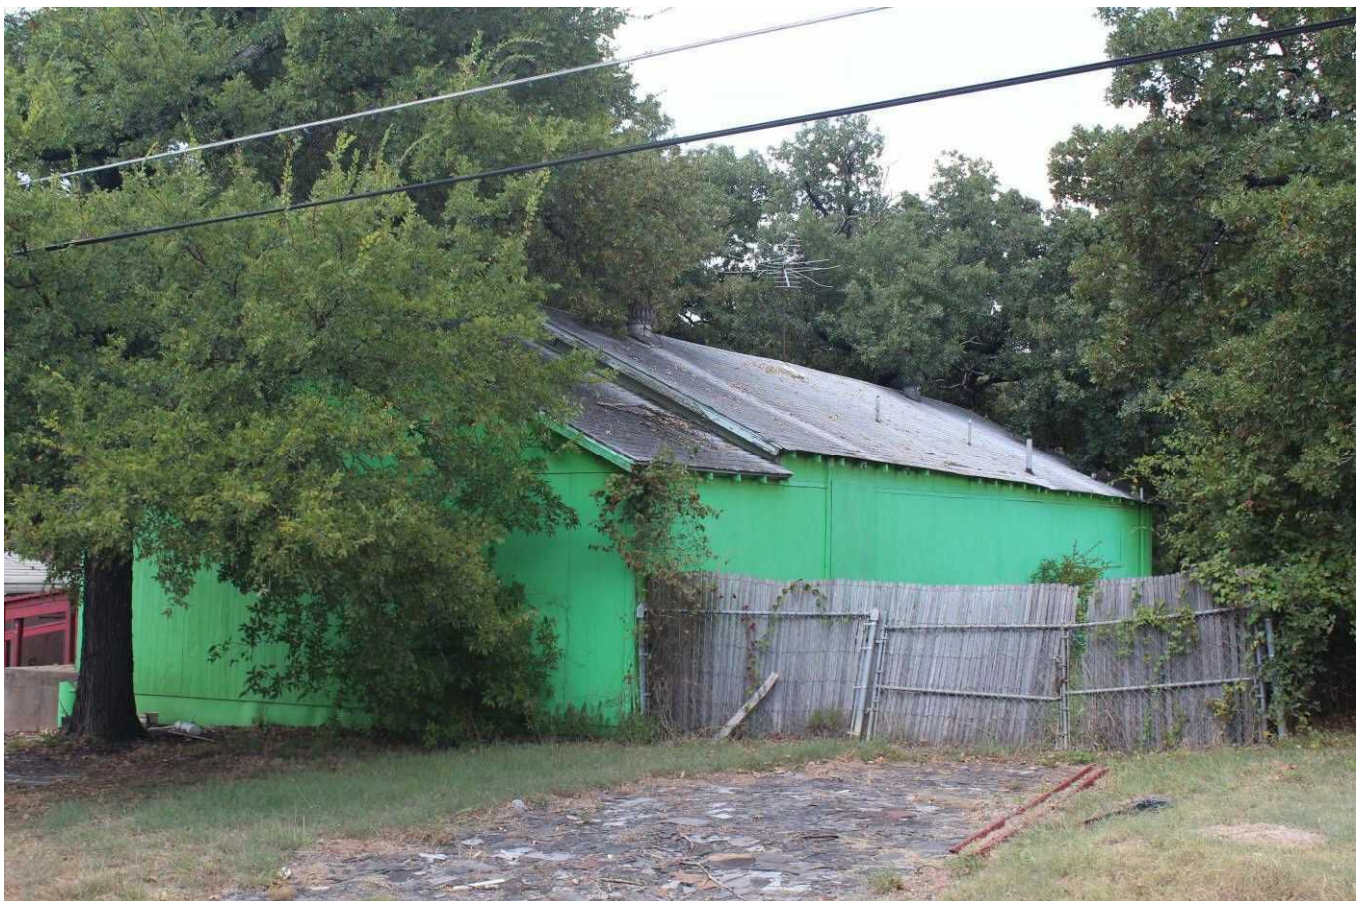
Camera facing northwest.

Survey Date:	September 5, 2019
Resource No:	339a
Project Location:	Tarrant County
Project Name and CSJ:	Southeast Connector, CSJ 0008-13-125, etc.
Address, Lat/Long:	4325 Pierce St. 32.695653° , -97.259663°
Function/Sub-function:	DOMESTIC/ Single family dwelling
Construction Date:	1948
NRHP Eligibility:	Not eligible
Integrity/Comments:	Minimal traditional style house with gable roof with exposed rafter tails, plywood siding and horizontal vinyl siding on the gable fronts, replacement windows, and an addition on the south façade of the house.

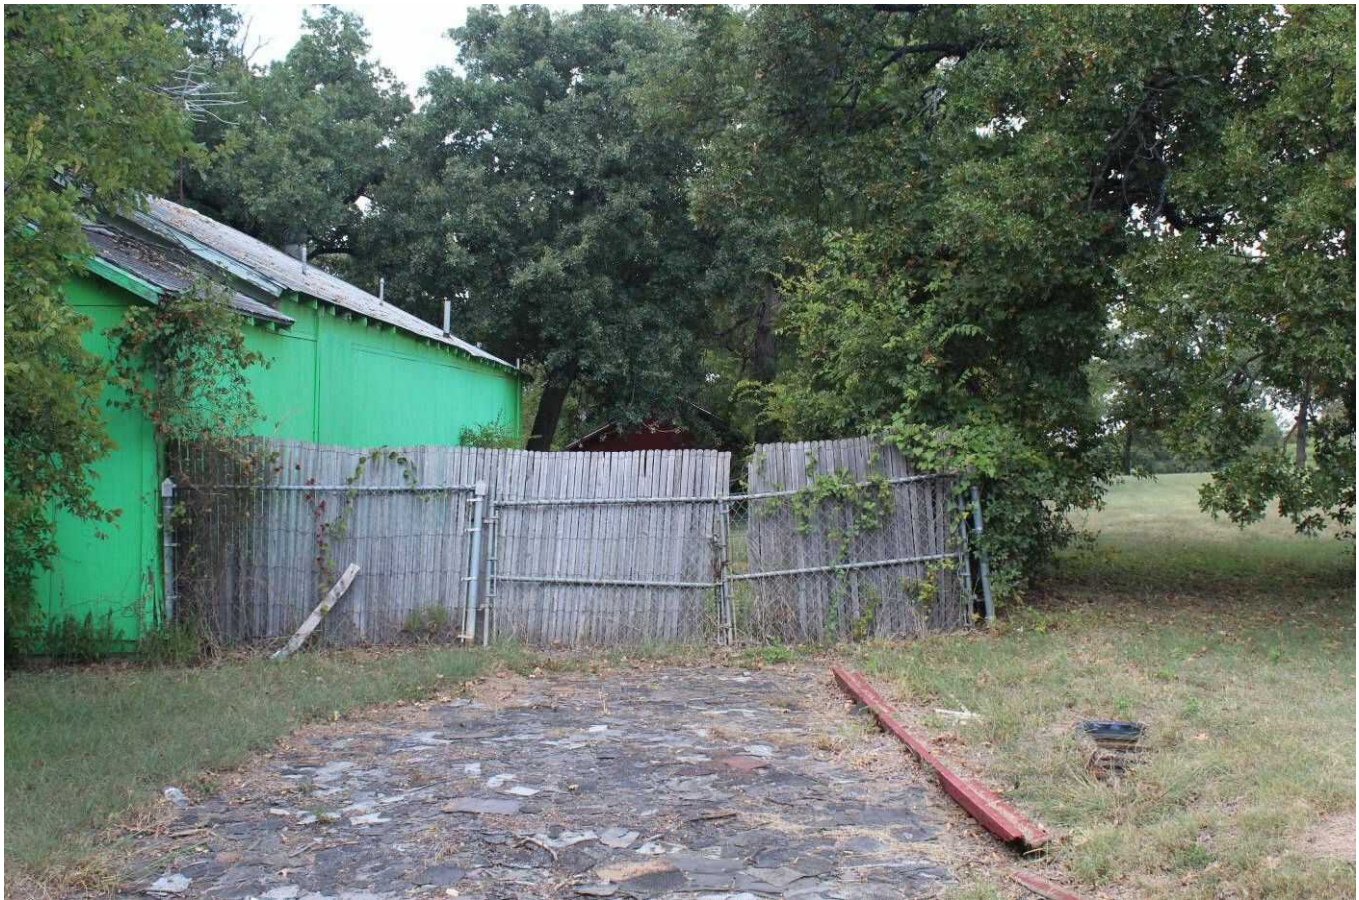
Camera facing north.

Survey Date:	September 5, 2019
Resource No:	339b
Project Location:	Tarrant County
Project Name and CSJ:	Southeast Connector, CSJ 0008-13-125, etc.
Address, Lat/Long:	4325 Pierce St. 32.695830°, -97.259607°
Function/Sub-function:	DOMESTIC/ Shed
Construction Date:	Ca. 1976
NRHP Eligibility:	Not eligible
Integrity/Comments:	Shed with gable roof and plywood siding.

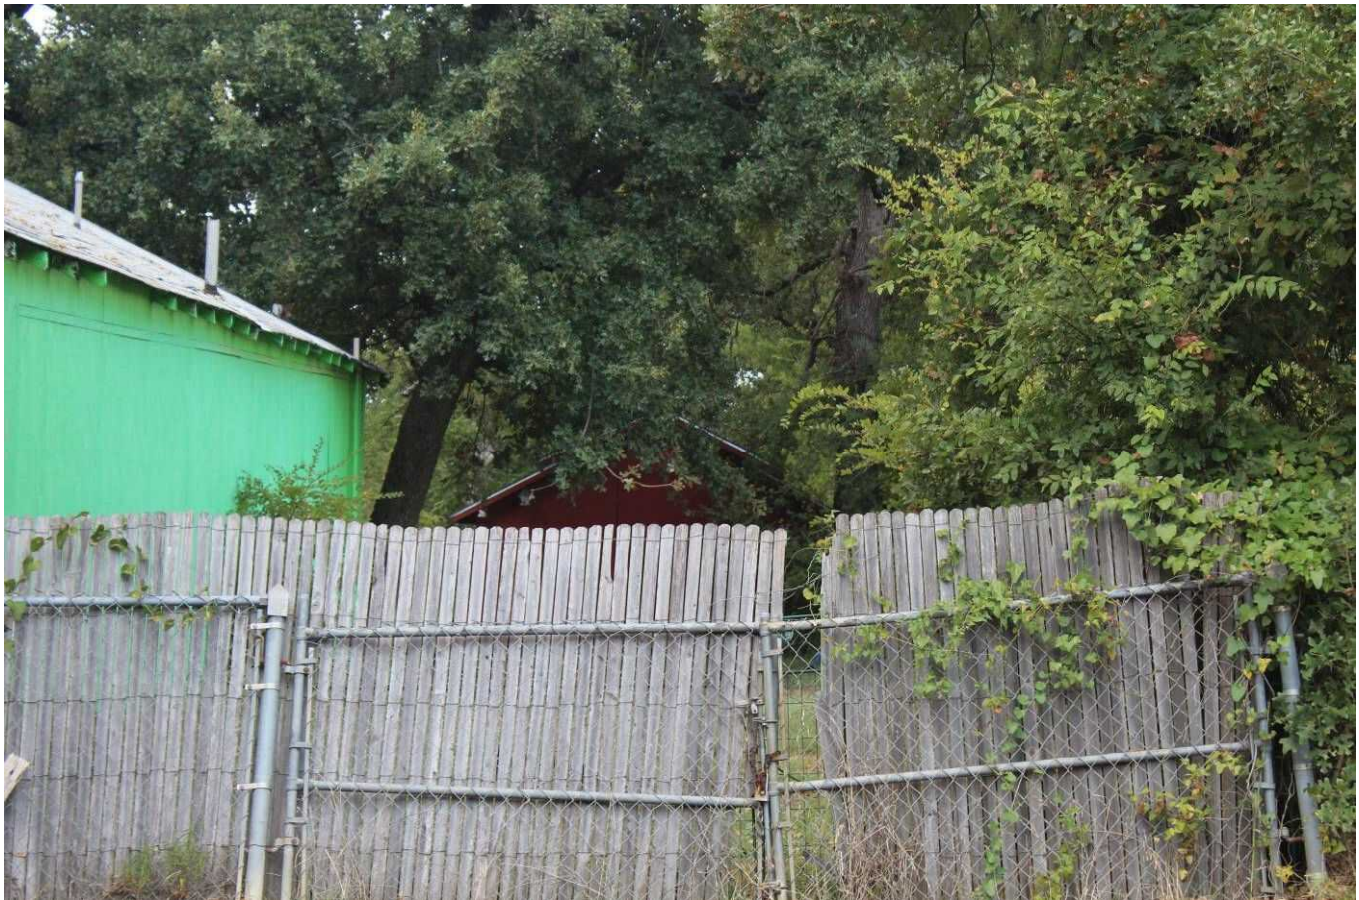
Camera facing north.

Survey Date:	September 5, 2019
Resource No:	339b
Project Location:	Tarrant County
Project Name and CSJ:	Southeast Connector, CSJ 0008-13-125, etc.
Address, Lat/Long:	4325 Pierce St. 32.695830° , -97.259607°
Function/Sub-function:	DOMESTIC/ Shed
Construction Date:	Ca. 1976
NRHP Eligibility:	Not eligible
Integrity/Comments:	Shed with gable roof and plywood siding.

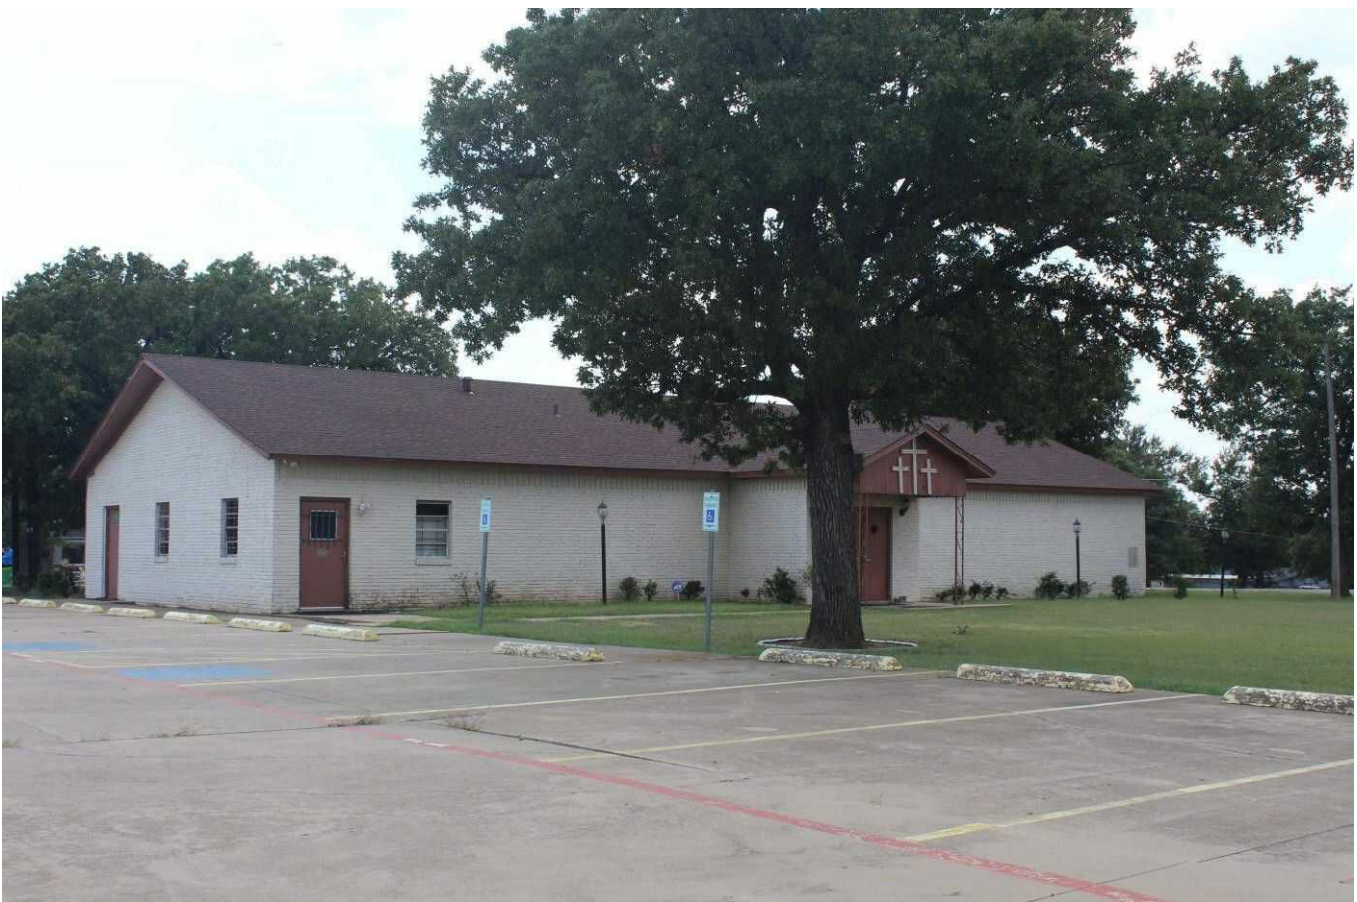
Camera facing southwest.

Survey Date:	September 5, 2019
Resource No:	340a
Project Location:	Tarrant County
Project Name and CSJ:	Southeast Connector, CSJ 0008-13-125, etc.
Address, Lat/Long:	4403 Martin Luther King, Jr. Hwy. / US 287 32.695672° , -97.258784°
Function/Sub-function:	RELIGIOUS/ Church
Construction Date:	1965
NRHP Eligibility:	Not eligible
Integrity/Comments:	Church with cross-box gable roof, brick siding with dentil detail and vertical wood siding on gable front, replacement windows, and a vestibule.

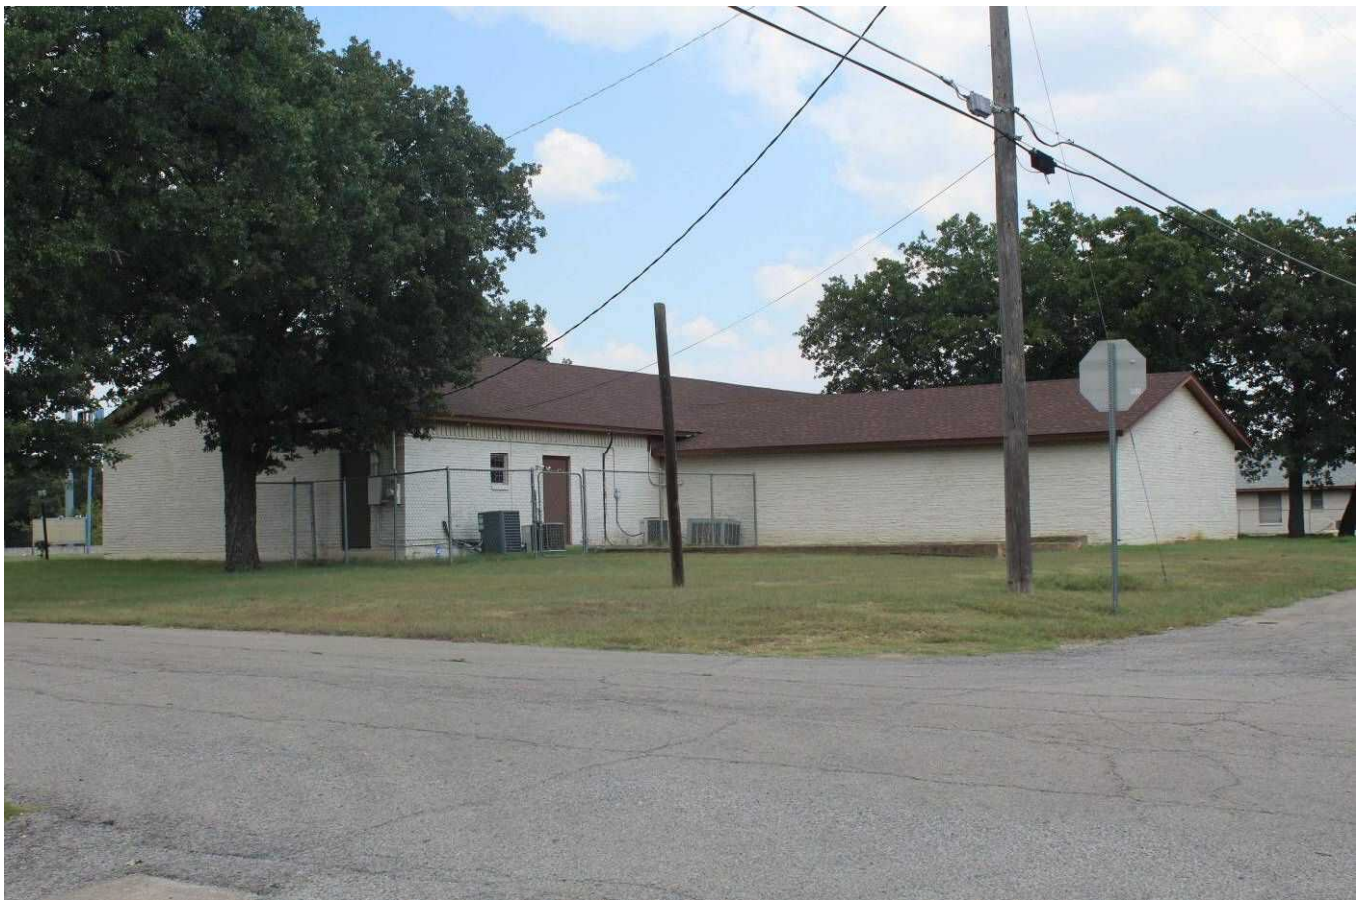
Camera facing northeast.

Survey Date:	September 5, 2019
Resource No:	340a
Project Location:	Tarrant County
Project Name and CSJ:	Southeast Connector, CSJ 0008-13-125, etc.
Address, Lat/Long:	4403 Martin Luther King, Jr. Hwy. / US 287 32.695672° , -97.258784°
Function/Sub-function:	RELIGIOUS/ Church
Construction Date:	1965
NRHP Eligibility:	Not eligible
Integrity/Comments:	Church with cross-box gable roof, brick siding with dentil detail and vertical wood siding on gable front, replacement windows, and a vestibule.

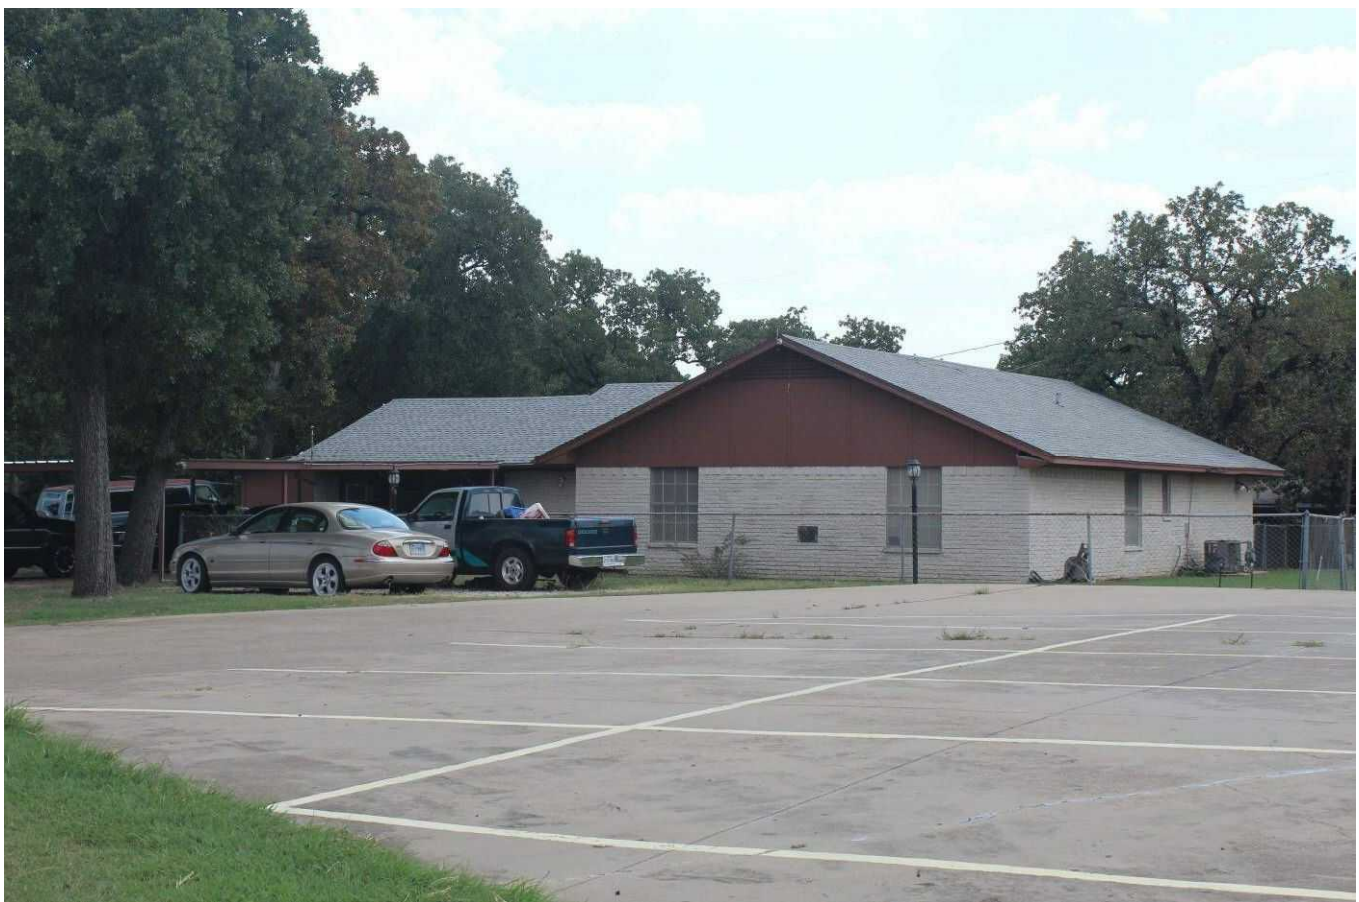
Camera facing southeast.

Survey Date:	September 5, 2019
Resource No:	340b
Project Location:	Tarrant County
Project Name and CSJ:	Southeast Connector, CSJ 0008-13-125, etc.
Address, Lat/Long:	4408 Martin Luther King, Jr. Hwy. / US 287 32.695579° , -97.258285°
Function/Sub-function:	DOMESTIC/ Single family dwelling
Construction Date:	1965
NRHP Eligibility:	Not eligible
Integrity/Comments:	Ranch style house with a half-courtyard plan, shallow-pitch, cross-gable roof, brick siding with dentil detail, vinyl siding on the gable ends, replacement windows, and a metal carport extending from the north façade. There is an addition on the east façade featuring a shed roof and plywood siding.

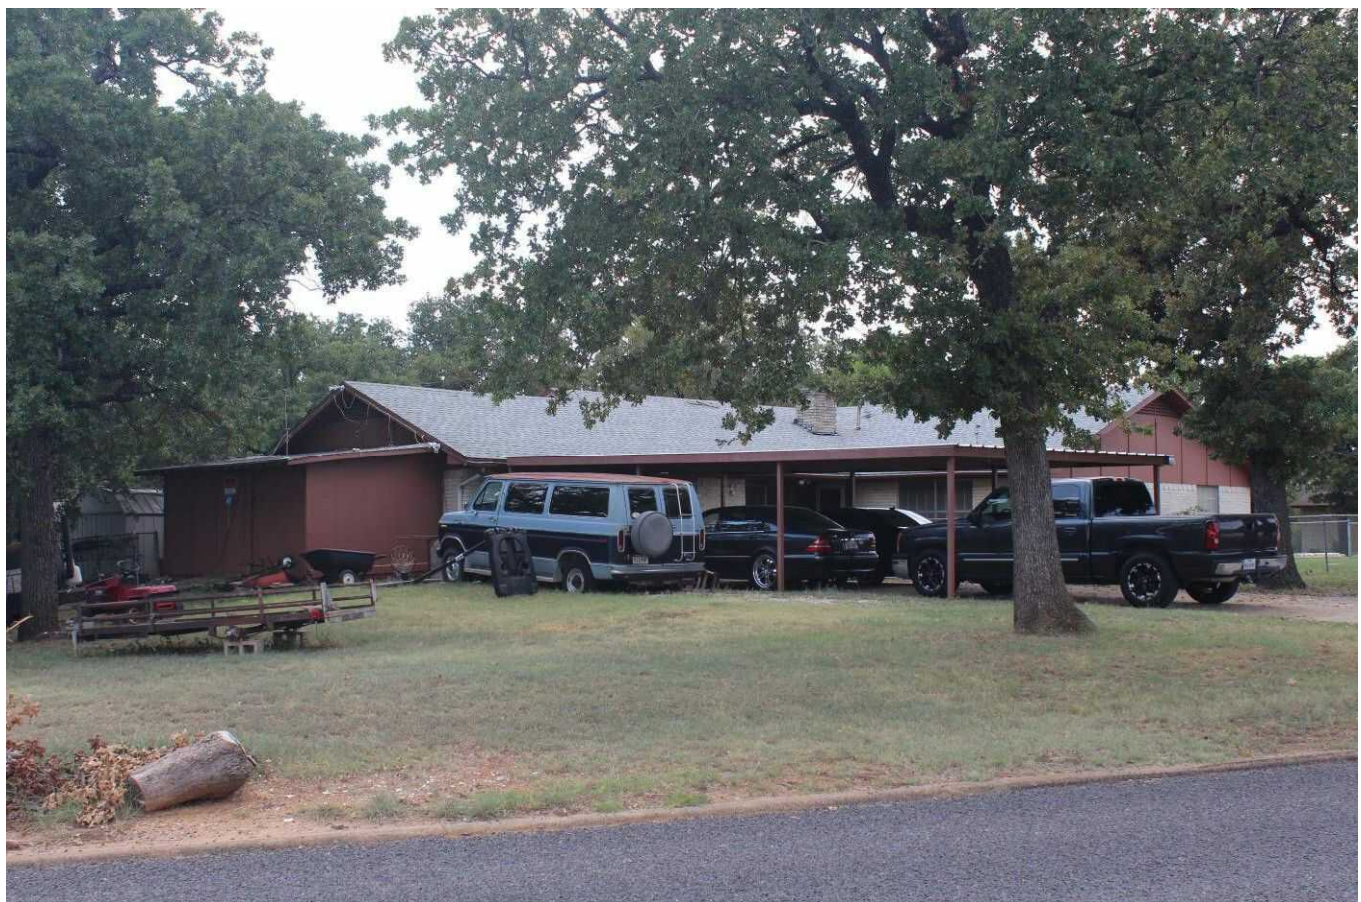
Camera facing southwest.

Survey Date:	September 5, 2019
Resource No:	340b
Project Location:	Tarrant County
Project Name and CSJ:	Southeast Connector, CSJ 0008-13-125, etc.
Address, Lat/Long:	4408 Martin Luther King, Jr. Hwy. / US 287 32.695579° , -97.258285°
Function/Sub-function:	DOMESTIC/ Single family dwelling
Construction Date:	1965
NRHP Eligibility:	Not eligible
Integrity/Comments:	Ranch style house with a half-courtyard plan, shallow-pitch, cross-gable roof, brick siding with dentil detail, vinyl siding on the gable ends, replacement windows, and a metal carport extending from the north façade. There is an addition on the east façade featuring a shed roof and plywood siding.

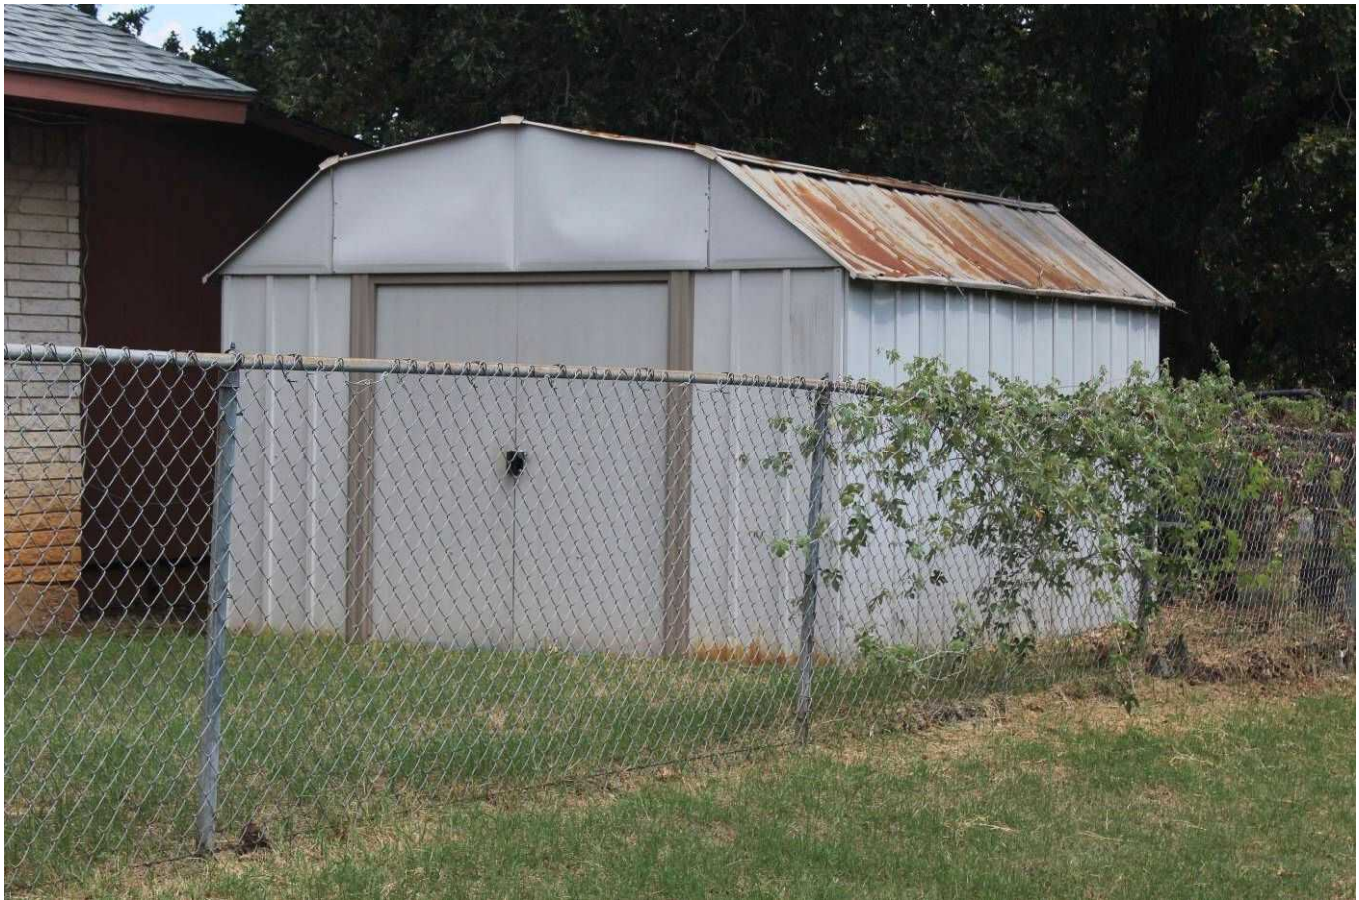
Camera facing northeast.

Survey Date:	September 5, 2019
Resource No:	340
Project Location:	Tarrant County
Project Name and CSJ:	Southeast Connector, CSJ 0008-13-125, etc.
Address, Lat/Long:	4403 Martin Luther King, Jr. Hwy. / US 287 32.695579° , -97.258285°
Function/Sub-function:	DOMESTIC/ Shed
Construction Date:	Ca. 2010
NRHP Eligibility:	Not eligible
Integrity/Comments:	Modern shed.

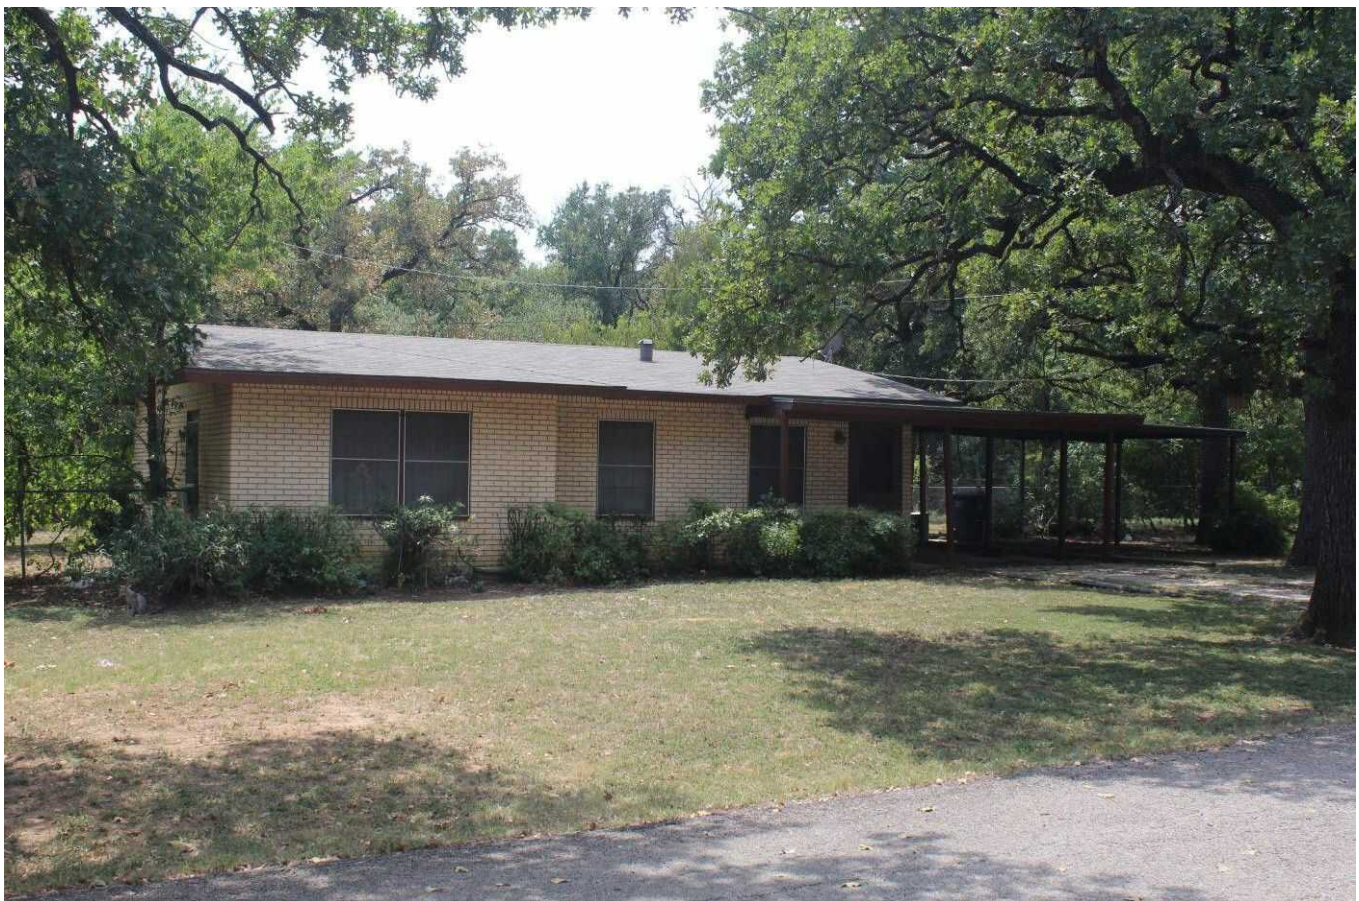
Camera facing southwest.

Survey Date:	September 5, 2019
Resource No:	341a
Project Location:	Tarrant County
Project Name and CSJ:	Southeast Connector, CSJ 0008-13-125, etc.
Address, Lat/Long:	4412 Pierce St. 32.695262° , -97.258253°
Function/Sub-function:	DOMESTIC/ Single family dwelling
Construction Date:	1953
NRHP Eligibility:	Not eligible
Integrity/Comments:	Ranch style house with shallow-pitch, side-gable roof, brick siding, replacement windows, and a metal carport extending from the northwest corner of the house. Per aerial imagery, there is a brick addition on the rear (south) façade
