## **Appendix H: Survey Forms for Removed Properties**

Survey Date:	September 3, 2019
Resource No:	001
Project Location:	Tarrant County
Project Name and CSJ:	Southeast Connector, CSJ 0008-13-125, etc.
Address, Lat/Long:	6501 Brentwood Dr. 32.755926° , -97.218520°
Function/Sub-function:	DOMESTIC/ Single family dwelling
Construction Date:	1958
NRHP Eligibility:	Not eligible
Integrity/Comments:	Ranch style house with wavy brick siding, horizontal vinyl siding under the gables, cross-gabled roof with a shallow pitch and generous eaves, and replacement windows.

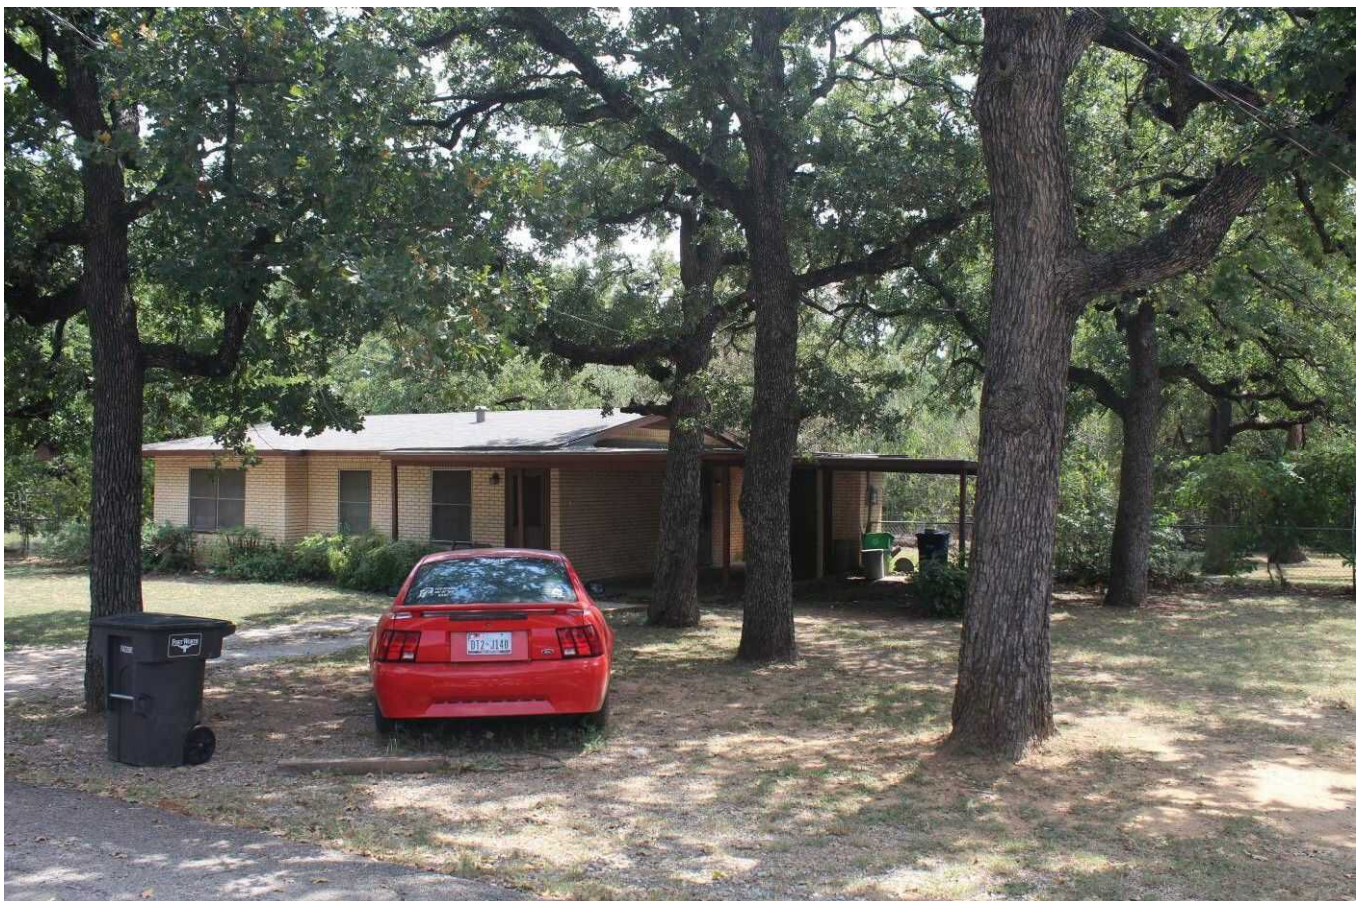
Camera facing southeast.

Survey Date:	September 5, 2019
Resource No:	341a
Project Location:	Tarrant County
Project Name and CSJ:	Southeast Connector, CSJ 0008-13-125, etc.
Address, Lat/Long:	4412 Pierce St. 32.695262° , -97.258253°
Function/Sub-function:	DOMESTIC/ Single family dwelling
Construction Date:	1953
NRHP Eligibility:	Not eligible
Integrity/Comments:	Ranch style house with shallow-pitch, side-gable roof, brick siding, replacement windows, and a metal carport extending from the northwest corner of the house. Per aerial imagery, there is a brick addition on the rear (south) façade

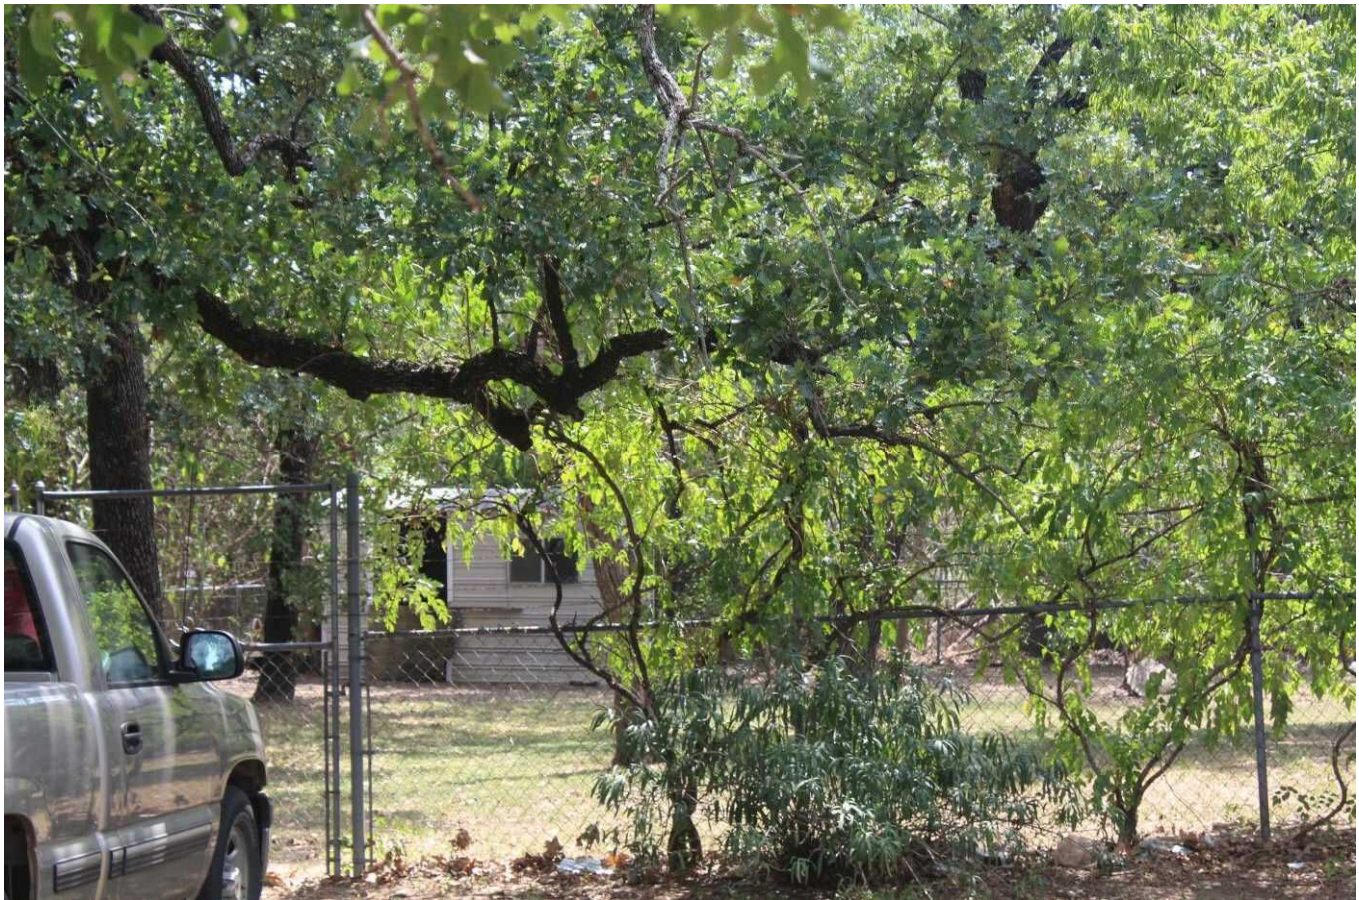
Camera facing south.

Survey Date:	September 5, 2019
Resource No:	341b
Project Location:	Tarrant County
Project Name and CSJ:	Southeast Connector, CSJ 0008-13-125, etc.
Address, Lat/Long:	4412 Pierce St. 32.695063° , -97.258074°
Function/Sub-function:	DOMESTIC/ Shed
Construction Date:	Ca. 1976
NRHP Eligibility:	Not eligible
Integrity/Comments:	Metal shed with original window.

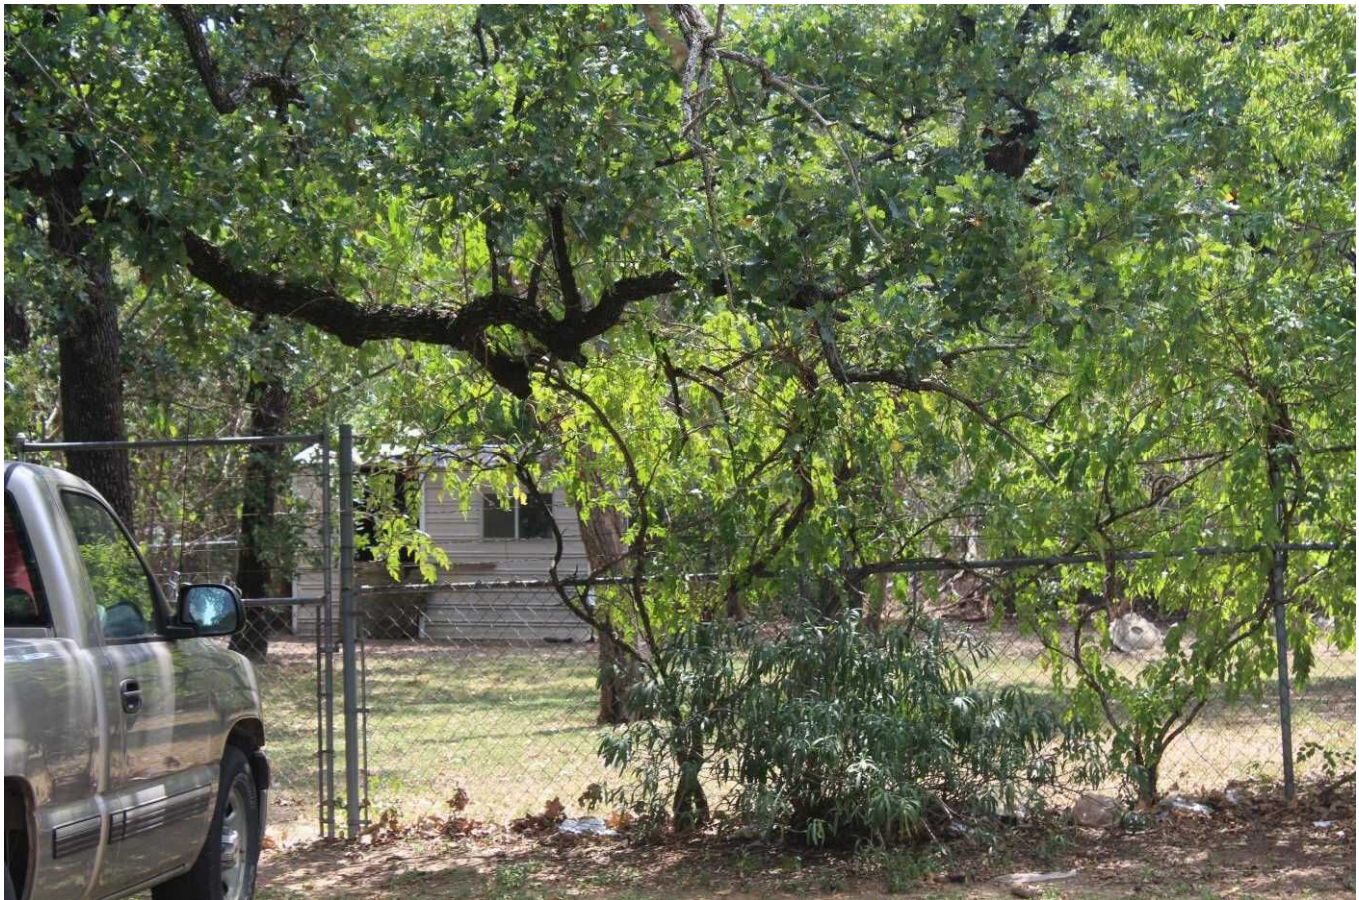
Camera facing southeast.

Survey Date:	September 5, 2019
Resource No:	341b
Project Location:	Tarrant County
Project Name and CSJ:	Southeast Connector, CSJ 0008-13-125, etc.
Address, Lat/Long:	4412 Pierce St. 32.695063° , -97.258074°
Function/Sub-function:	DOMESTIC/ Shed
Construction Date:	Ca. 1976
NRHP Eligibility:	Not eligible
Integrity/Comments:	Metal shed with original window.

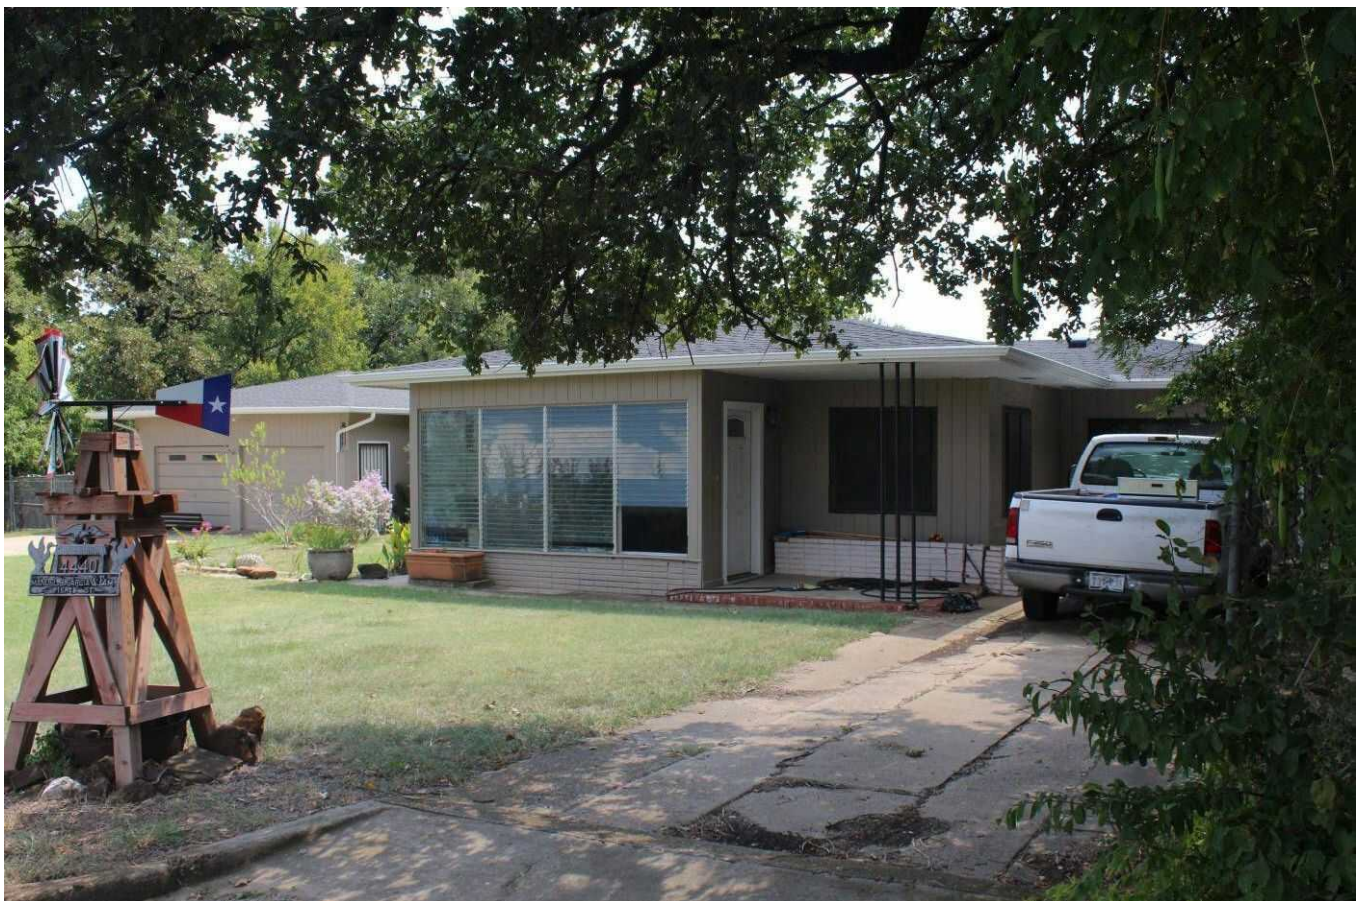
Camera facing southeast.

Survey Date:	September 5, 2019
Resource No:	342
Project Location:	Tarrant County
Project Name and CSJ:	Southeast Connector, CSJ 0008-13-125, etc.
Address, Lat/Long:	4440 Pierce St. 32.695222°, -97.256907°
Function/Sub-function:	DOMESTIC/ Single family dwelling
Construction Date:	1947
NRHP Eligibility:	Not eligible
Integrity/Comments:	Ranch style house with courtyard plan, shallow-pitch, hip roofs, generous eaves, vertical vinyl siding, and replacement windows, and a modern garage with a hip roof, vertical vinyl siding, and replacement garage doors.

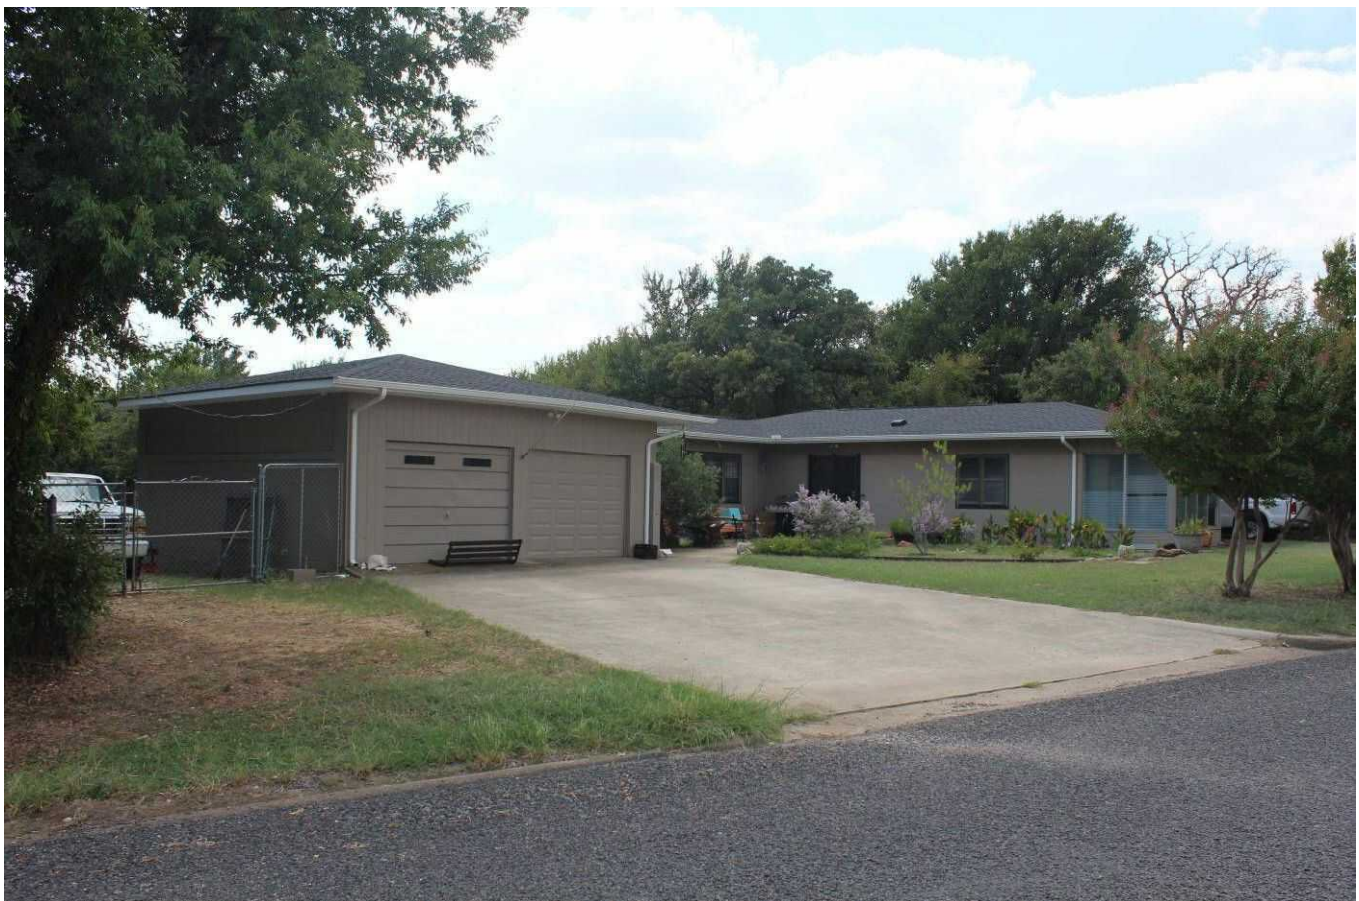
Camera facing southwest.

Survey Date:	September 5, 2019
Resource No:	342
Project Location:	Tarrant County
Project Name and CSJ:	Southeast Connector, CSJ 0008-13-125, etc.
Address, Lat/Long:	4440 Pierce St. 32.695222° , -97.256907°
Function/Sub-function:	DOMESTIC/ Single family dwelling
Construction Date:	1947
NRHP Eligibility:	Not eligible
Integrity/Comments:	Ranch style house with courtyard plan, shallow-pitch, hip roofs, generous eaves, vertical vinyl siding, and replacement windows, and a modern garage with a hip roof, vertical vinyl siding, and replacement garage doors.

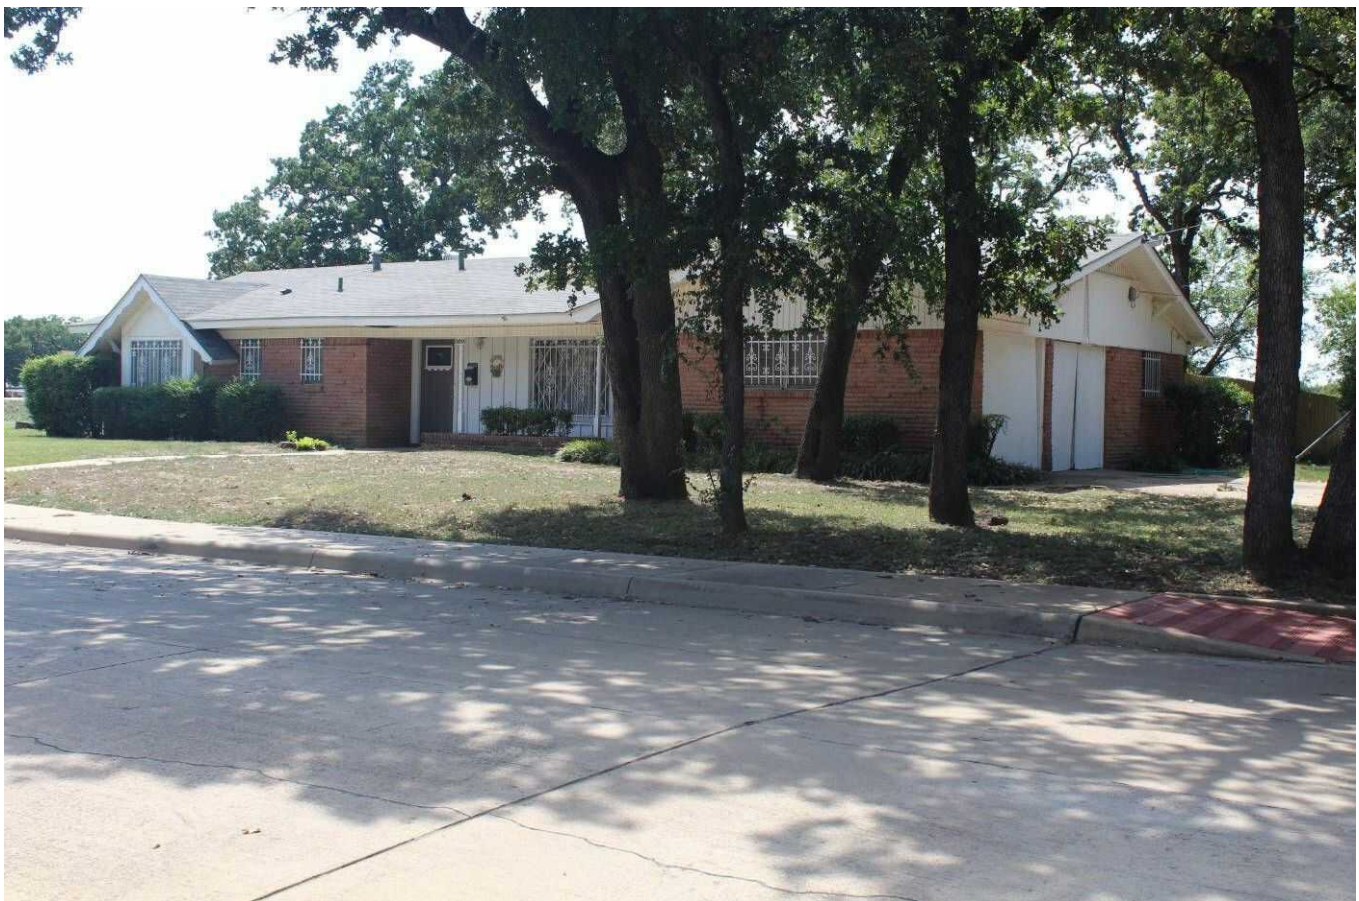
Camera facing southwest.

Survey Date:	September 4, 2019
Resource No:	343
Project Location:	Tarrant County
Project Name and CSJ:	Southeast Connector, CSJ 0008-13-125, etc.
Address, Lat/Long:	4520 S. Hughes Ave. 32.696871° , -97.257739°
Function/Sub-function:	DOMESTIC/ Single family dwelling
Construction Date:	1962
NRHP Eligibility:	Not eligible
Integrity/Comments:	Ranch style house with a shallow-pitch, cross-gable roof with generous eaves and scalloped rakes, brick and vertical vinyl siding, a recessed porch, replacement windows, and replacement/nonextant garage doors.

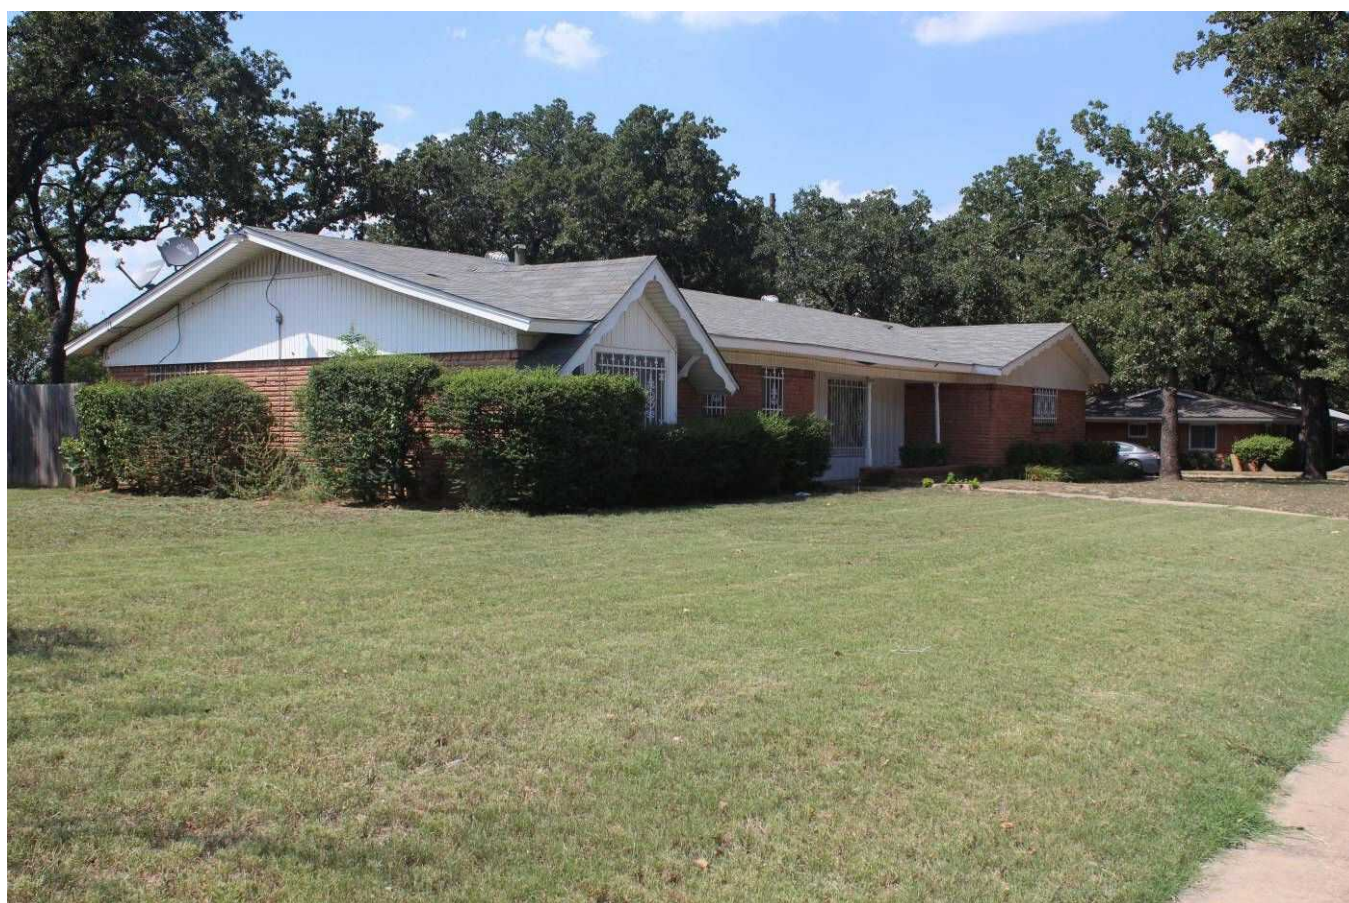
Camera facing west.

Survey Date:	September 4, 2019
Resource No:	343
Project Location:	Tarrant County
Project Name and CSJ:	Southeast Connector, CSJ 0008-13-125, etc.
Address, Lat/Long:	4520 S. Hughes Ave. 32.696871° , -97.257739°
Function/Sub-function:	DOMESTIC/ Single family dwelling
Construction Date:	1962
NRHP Eligibility:	Not eligible
Integrity/Comments:	Ranch style house with a shallow-pitch, cross-gable roof with generous eaves and scalloped rakes, brick and vertical vinyl siding, a recessed porch, replacement windows, and replacement/nonextant garage doors.

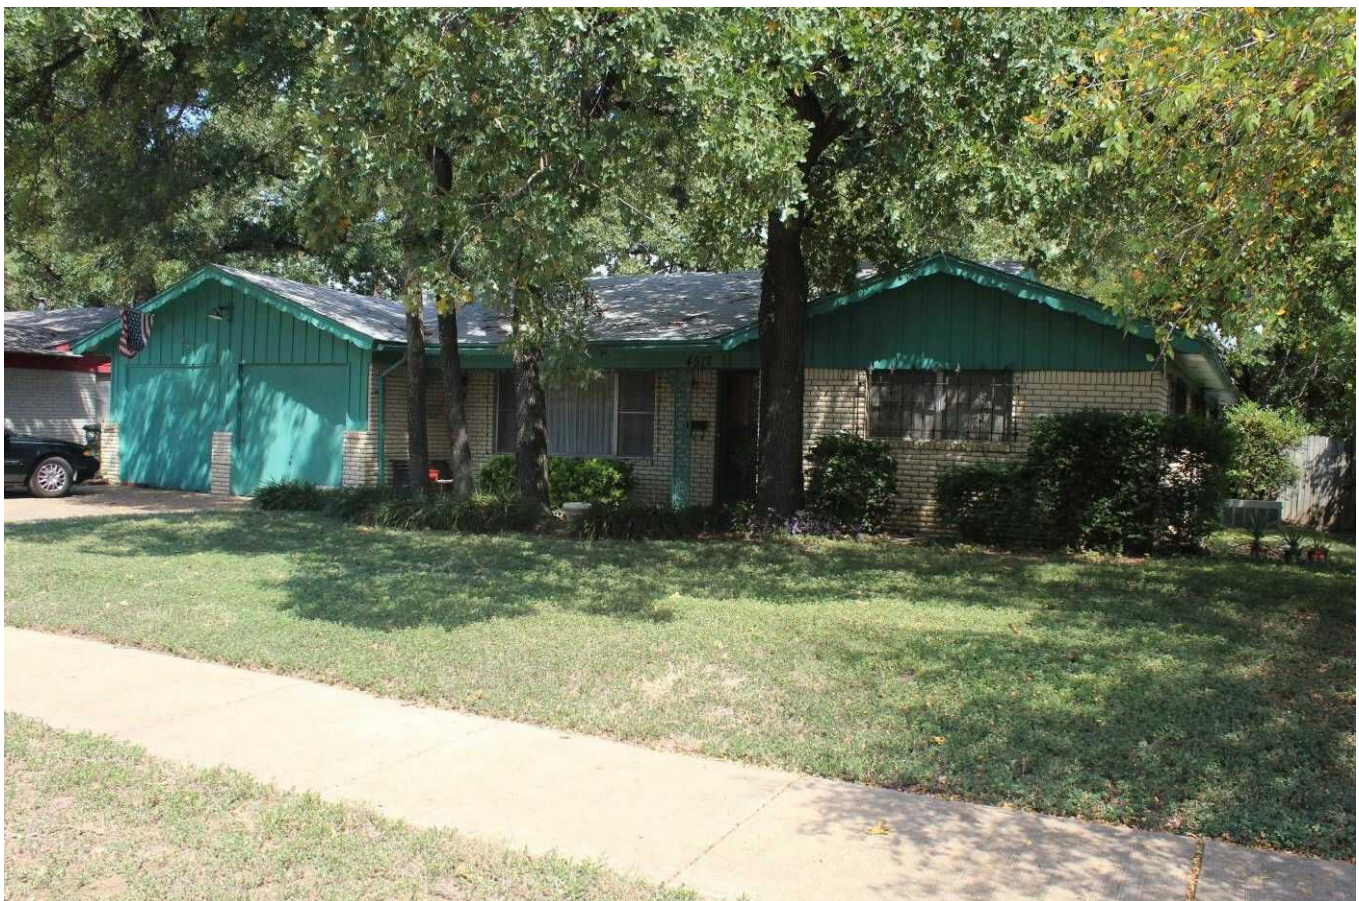
Camera facing northeast.

Survey Date:	September 4, 2019
Resource No:	344
Project Location:	Tarrant County
Project Name and CSJ:	Southeast Connector, CSJ 0008-13-125, etc.
Address, Lat/Long:	4517 S. Hughes Ave. 32.697015° , -97.257266°
Function/Sub-function:	DOMESTIC/ Single family dwelling
Construction Date:	1959
NRHP Eligibility:	Not eligible
Integrity/Comments:	Ranch style house cross-gable roof, generous eaves, scalloped rakes, vertical wood and brick siding with dentil detail, a recessed porch, original windows, and replacement garage doors.

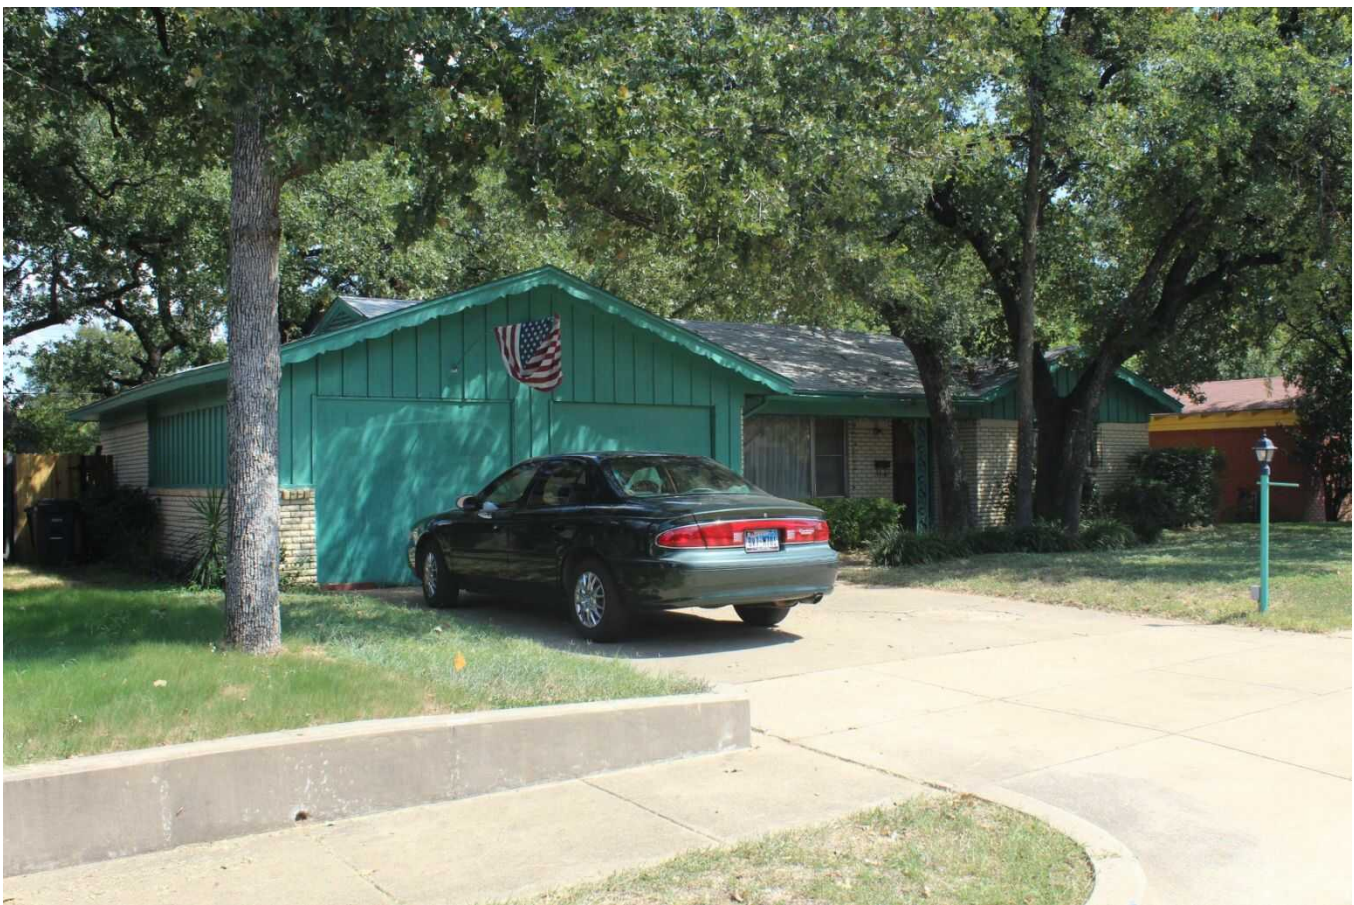
Camera facing southeast.

Survey Date:	September 4, 2019
Resource No:	344
Project Location:	Tarrant County
Project Name and CSJ:	Southeast Connector, CSJ 0008-13-125, etc.
Address, Lat/Long:	4517 S. Hughes Ave. 32.697015° , -97.257266°
Function/Sub-function:	DOMESTIC/ Single family dwelling
Construction Date:	1959
NRHP Eligibility:	Not eligible
Integrity/Comments:	Ranch style house cross-gable roof, generous eaves, scalloped rakes, vertical wood and brick siding with dentil detail, a recessed porch, original windows, and replacement garage doors.

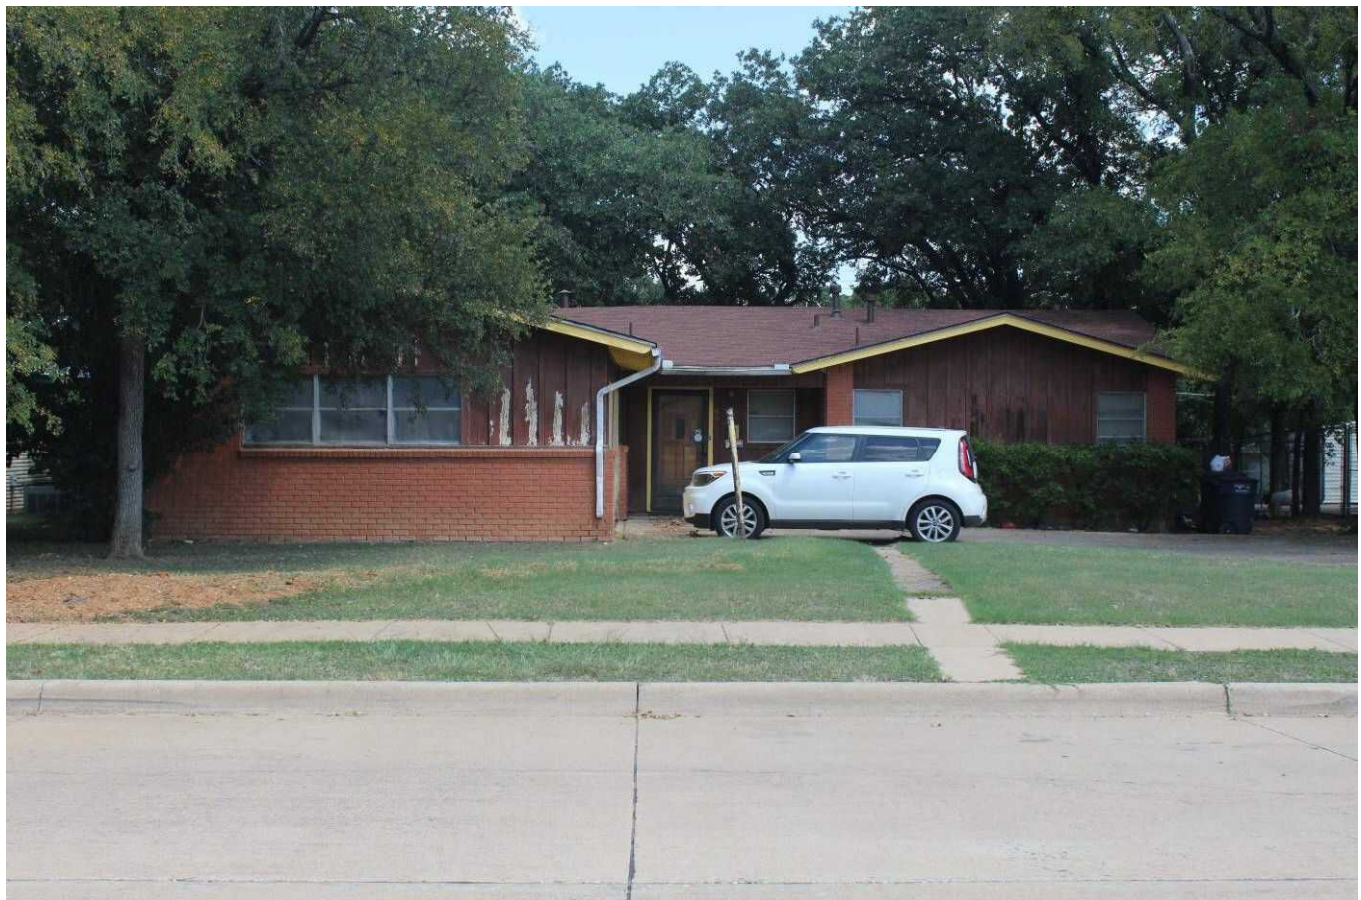
Camera facing northeast.

Survey Date:	September 4, 2019
Resource No:	345
Project Location:	Tarrant County
Project Name and CSJ:	Southeast Connector, CSJ 0008-13-125, etc.
Address, Lat/Long:	4521 S. Hughes Ave. 32.696847° , -97.257286°
Function/Sub-function:	DOMESTIC/ Single family dwelling
Construction Date:	1959
NRHP Eligibility:	Not eligible
Integrity/Comments:	Ranch style house with courtyard plan, shallow-pitch, cross-gable roof, vertical wood and brick siding, a recessed porch, replacement windows, and replacement garage doors.

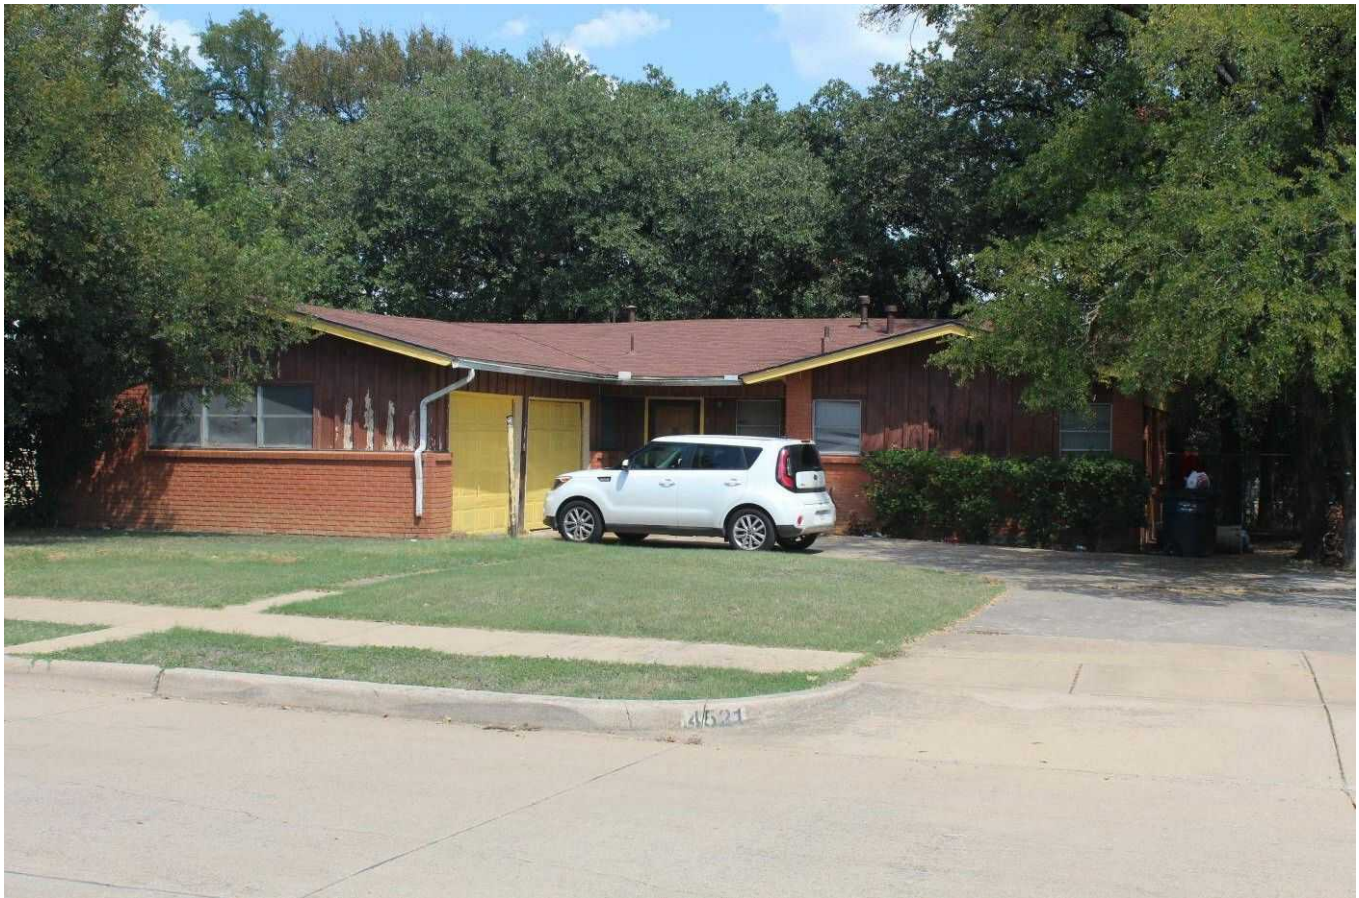
Camera facing north.

Survey Date:	September 4, 2019
Resource No:	345
Project Location:	Tarrant County
Project Name and CSJ:	Southeast Connector, CSJ 0008-13-125, etc.
Address, Lat/Long:	4521 S. Hughes Ave. 32.696847° , -97.257286°
Function/Sub-function:	DOMESTIC/ Single family dwelling
Construction Date:	1959
NRHP Eligibility:	Not eligible
Integrity/Comments:	Ranch style house with courtyard plan, shallow-pitch, cross-gable roof, vertical wood and brick siding, a recessed porch, replacement windows, and replacement garage doors.

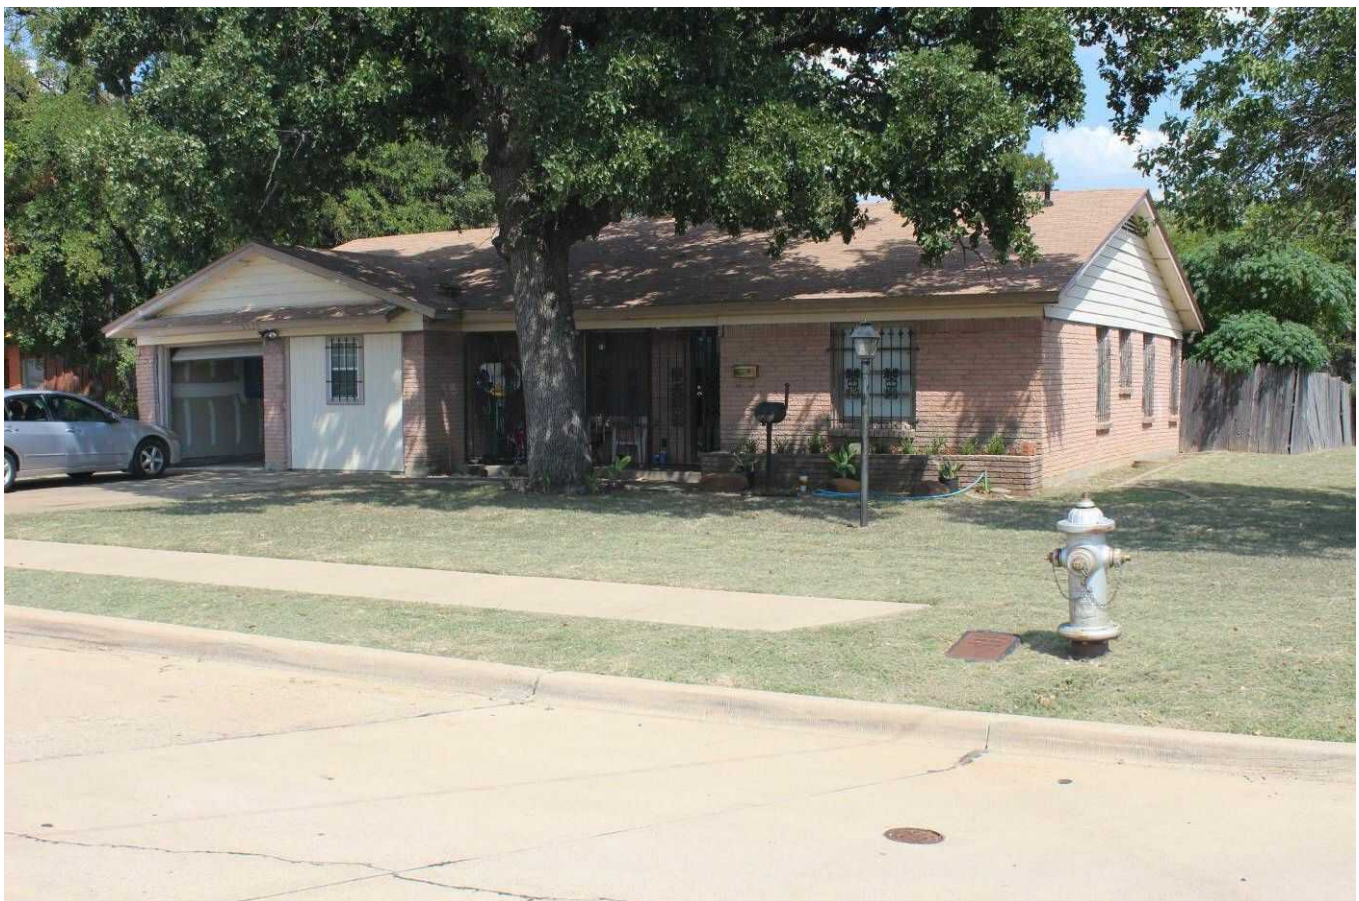
Camera facing northeast.

Survey Date:	September 4, 2019
Resource No:	346
Project Location:	Tarrant County
Project Name and CSJ:	Southeast Connector, CSJ 0008-13-125, etc.
Address, Lat/Long:	4525 S. Hughes Ave. 32.696649° , -97.257289°
Function/Sub-function:	DOMESTIC/ Single family dwelling
Construction Date:	1959
NRHP Eligibility:	Not eligible
Integrity/Comments:	Ranch style house with shallow-pitch, cross-gable roof, brick siding, vertical wood siding, horizontal wood siding on gable ends, recessed porch, replacement windows, and replaced/nonextant garage doors.

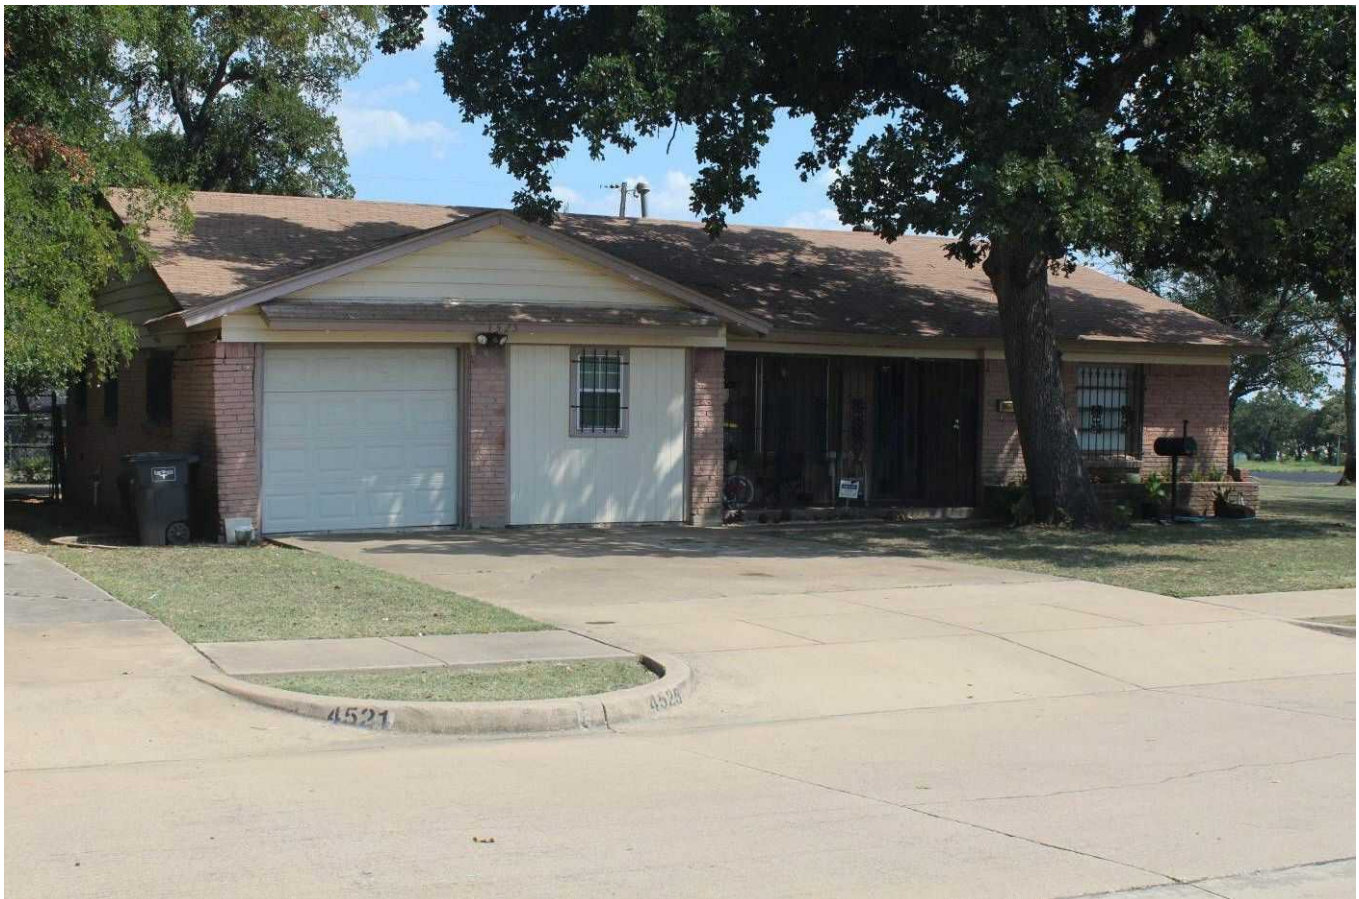
Camera facing north.

Survey Date:	September 4, 2019
Resource No:	346
Project Location:	Tarrant County
Project Name and CSJ:	Southeast Connector, CSJ 0008-13-125, etc.
Address, Lat/Long:	4525 S. Hughes Ave. 32.696649° , -97.257289°
Function/Sub-function:	DOMESTIC/ Single family dwelling
Construction Date:	1959
NRHP Eligibility:	Not eligible
Integrity/Comments:	Ranch style house with shallow-pitch, cross-gable roof, brick siding, vertical wood siding, horizontal wood siding on gable ends, recessed porch, replacement windows, and replaced/nonextant garage doors.

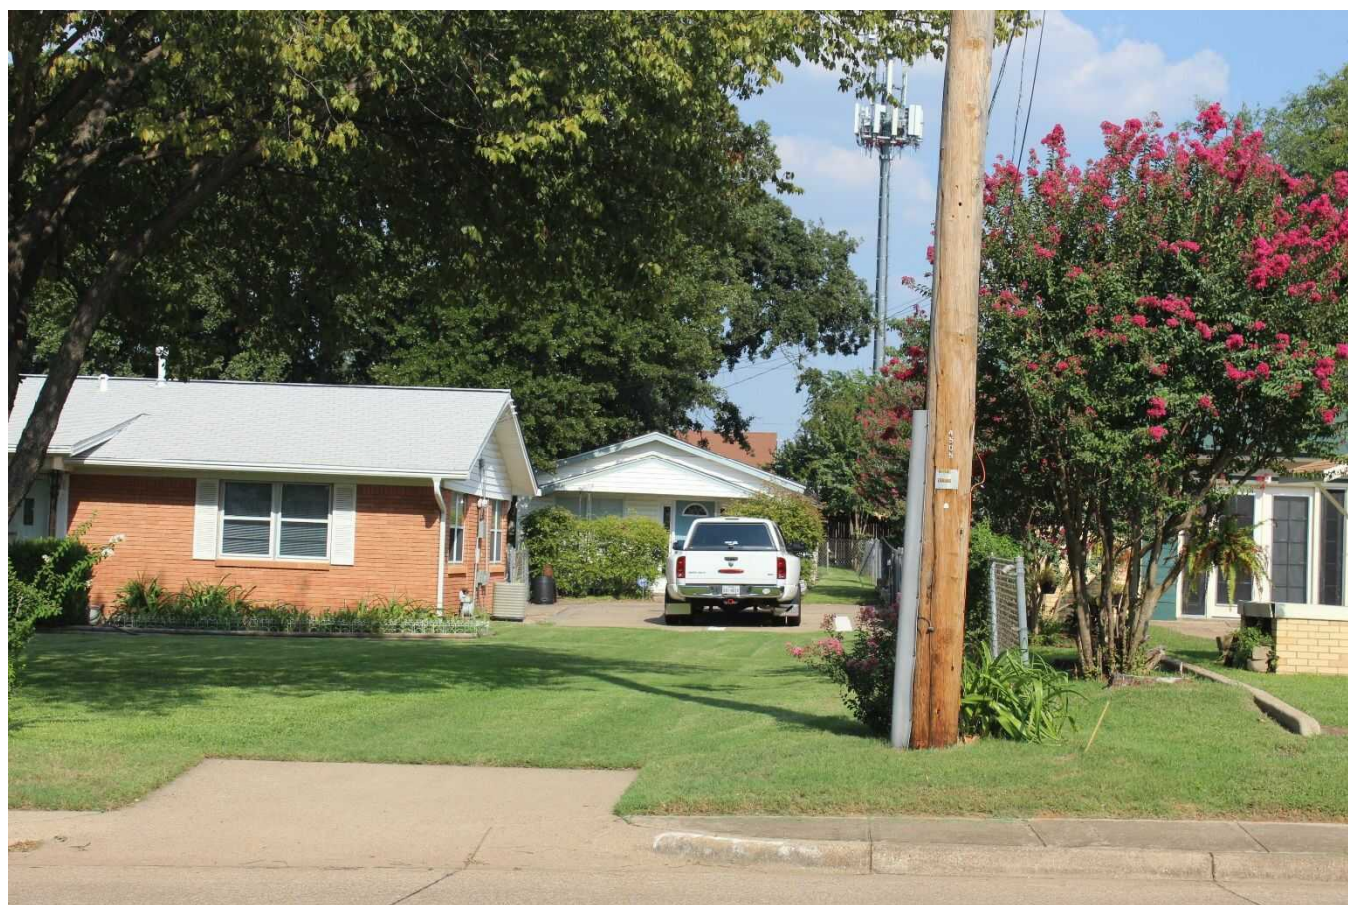
Camera facing east.

Survey Date:	September 5, 2019
Resource No:	453b
Project Location:	Tarrant County
Project Name and CSJ:	Southeast Connector, CSJ 0008-13-125, etc.
Address, Lat/Long:	4505 Hawkins Cemetery Rd. 32.673197°, -97.195611°
Function/Sub-function:	DOMESTIC/ Secondary housing
Construction Date:	Ca. 1975
NRHP Eligibility:	Not Eligible
Integrity/Comments:	Secondary apartment with vinyl siding, metal sash windows, and a shallow-pitch front-gabled roof with modest eaves. The modern door has flanking side lights. The projecting porch features two decorative metal supports.

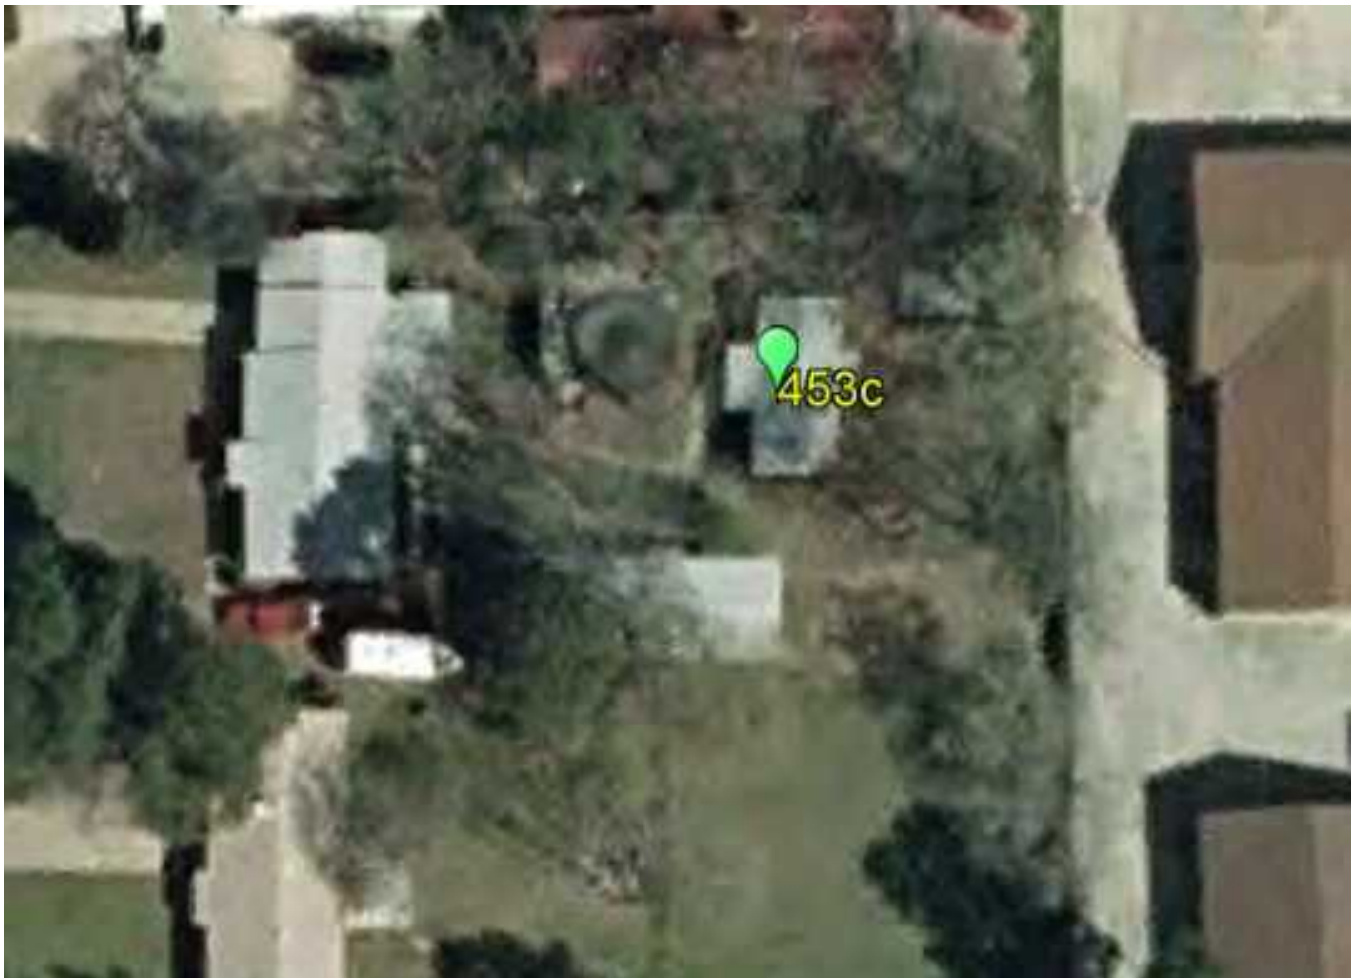
Survey Date:	September 5, 2019
Resource No:	453c
Project Location:	Tarrant County
Project Name and CSJ:	Southeast Connector, CSJ 0008-13-125, etc.
Address, Lat/Long:	4505 Hawkins Cemetery Rd. 32.673319°, -97.195494°
Function/Sub-function:	DOMESTIC/ Guesthouse
Construction Date:	Ca. 1975
NRHP Eligibility:	Not Eligible
Integrity/Comments:	Small guesthouse or similar building behind the main house. Not visible from public ROW, partially obscured by vegetation in aerial photos.

2001 aerial photo showing guesthouse. *Google Earth*

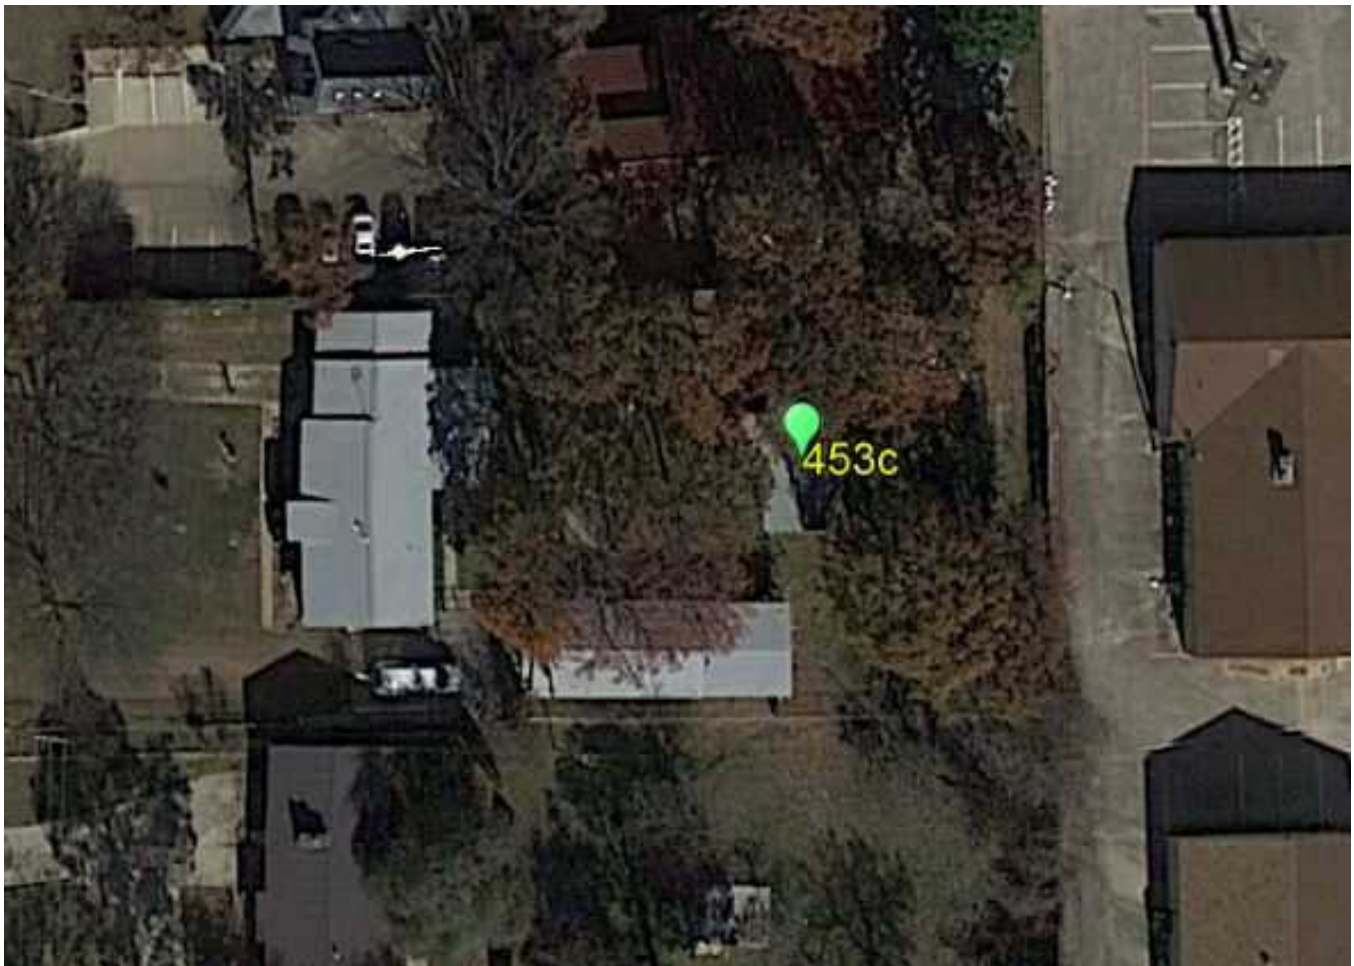
Survey Date:	September 5, 2019
Resource No:	453c
Project Location:	Tarrant County
Project Name and CSJ:	Southeast Connector, CSJ 0008-13-125, etc.
Address, Lat/Long:	4505 Hawkins Cemetery Rd. 32.673319°, -97.195494°
Function/Sub-function:	DOMESTIC/ Guesthouse
Construction Date:	Ca. 1975
NRHP Eligibility:	Not Eligible
Integrity/Comments:	Small guesthouse or similar building behind the main house. Not visible from public ROW, partially obscured by vegetation in aerial photos.

Aerial photo showing guesthouse. *Google Earth*
