## **Appendix H: Survey Forms for Removed Properties**

Survey Date:	September 3, 2019
Resource No:	001
Project Location:	Tarrant County
Project Name and CSJ:	Southeast Connector, CSJ 0008-13-125, etc.
Address, Lat/Long:	6501 Brentwood Dr. 32.755926° , -97.218520°
Function/Sub-function:	DOMESTIC/ Single family dwelling
Construction Date:	1958
NRHP Eligibility:	Not eligible
Integrity/Comments:	Ranch style house with wavy brick siding, horizontal vinyl siding under the gables, cross-gabled roof with a shallow pitch and generous eaves, and replacement windows.

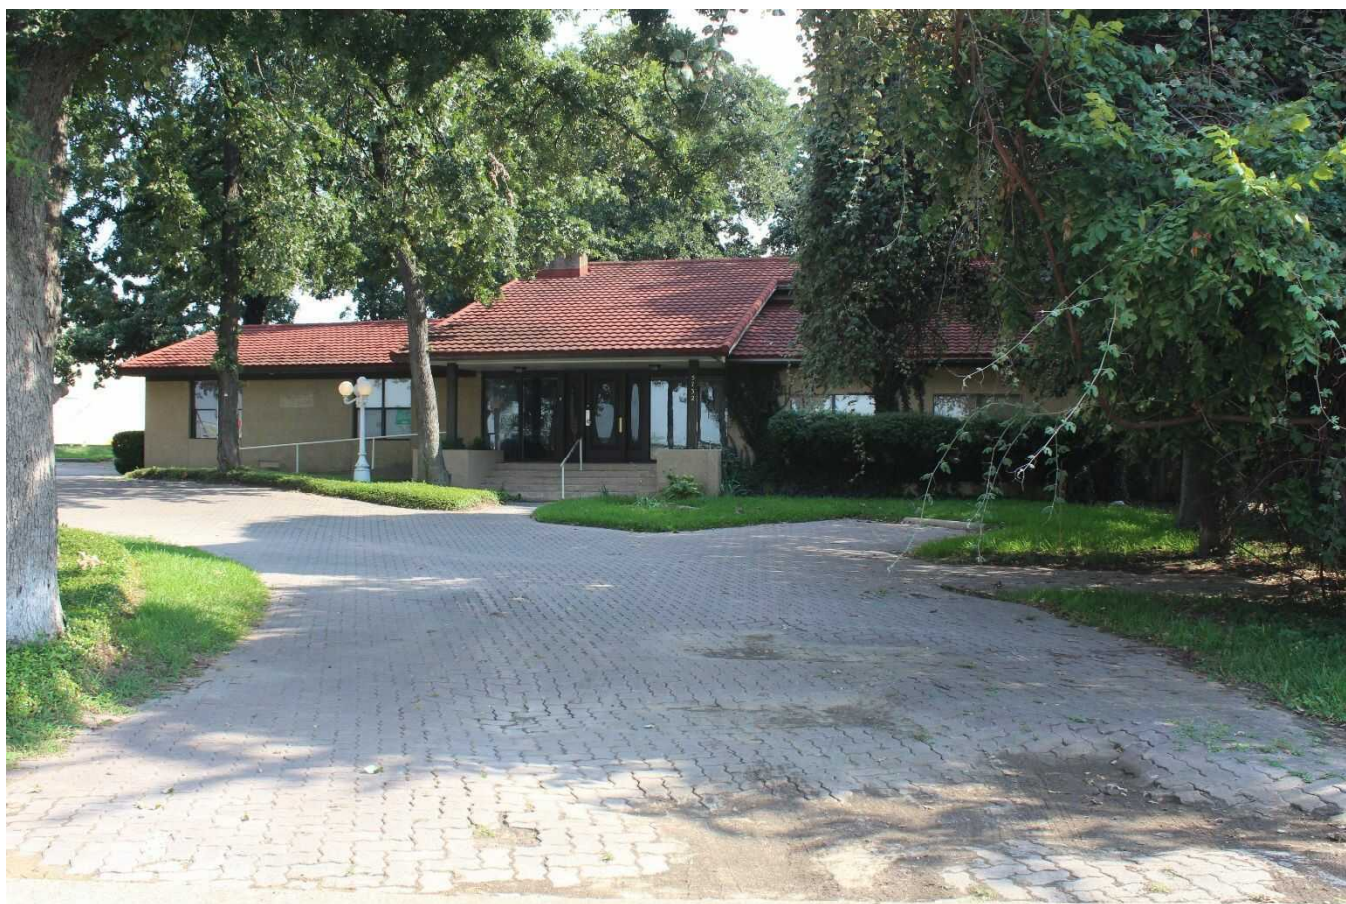
Camera facing southeast.

Survey Date:	September 5, 2019
Resource No:	454
Project Location:	Tarrant County
Project Name and CSJ:	Southeast Connector, CSJ 0008-13-125, etc.
Address, Lat/Long:	5732 Forest Bend Dr. 32.673287°, -97.195834°
Function/Sub-function:	DOMESTIC/ Single family dwelling
Construction Date:	Ca. 1970
NRHP Eligibility:	Not Eligible
Integrity/Comments:	Two-story Contemporary Ranch style house converted into a private learning center. The house features stucco siding, replacement vinyl sash windows and metal frame picture windows, replacement door with modern side lights, and a shallow-pitch side-gabled roof with generous eaves and clay tile roofing. The inset raised porch features concrete steps flanked by large concrete planters, with square wood columns. The garage has been converted into interior space.

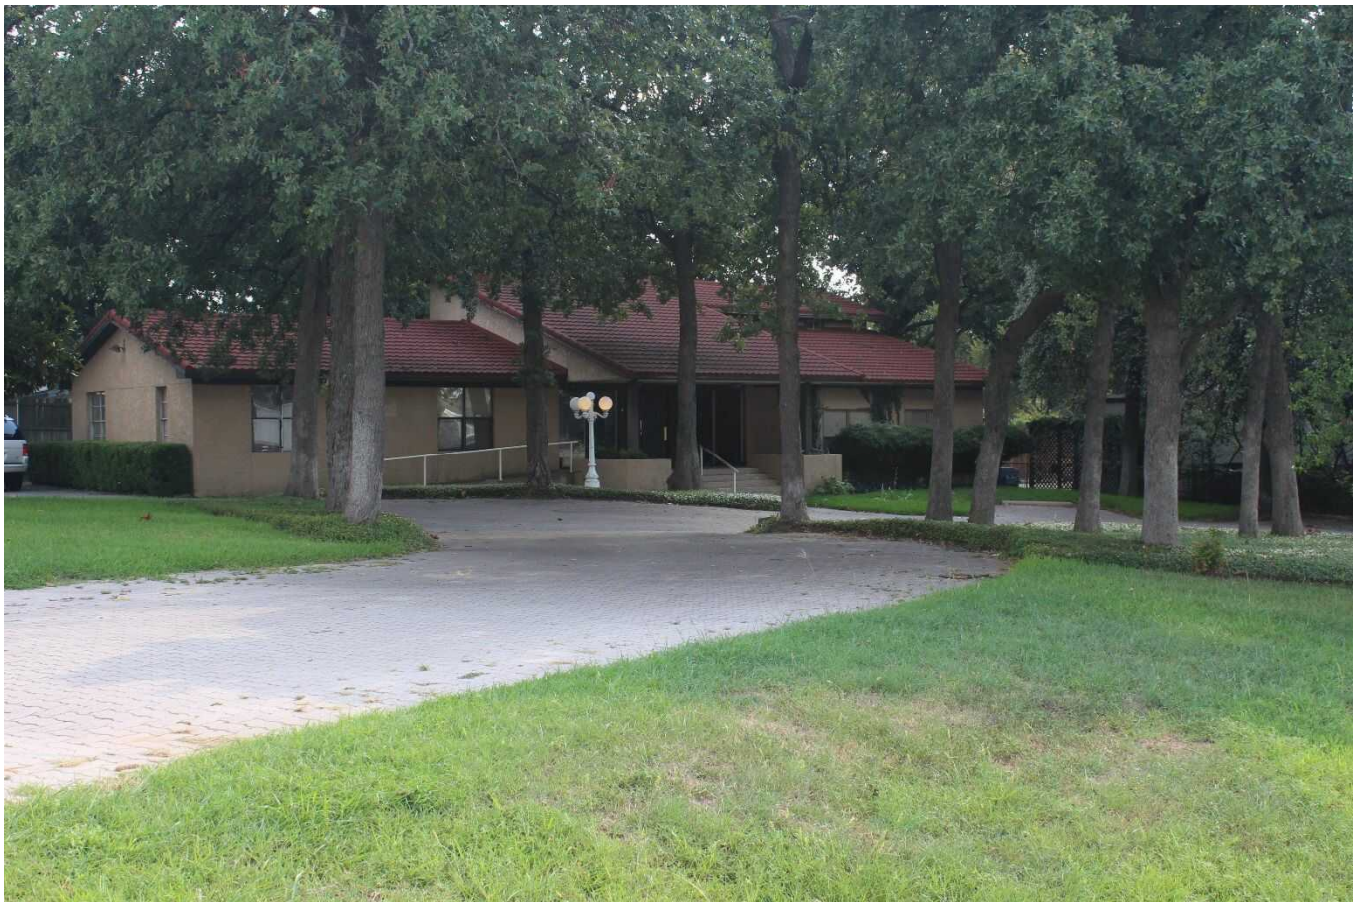
Camera facing southwest.

Survey Date:	September 5, 2019
Resource No:	454
Project Location:	Tarrant County
Project Name and CSJ:	Southeast Connector, CSJ 0008-13-125, etc.
Address, Lat/Long:	5732 Forest Bend Dr. 32.673287°, -97.195834°
Function/Sub-function:	DOMESTIC/ Single family dwelling
Construction Date:	Ca. 1965
NRHP Eligibility:	Not Eligible
Integrity/Comments:	Two-story Contemporary Ranch style house converted into a private learning center. The house features stucco siding, replacement vinyl sash windows and metal frame picture windows, replacement door with modern side lights, and a shallow-pitch side-gabled roof with generous eaves and clay tile roofing. The inset raised porch features concrete steps flanked by large concrete planters, with square wood columns. The garage has been converted into interior space.
